Geotechnical and Structural Field Observations from Christchurch, February 2011 Earthquake, in New Zealand

Research Report

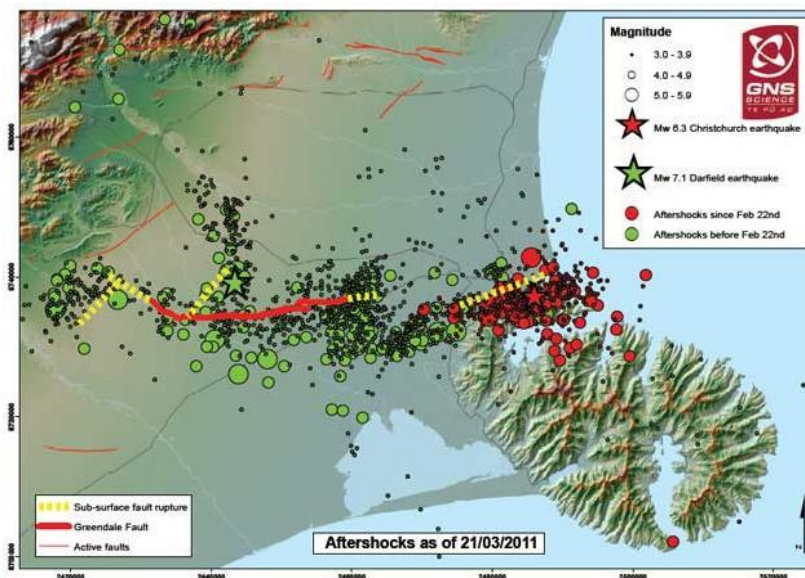
Figure 1.1. Map of the Canterbury regions showing epicenters of the Darfield and Christchurch earthquake sequences. Map axes show N. Zealand Map Grid coordinates in meters. Subsurface rupture segments are based on geodetic and strong motion modeling, with the top edges of the rupture mapped (Graphic by Rob Langridge and William Ries, GNS Science).

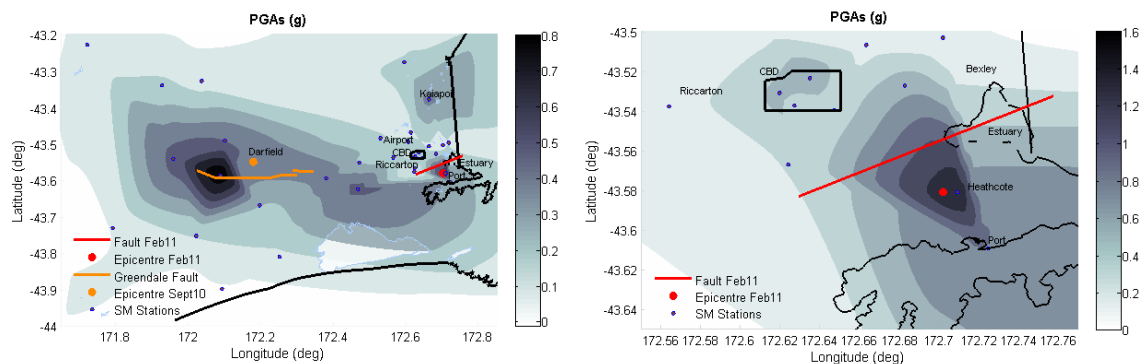
Figure 1.2. Approximate spatial distribution of the peak ground accelerations from the Darfield (left) and Christchurch (right) earthquakes.

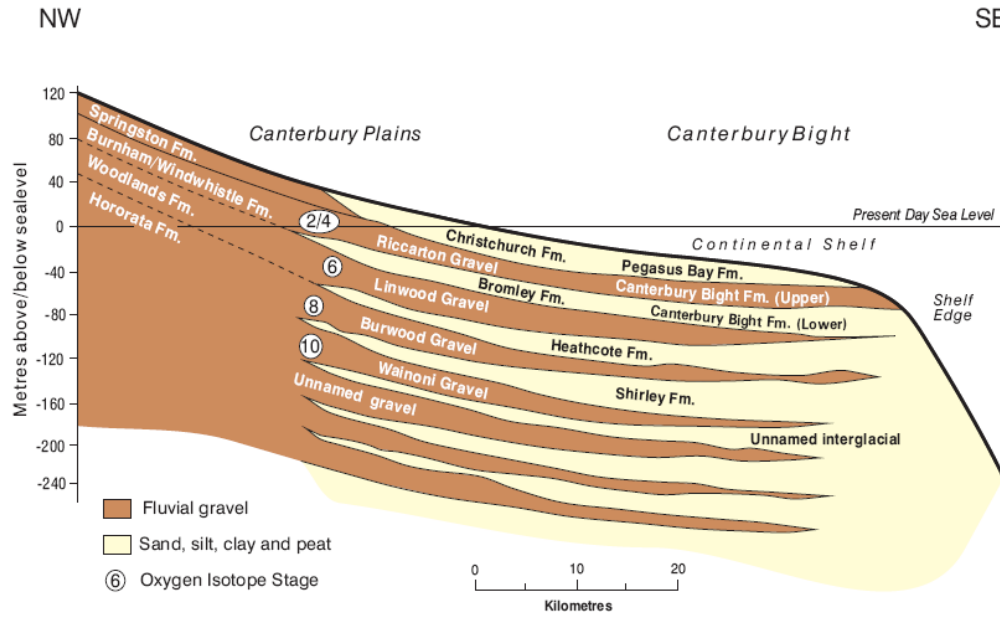
Figure 2.1. Cross section of deposits underlying Christchurch (Brown and Weeber, 1992).

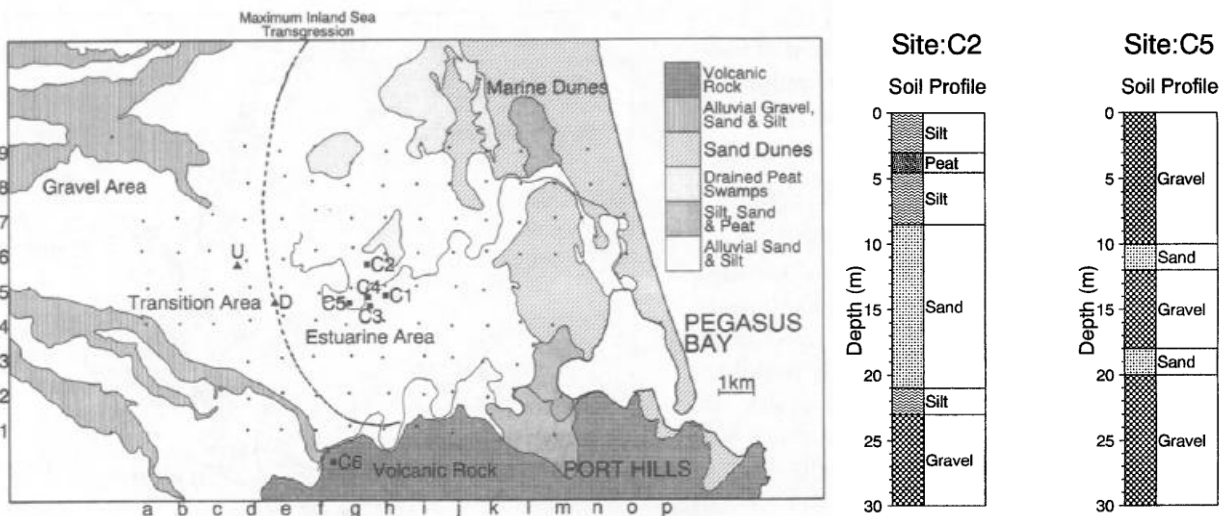
Figure 2.2. Surface geological map of Christchurch (Brown and Weeber, 1992) and soil profiles of the top 30 m of the characteristic sites, C2 and C5 (Elder et al., 1991, and Berrill et al., 1993).

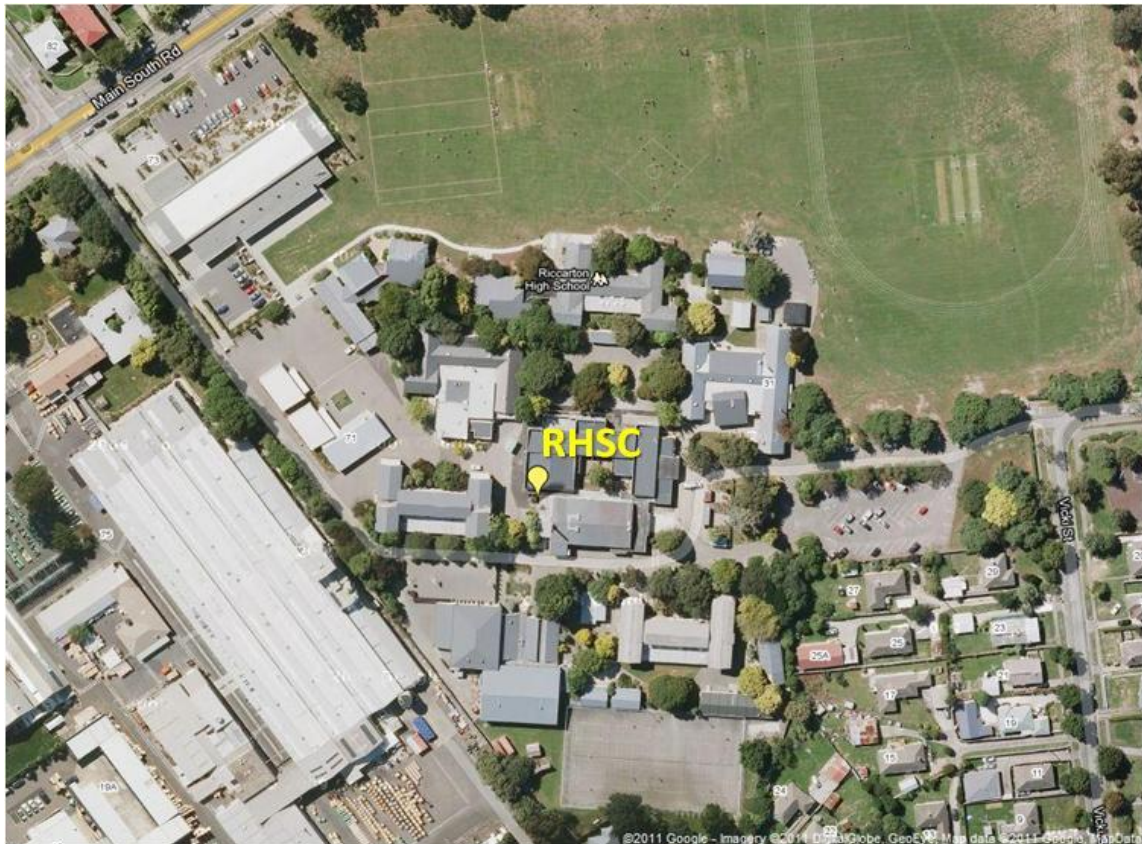
Figure 2.4. Aerial view of RHSC seismic station site.

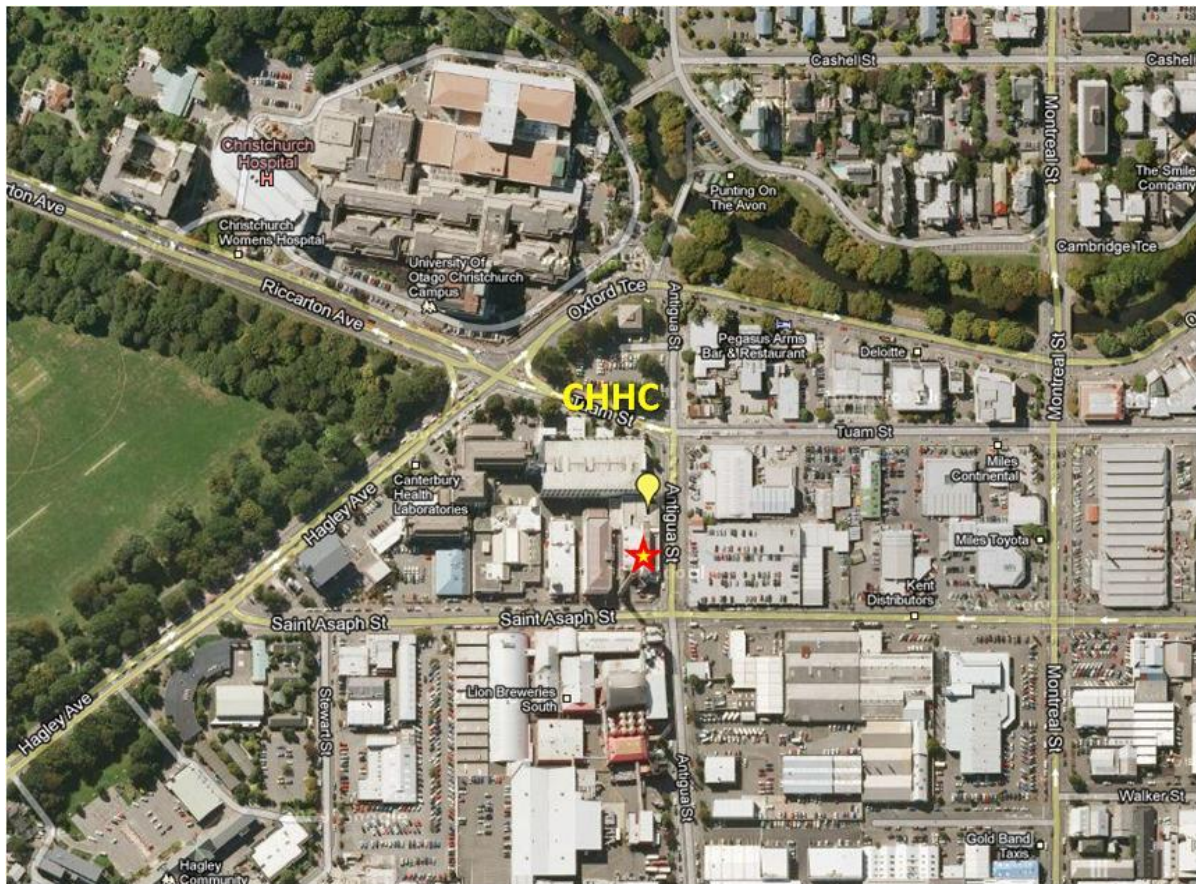
Figure 2.10. Aerial view of RHSC seismic station site. The star indicates the location of the borelog.

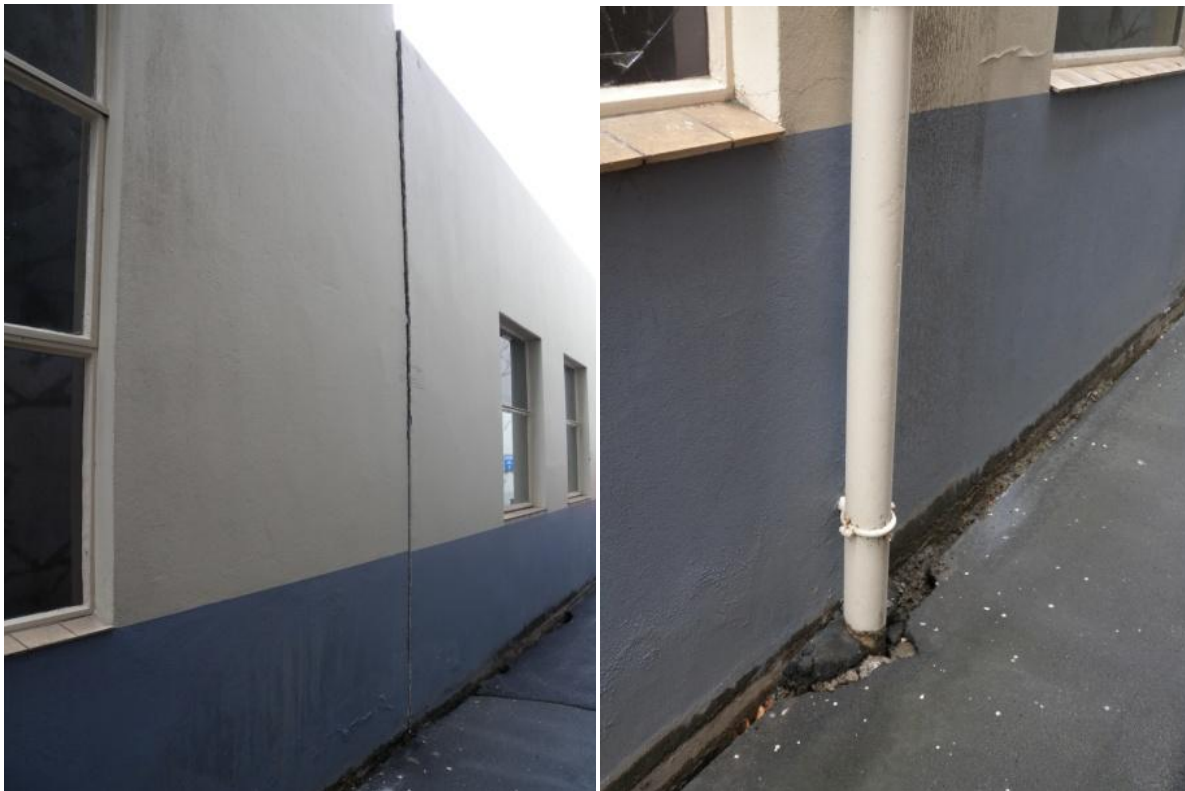
Figure 2.15. Gap between the front and rear section of CHHC seismic station building (left). Liquefied sand was ejected from the crack (right).

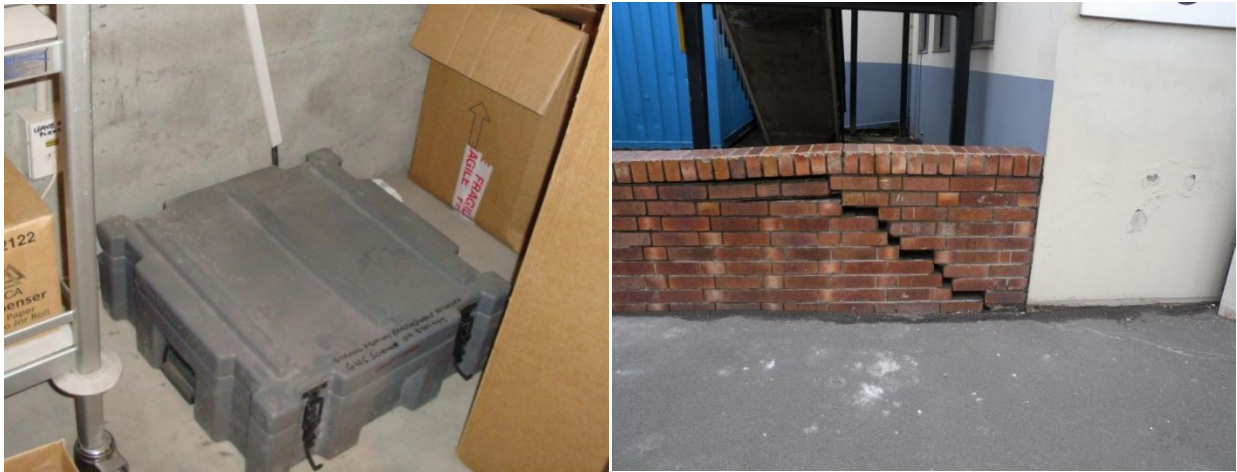
Figure 2.16. Seismograph placed on the ground floor (left). Shear crack in a wall adjacent to CHHC seismic station building due to liquefaction-induced differential settlement and possible heaving (right).

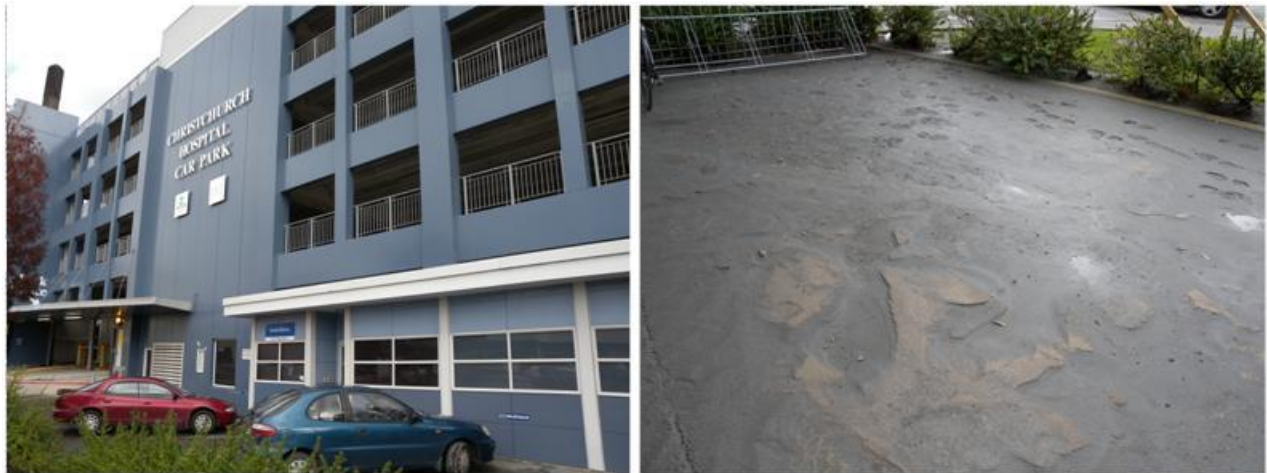
Figure 2.17. Christchurch Hospital Car Park (239 Antigua St) adjacent to CHHC seismic station building (left). Ejected sand in front of Christchurch Hospital Car Park 40 days after the earthquake (right).

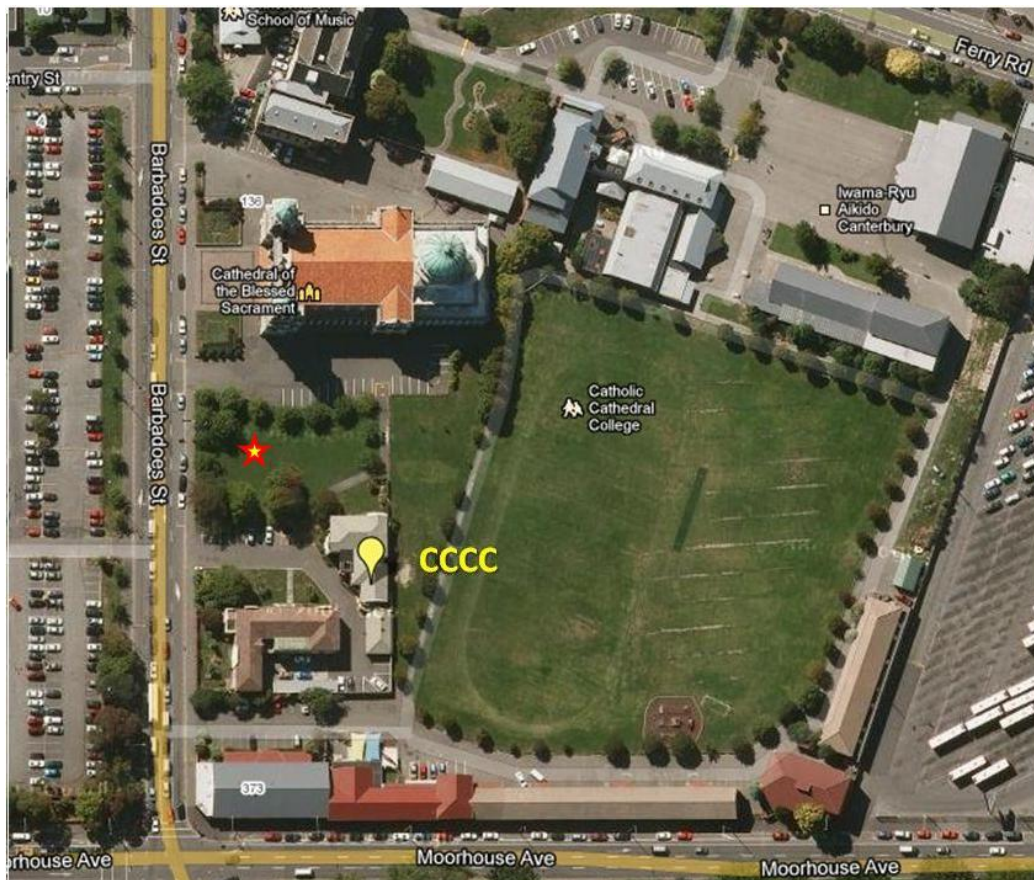
Figure 2.18. Aerial view of CCCC seismic station site. The star indicates the location of the borelog.

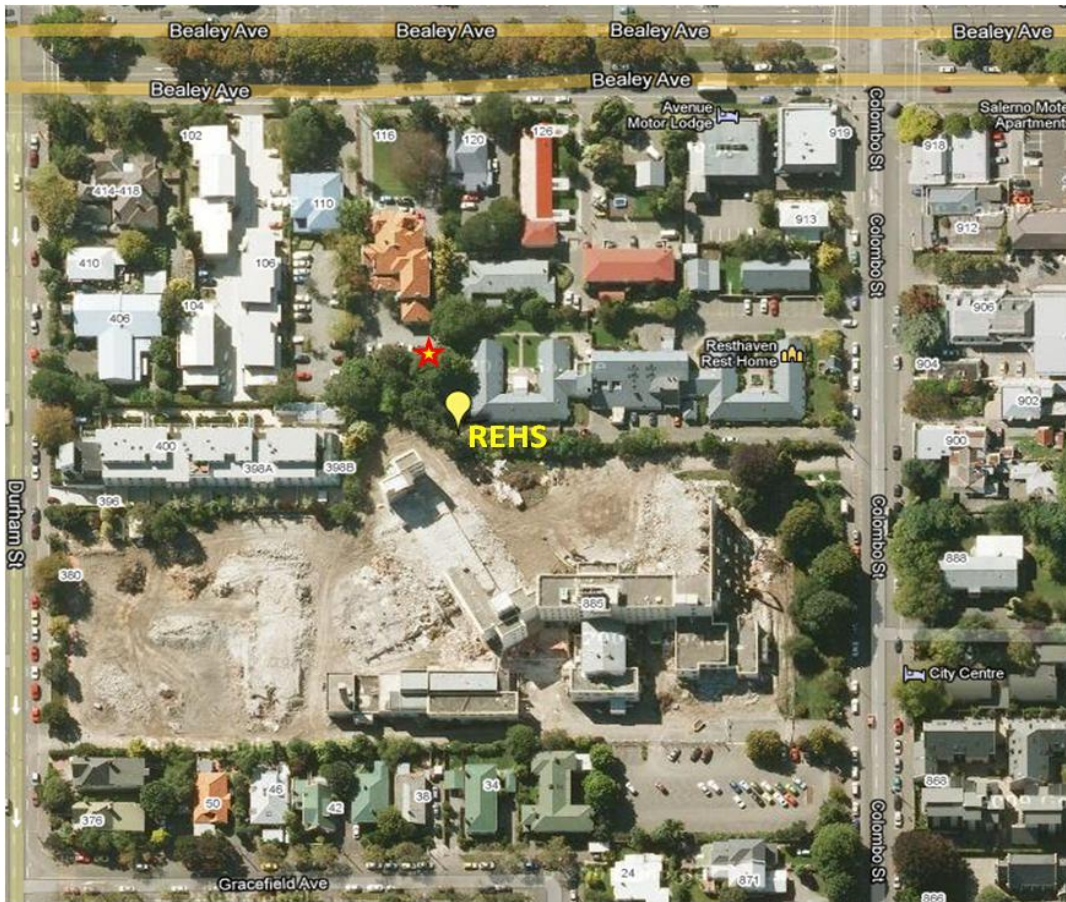
Figure 2.25. Close plan view of REHS seismic station site. The star indicates the location of the borelog.

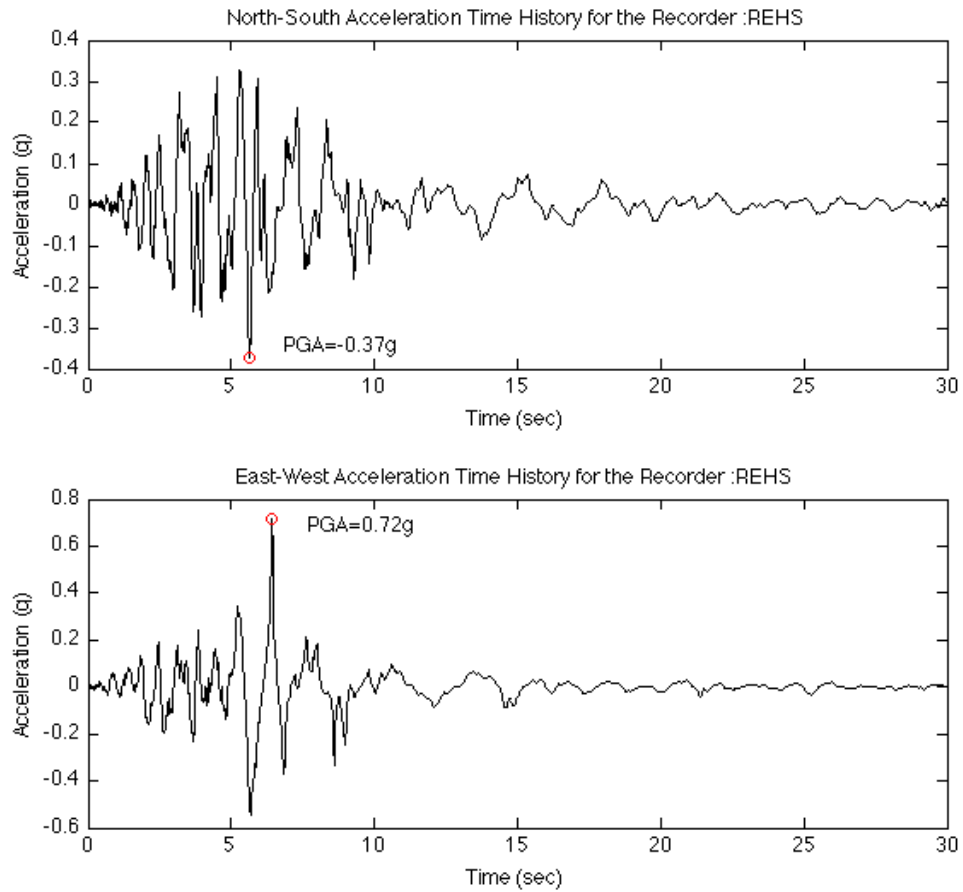
Figure 2.26. The two horizontal components of the REHS record.

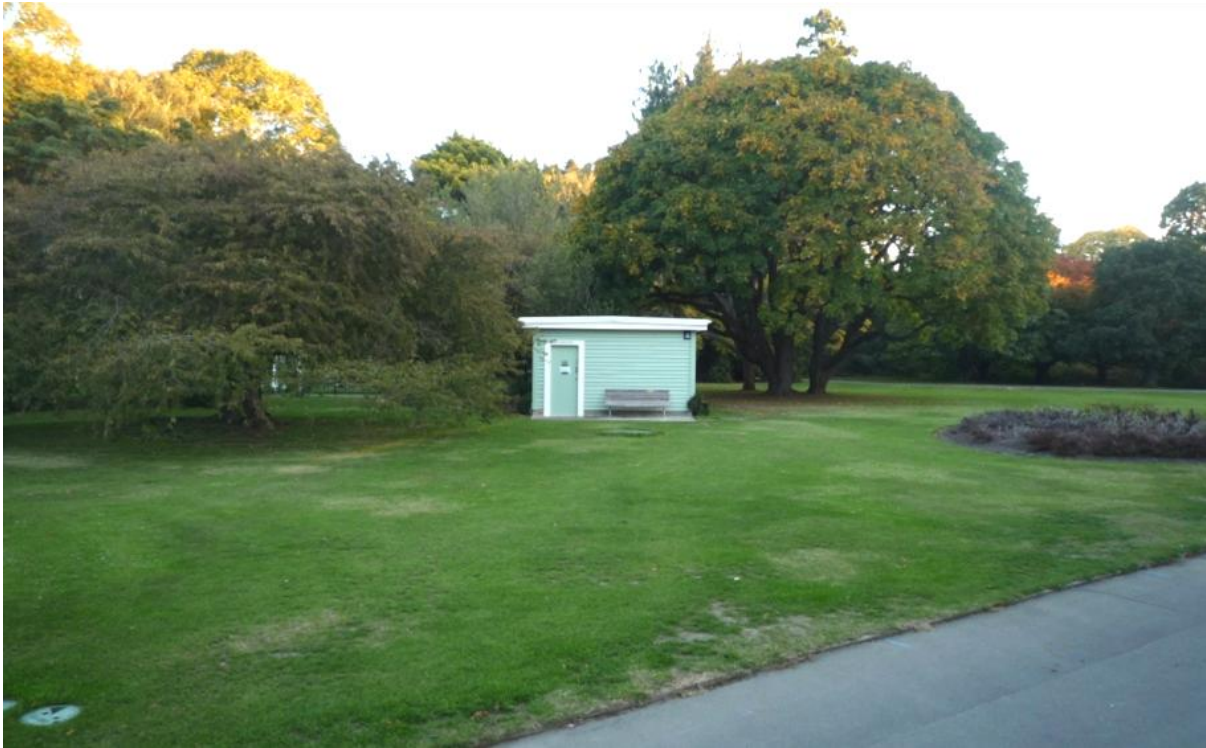
Figure 2.34. CBGS seismic station. The stains on the grass were from liquefaction, once the sand boils had been cleaned.

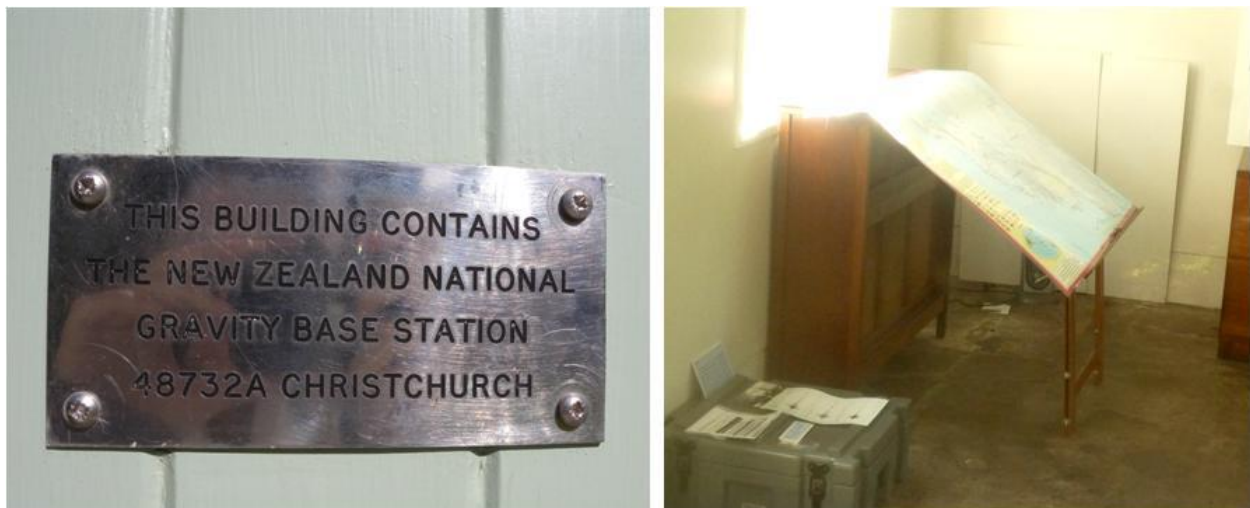
Figure 2.35. The seismograph in CBGS seismic station.

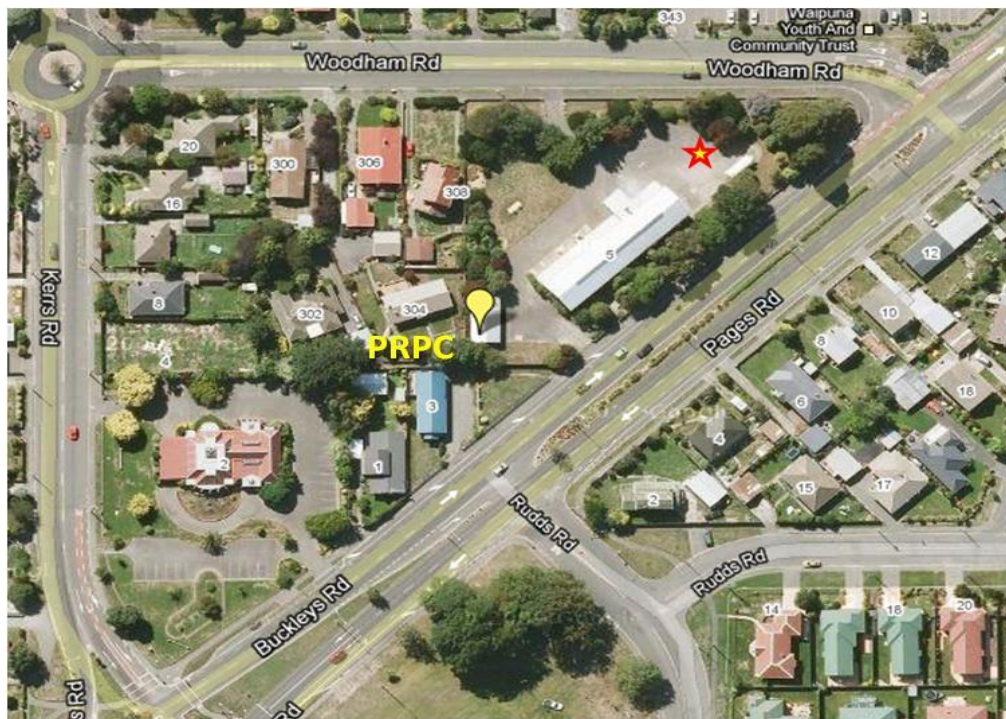
Figure 2.40. Aerial view of PRPC seismic station site. The star indicates the location of the borelog.

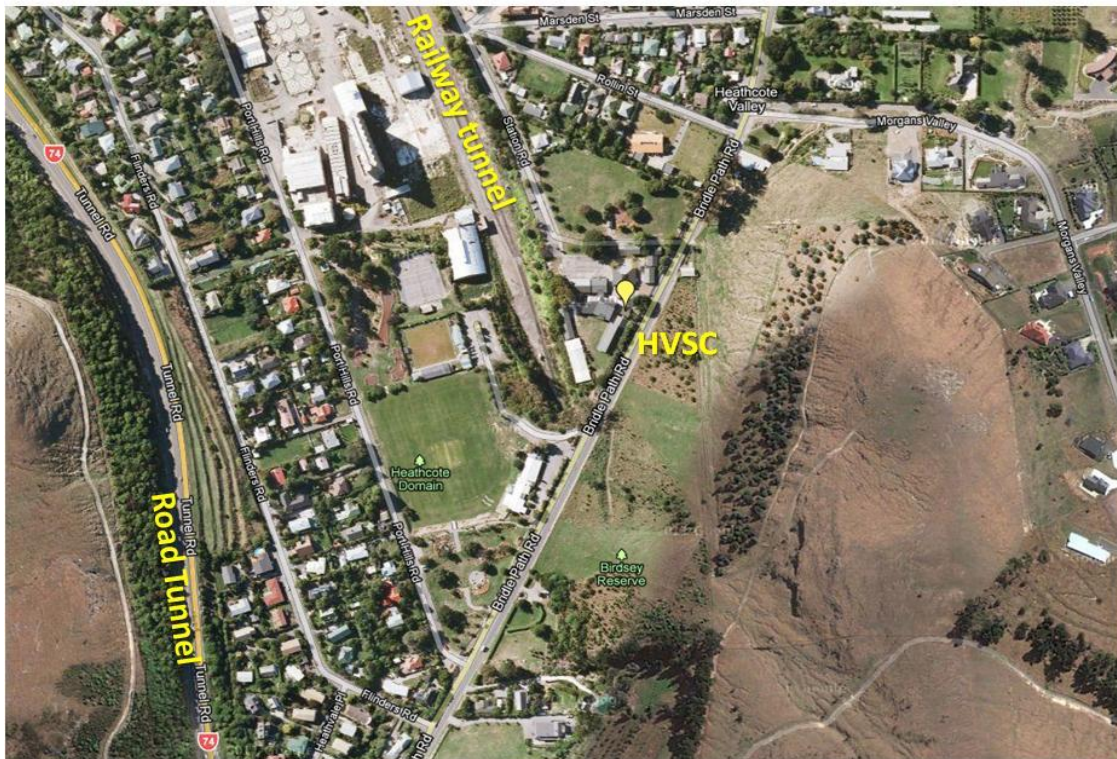
Figure 2.47. Aerial view of HVSC seismic station site.

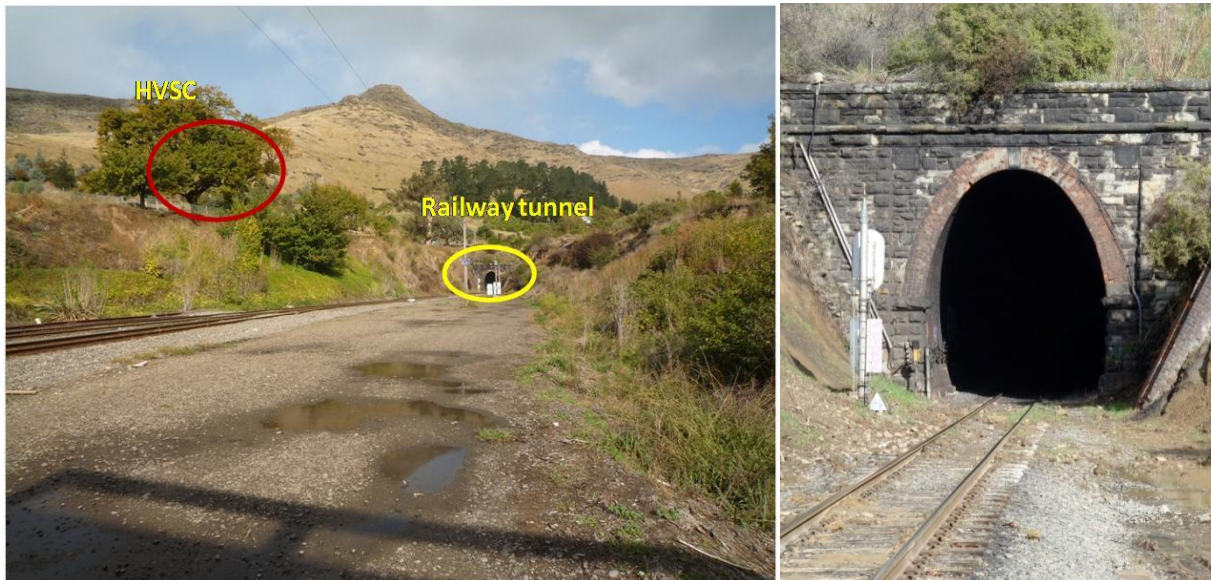
Figure 2.48. The excavation adjacent to HVSC station, leading to railway tunnel. The remnants of rain water show that it cannot be easily absorbed by the soil which is indicative of clayey soil with low permeability(left). The entrance to the railway tunnel. No damage was reported (right).

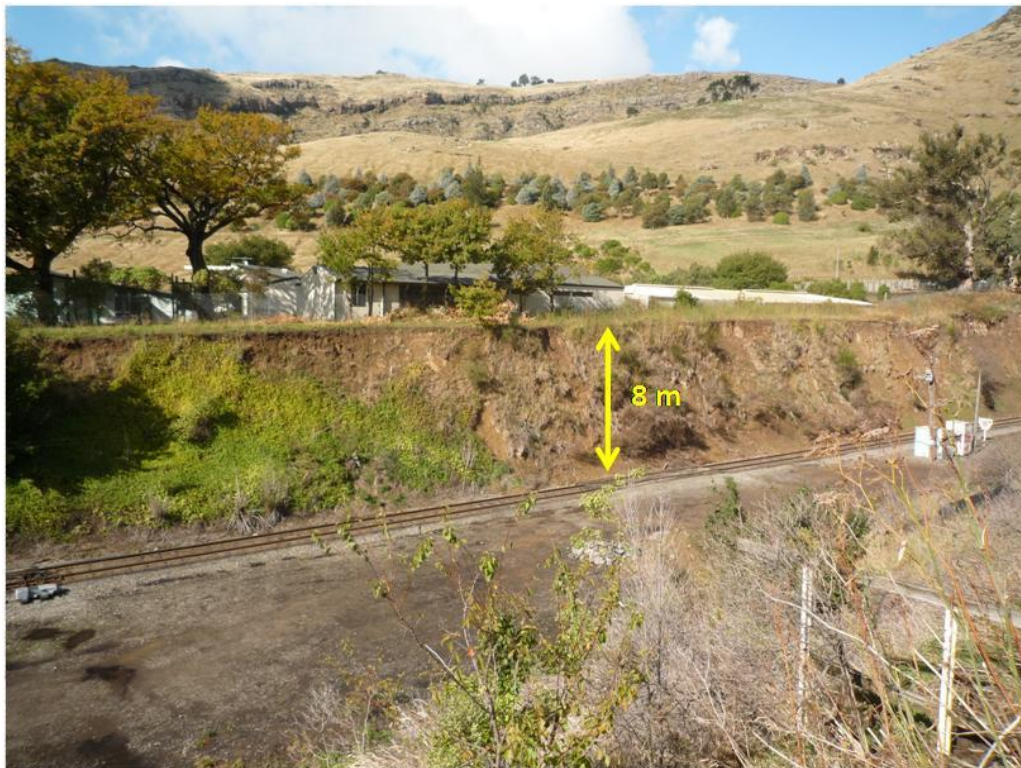
Figure 2.49. The vertical slope of stiff clay (8 m high) adjacent to HVSC station.

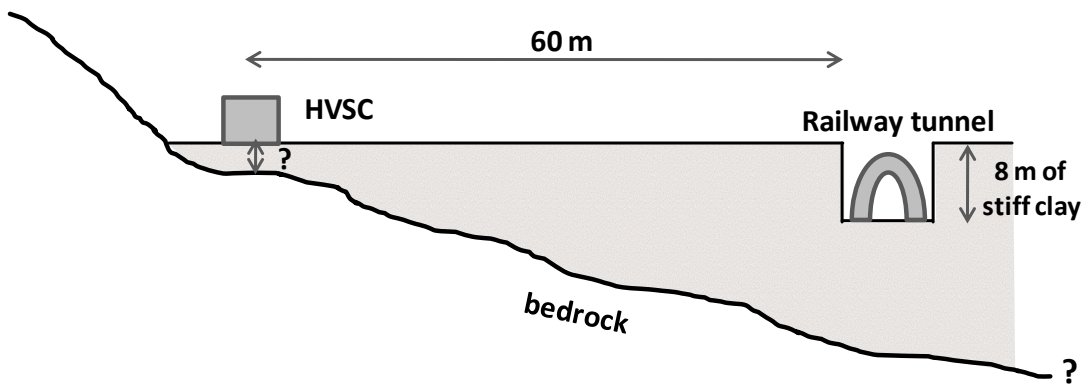
Figure 2.50. Sketch of the topography and soil geometry of the HVSC seismic station site.

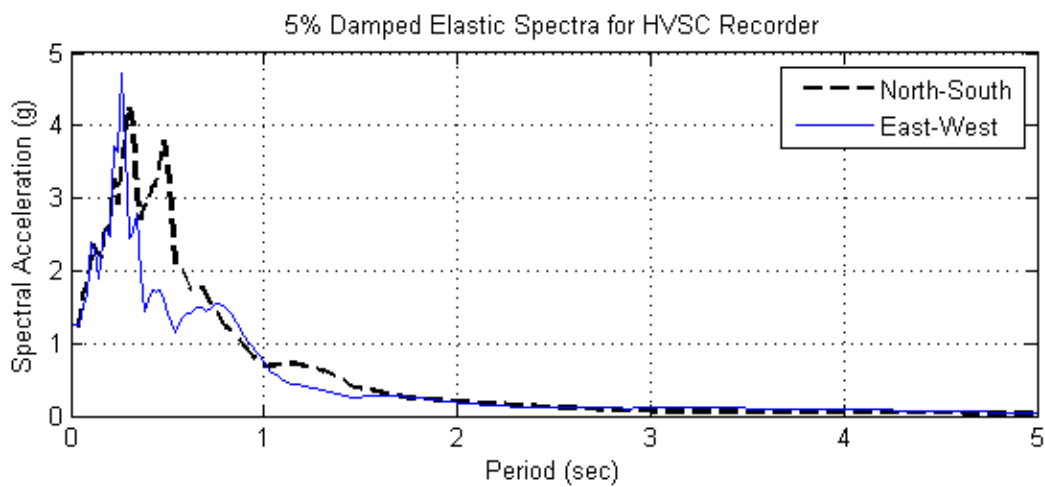
Figure 2.53. Acceleration spectra in NS-EW directions of the HVSC record.

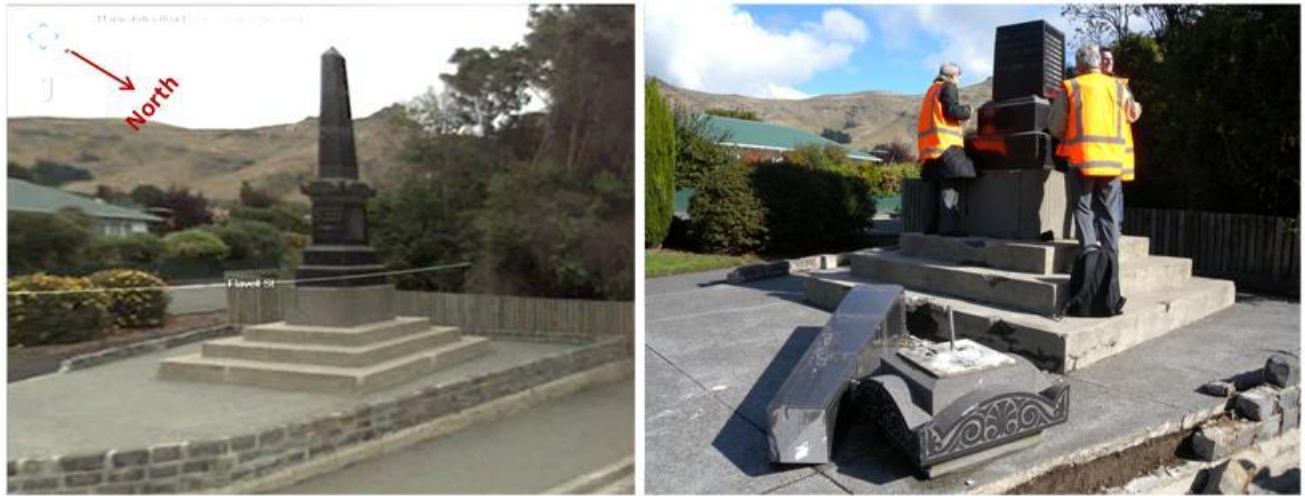
Figure 2.54. Obelisk at the corner of Bridle Path Road and Martindales Road close to HVSC station before Christchurch earthquake (left). Fallen obelisk after the earthquake (right).

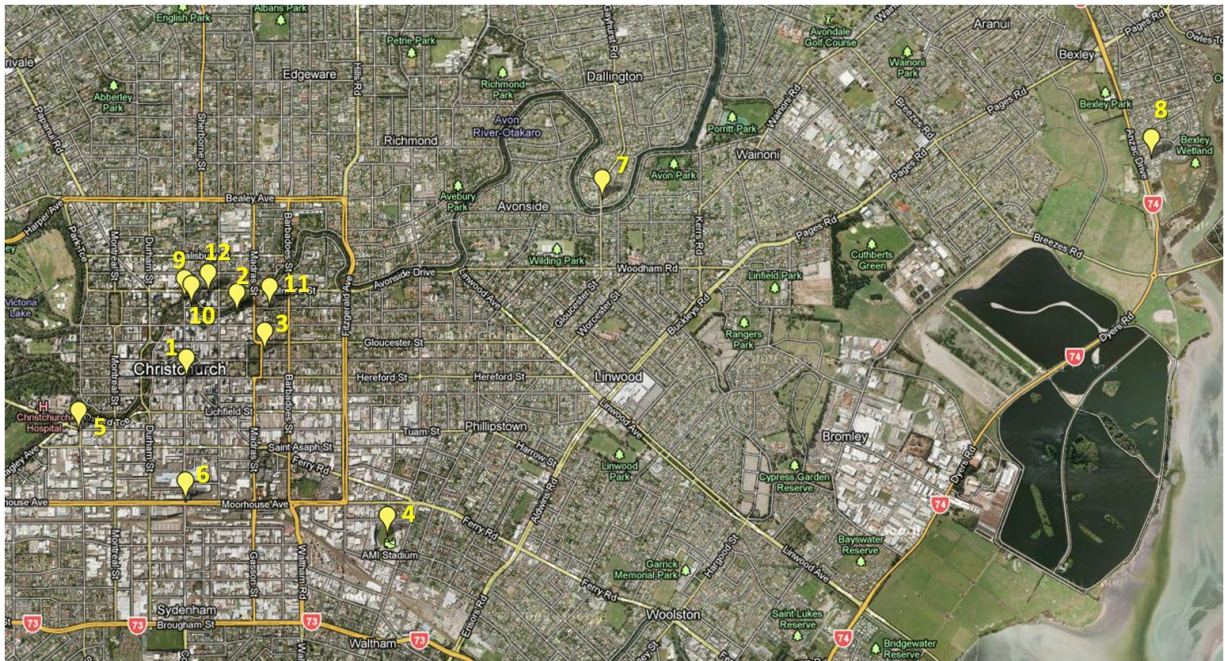
Figure 2.61. Map pointing indicative liquefied sites corresponding to the photos in Figure 2.62.

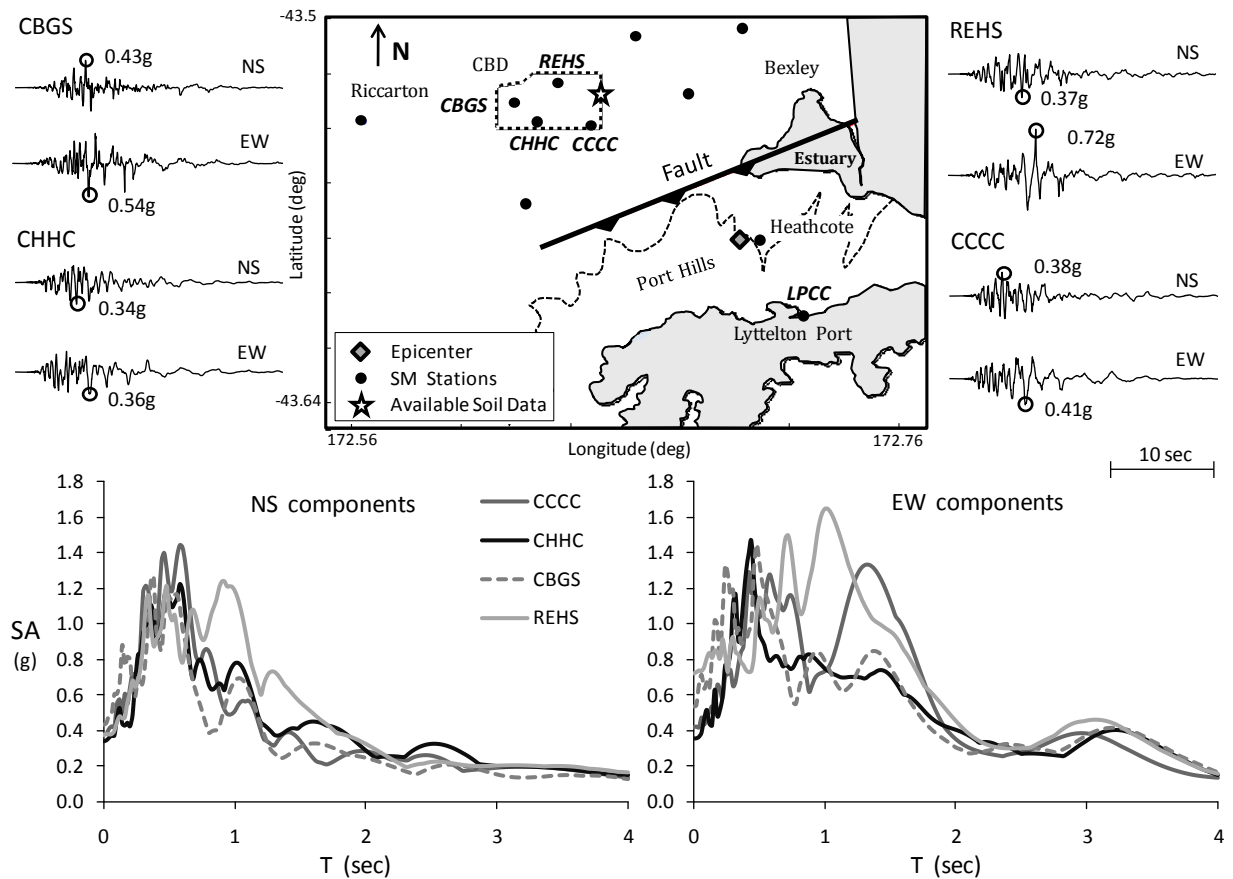
Figure 2.64 Map of the Christchurch broader area showing the intersection of the fault plane with the ground surface (from GNS Science), the location of the accelerograph stations, the epicenter, and the location with available soil data. Acceleration time histories and spectra of four CBD (Central Business District) seismic stations for NS and EW directions. Source: Smyrou et al., 2011.

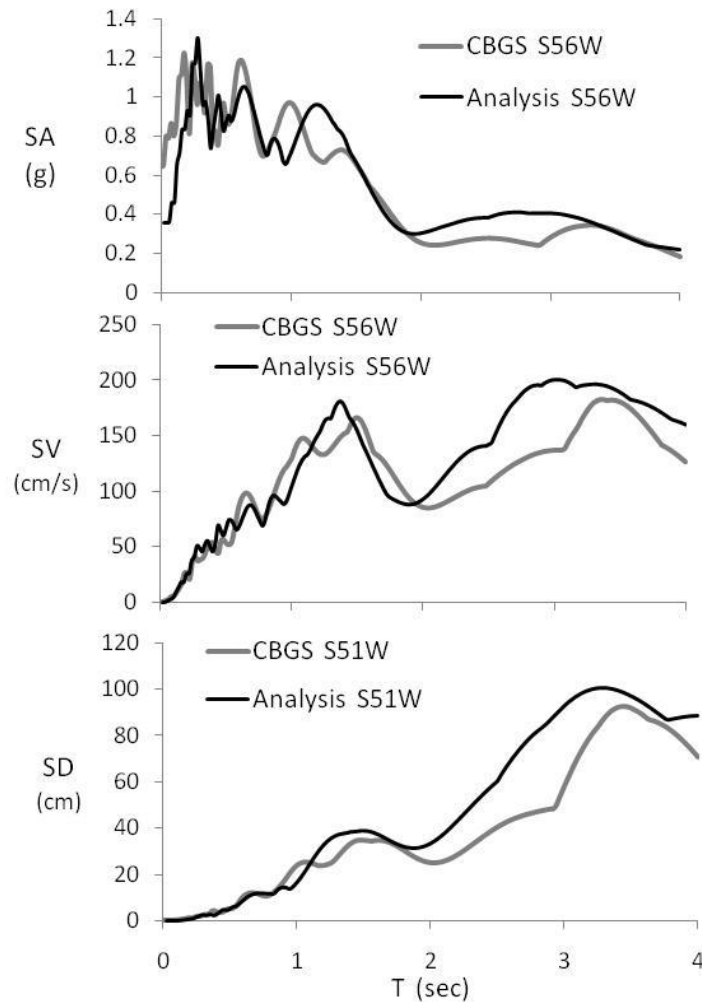
Figure 2.65 Comparison of 5%-damped spectra between CBGS record and analysis. Source: Smyrou et al. (2011).

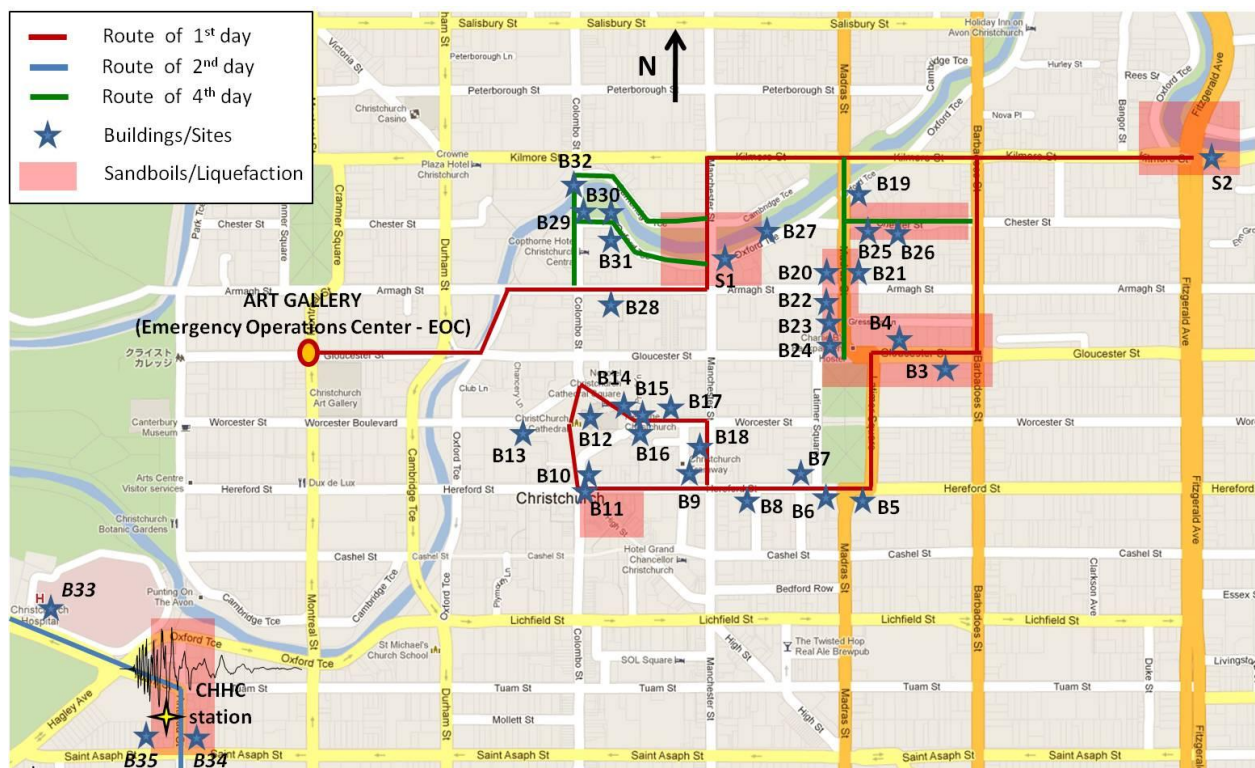
Figure 3.1. Red, blue and green routes followed in CBD and the spatial distribution of structural damages and building sites.

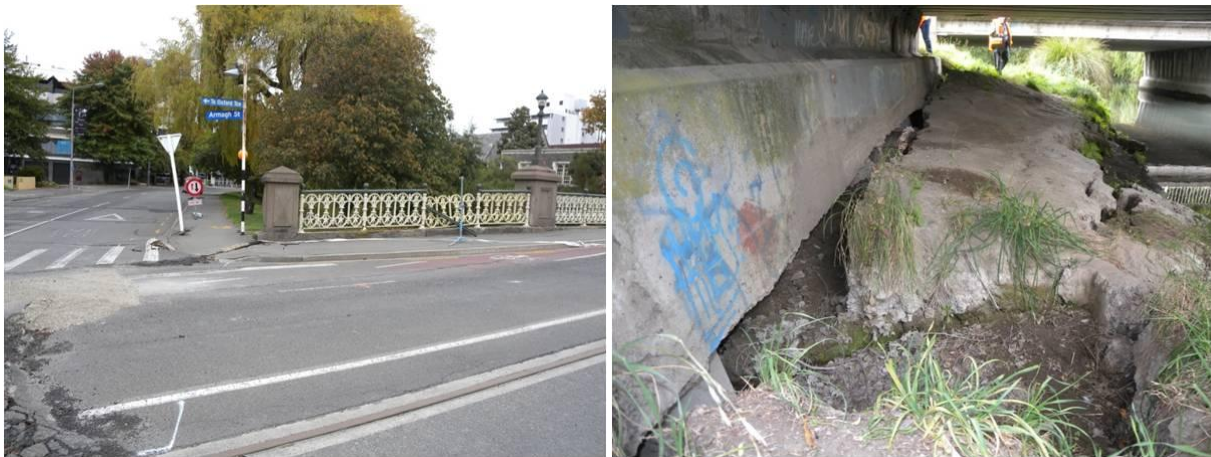
Figure 3.2. Bridge at Oxford Terrace (left) and rotated abutment of Fitzgerald bridge (right).

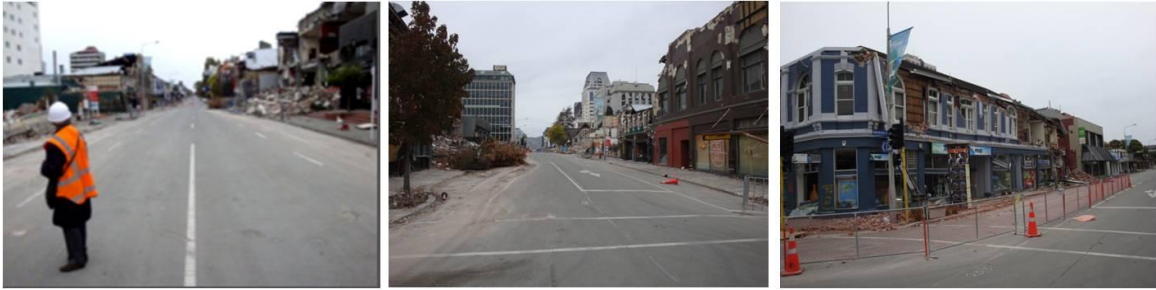
Figure 3.3. View of Manchester Street.

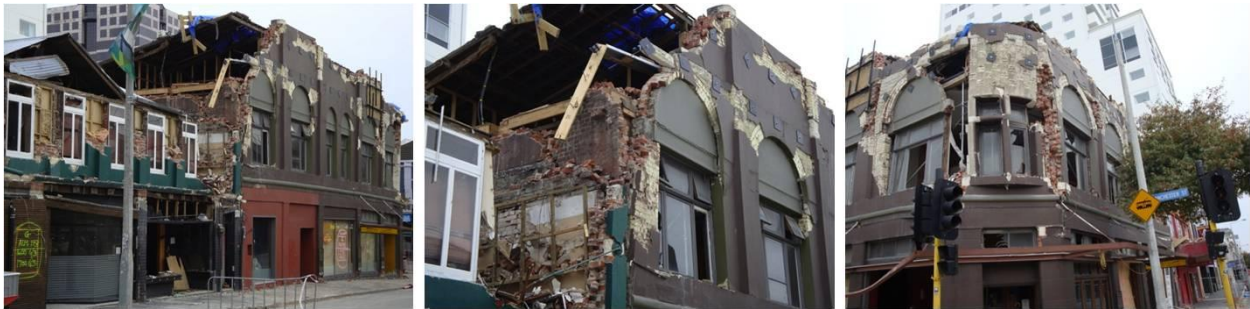
Figure 3.4. Damaged buildings at Manchester Street.

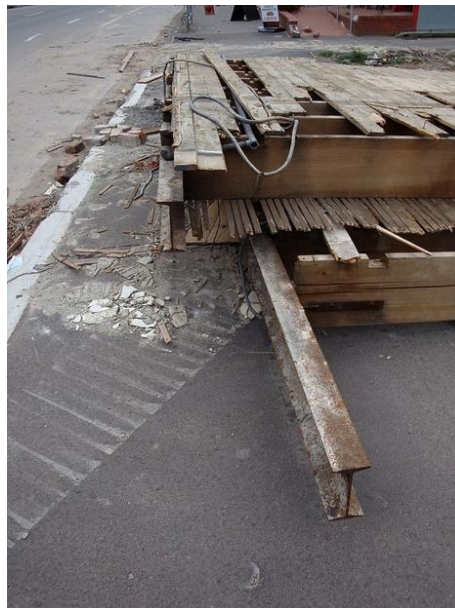
Figure 3.5. A composite slab found at Manchester Street.

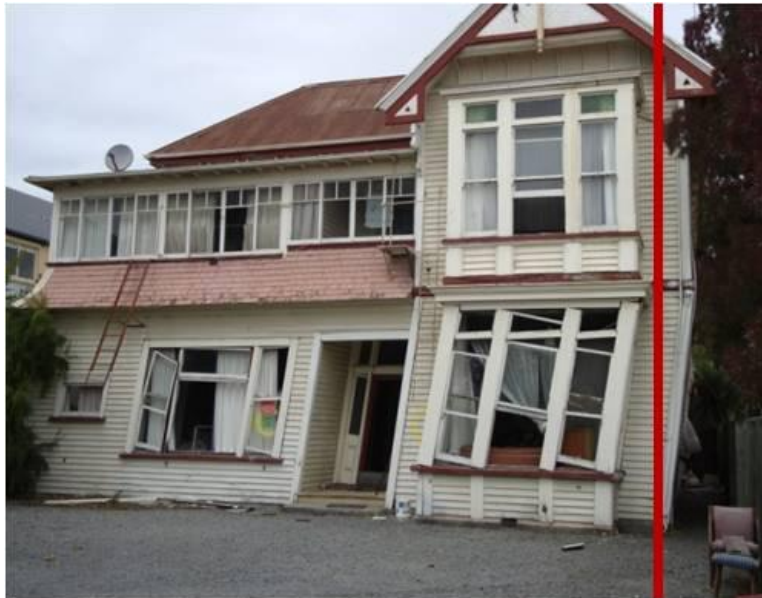
Figure 3.6. Collapsed wooden residence at Gloucester St.

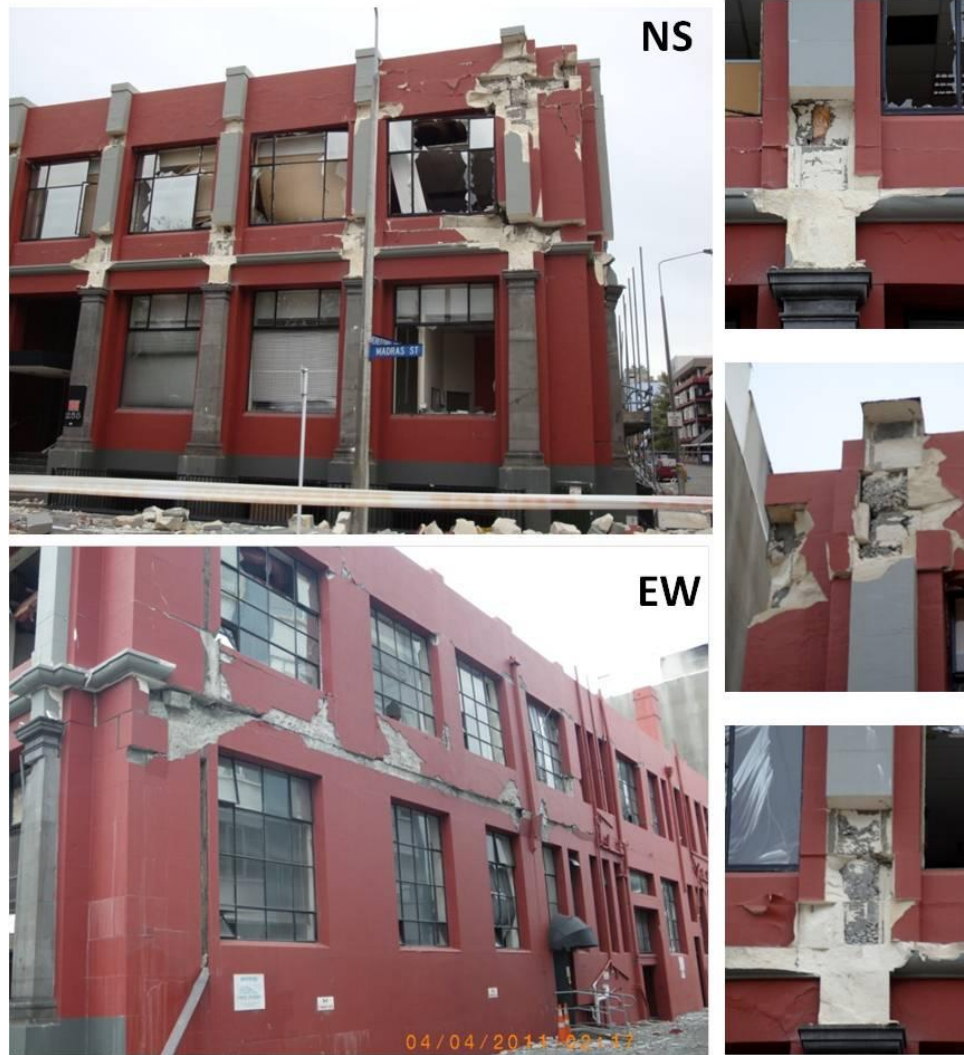
Figure 3.10. Building at Hereford and Madras Streets.
