Geotechnical and Structural Field Observations from Christchurch, February 2011 Earthquake, in New Zealand

Research Report

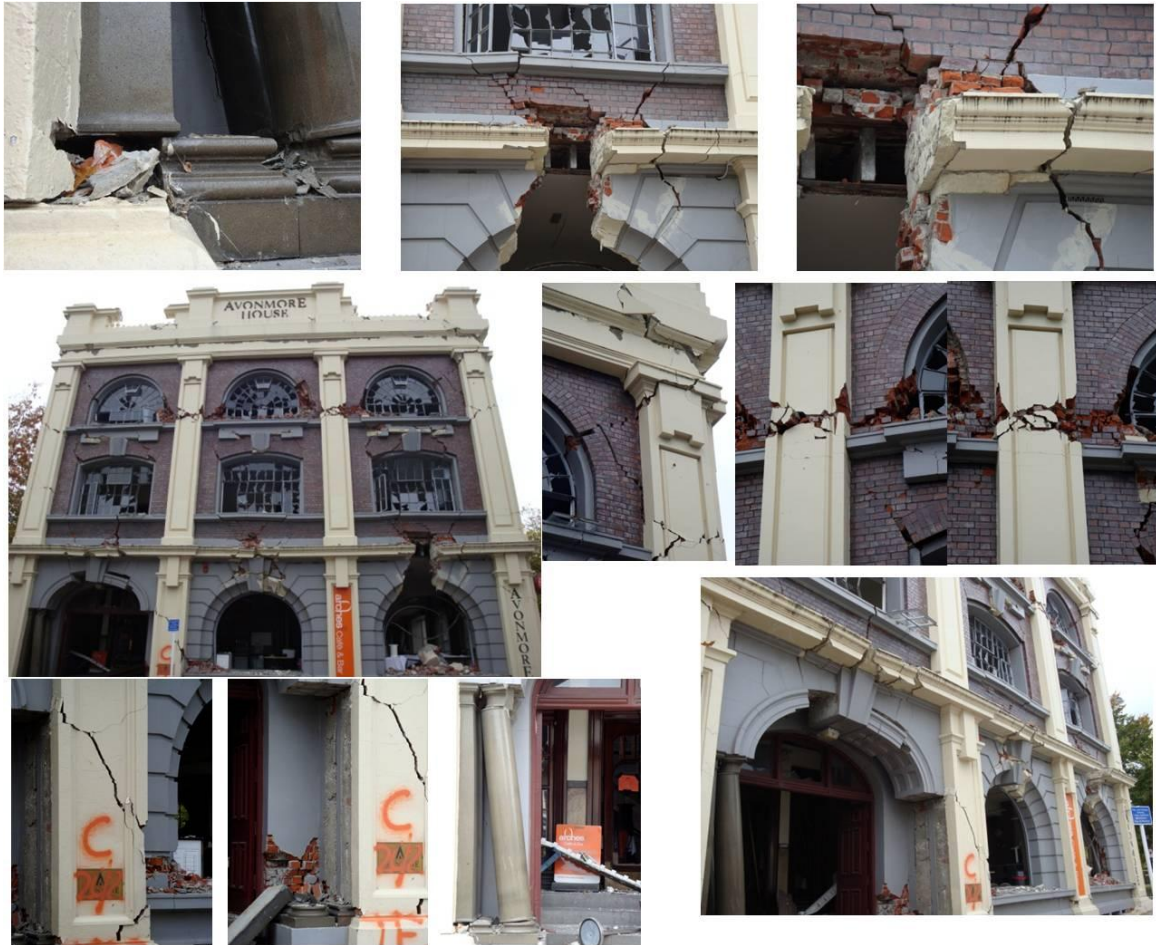
Figure 3.11. Building at Hereford St and Latimer Square – EW direction

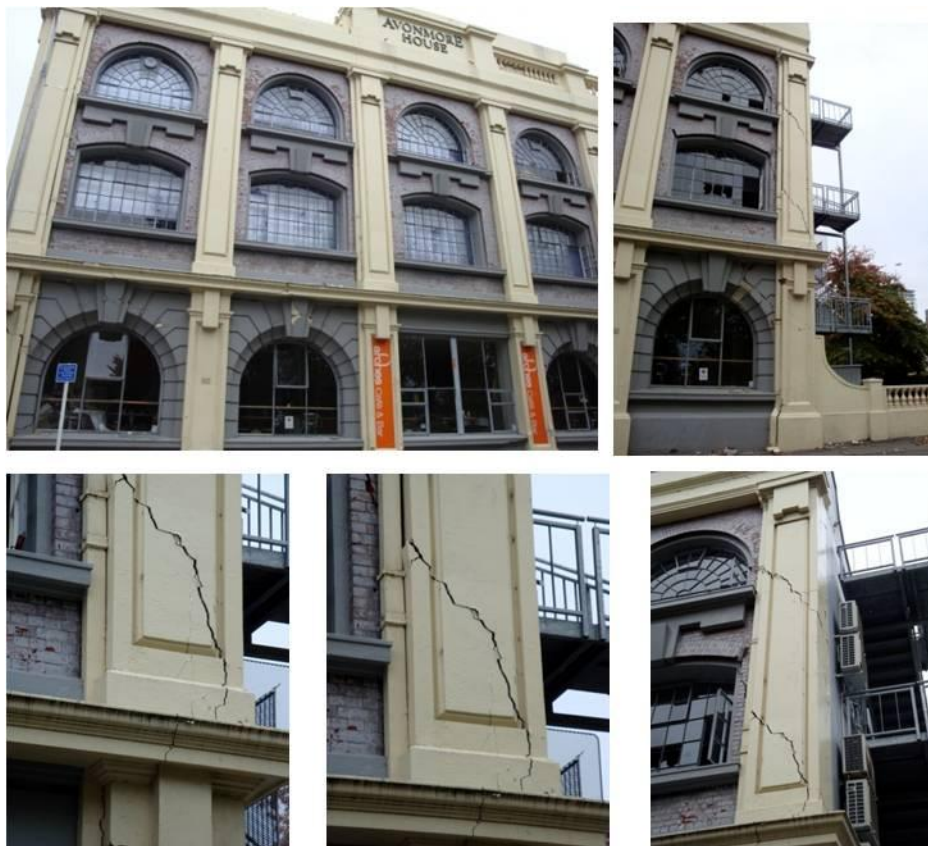
Figure 3.13. Building at Hereford St and Latimer Square – NS direction.

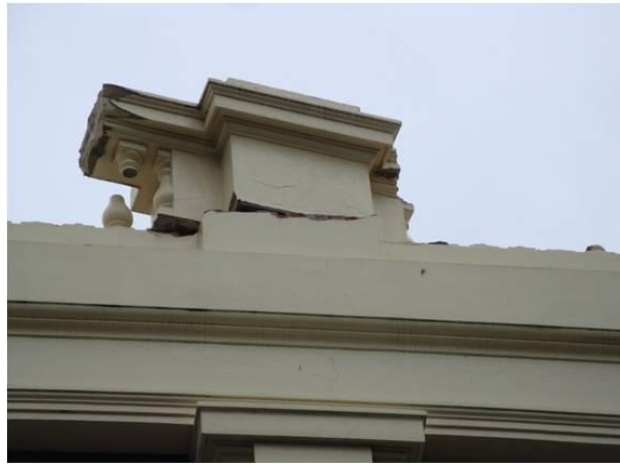
Figure 3.14. Massive decorative element disconnected from the main body of the structure.

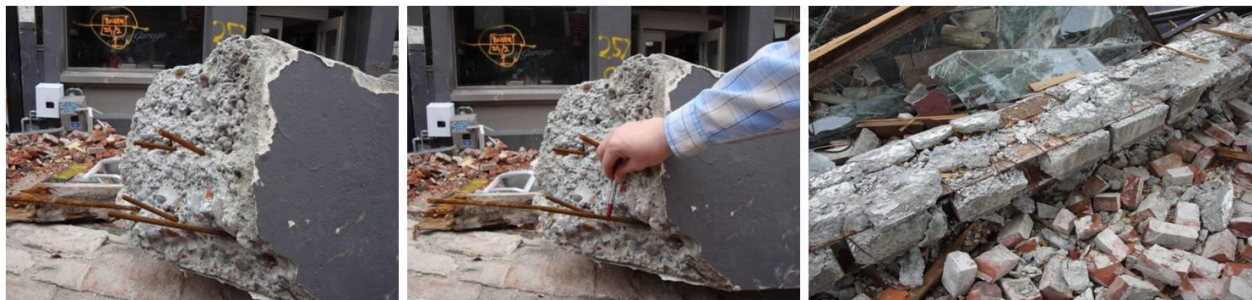
Figure 3.15. Insufficient reinforcement, low quality concrete and bad application caused collapse of a decorative beam and 1 casualty.

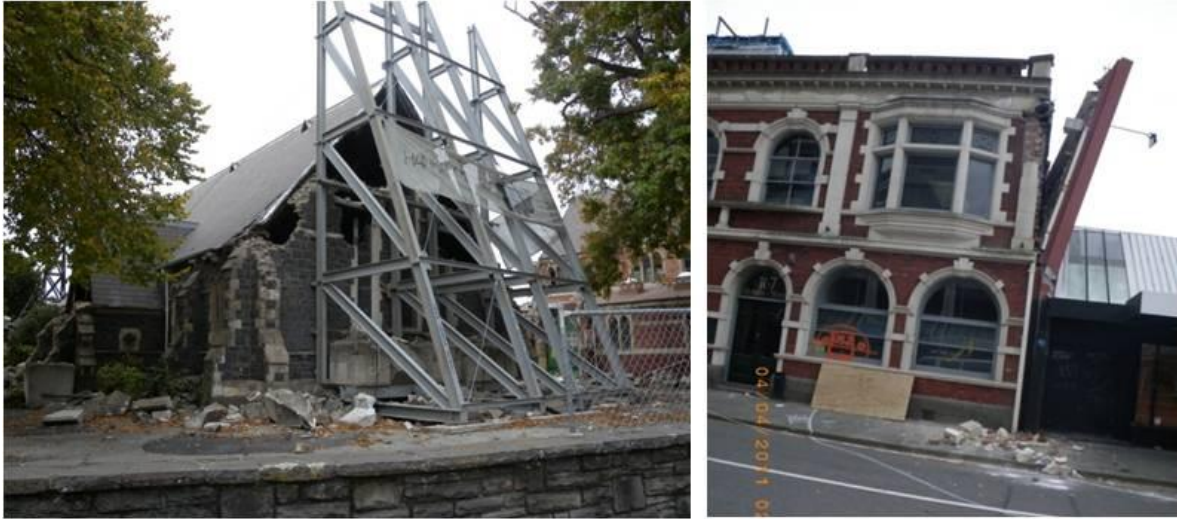
Figure 3.16. Out-of-plane failures around Hereford Street.

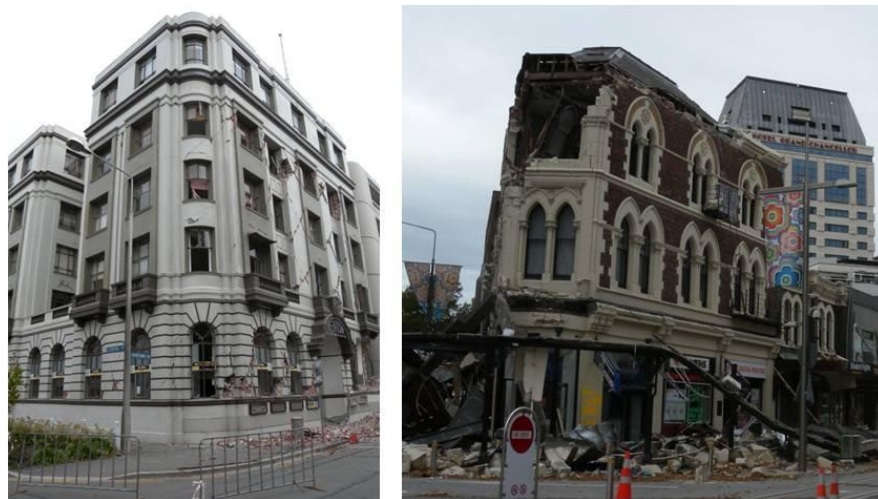
Figure 3.17. Severely damaged building at Hereford St with characteristic shear cracks and historical building at Stewart Square.

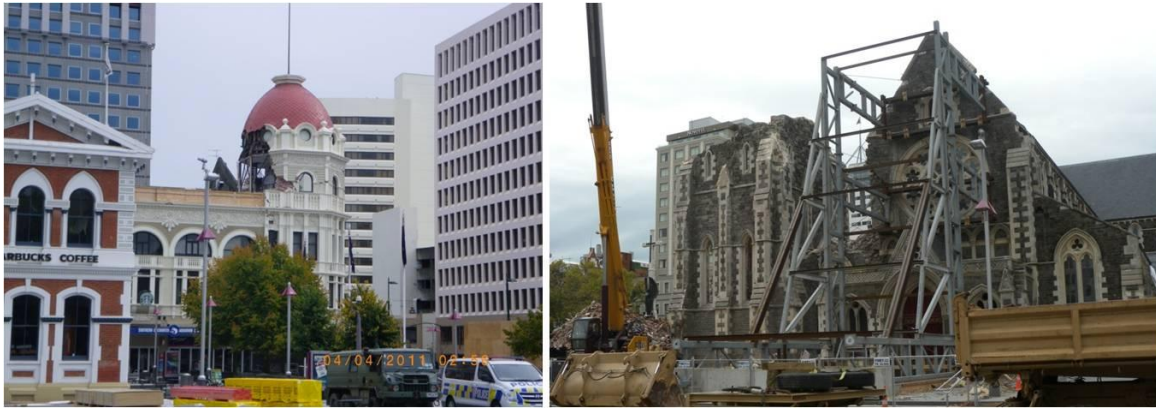
Figure 3.18. Collapse of dome and view of the heavily damaged and partially collapsed Cathedral.

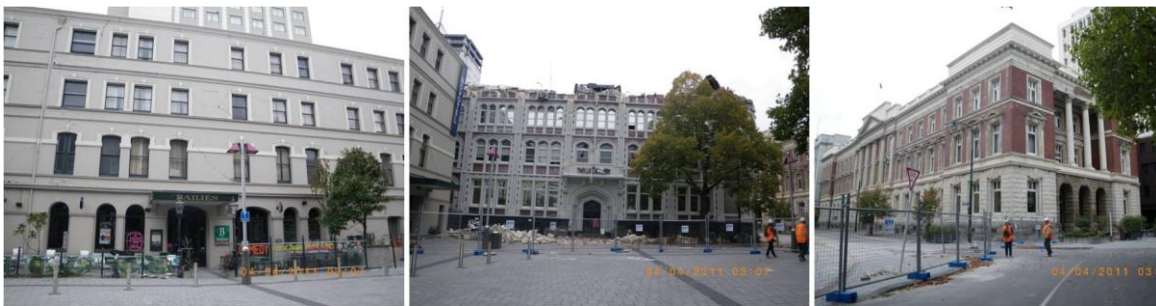
Figure 3.19. Buildings in the Cathedral Square.

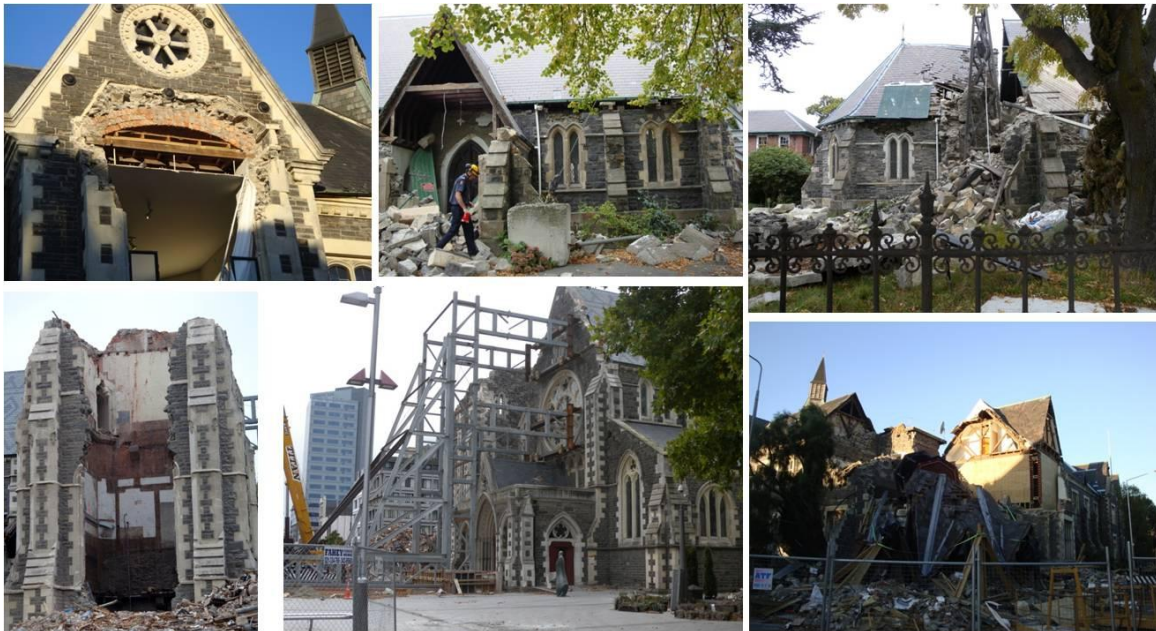
Figure 3.20. Several historical masonry buildings, including the Cathedral, with significant damage.

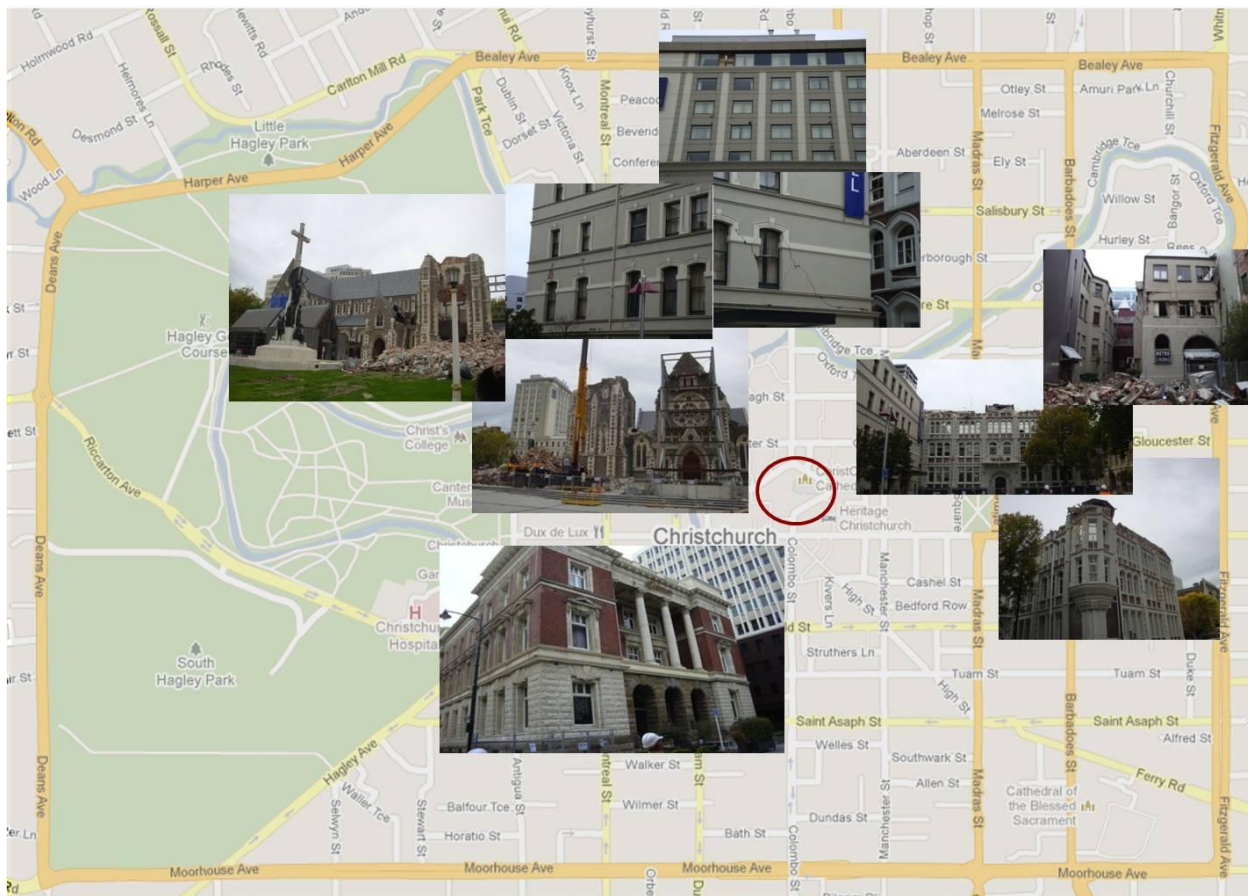
Figure 3.21. Buildings around the Cathedral Square.

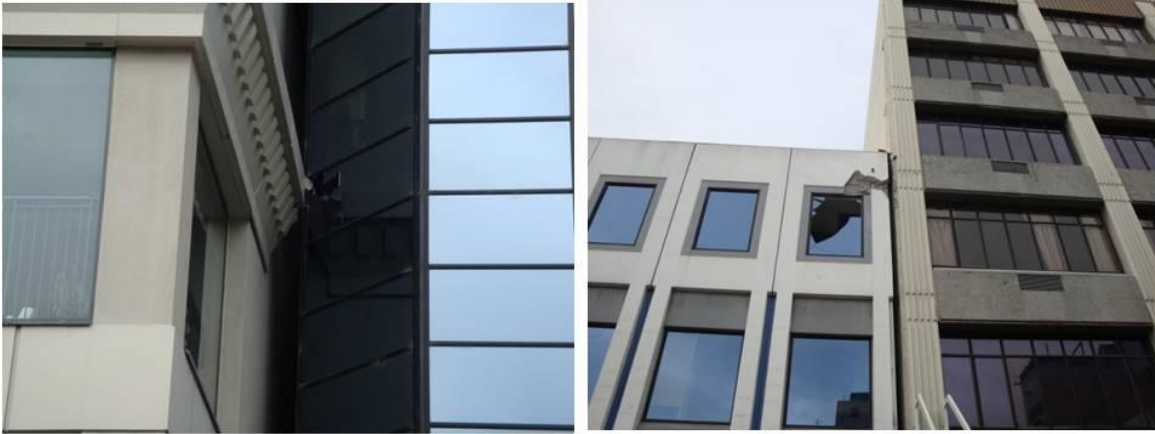
Figure 3.22. Observed pounding effect in CBD.

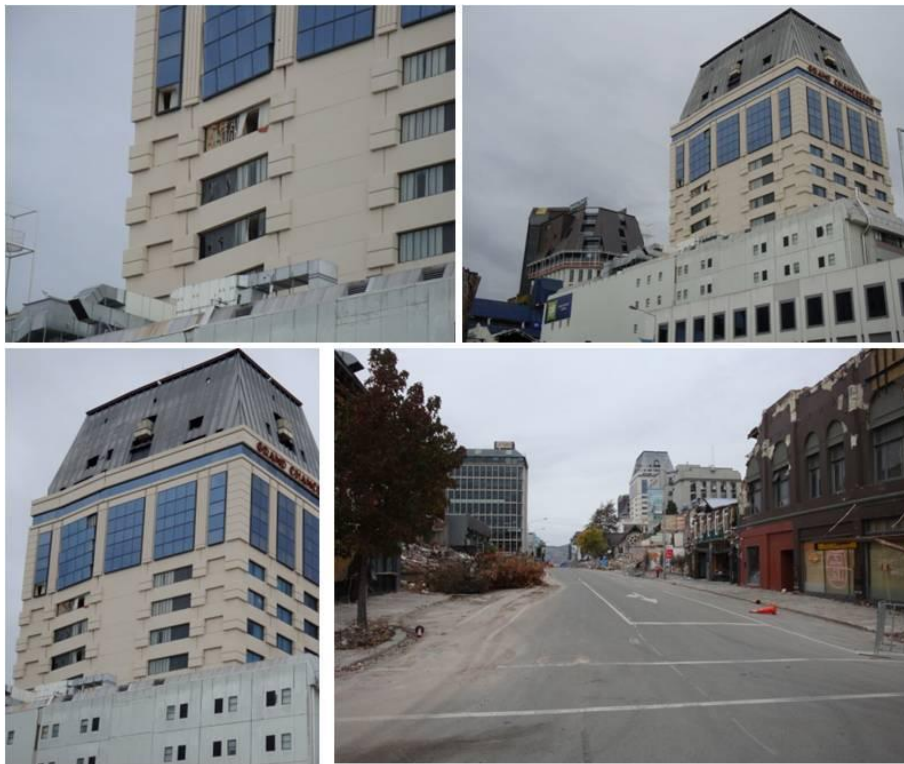
Figure 3.23. Views of the Hotel Grand Chancellor.

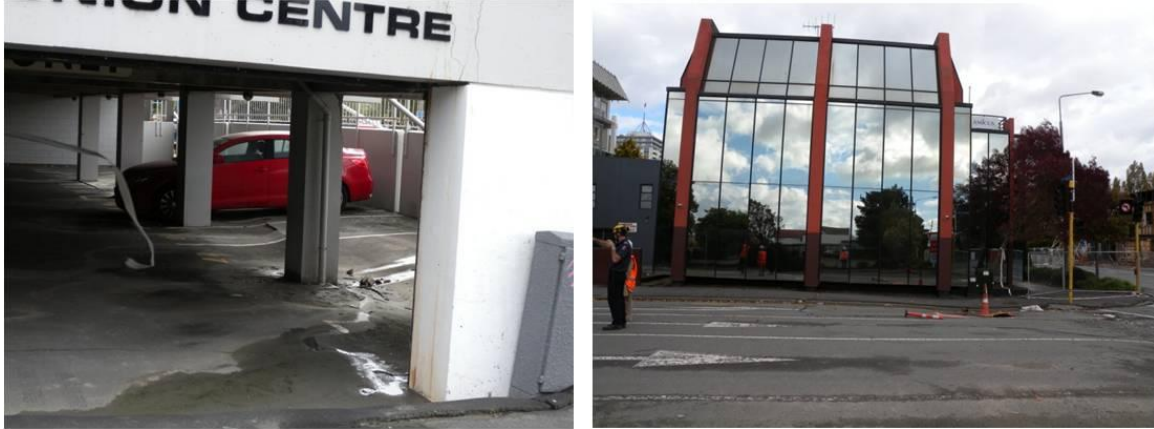
Figure 3.24. Buildings (B20 left and B22 right) damaged due to differential settlements induced by liquefaction.

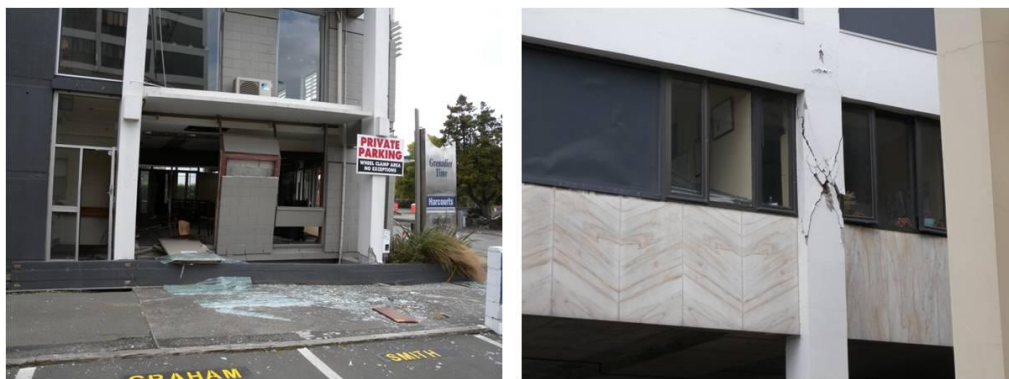
Figure 3.25. Heavily damaged buildings at Madras Street.

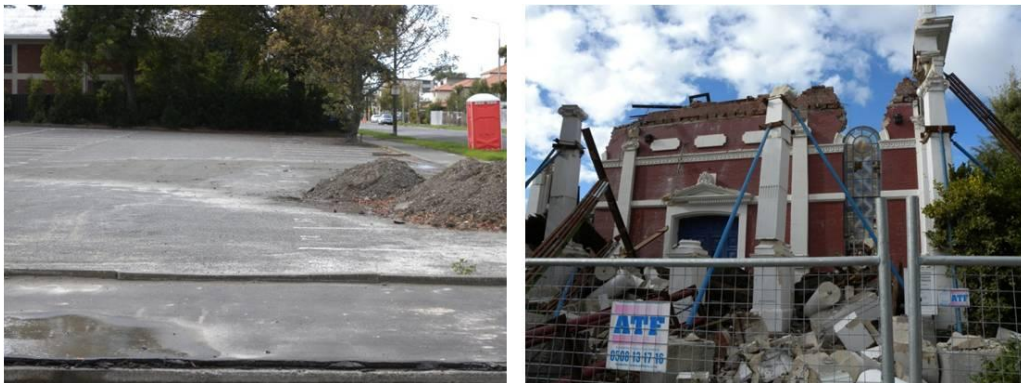
Figure 3.26. Sand boils after liquefaction and collapsed masonry structure at Madras Street.

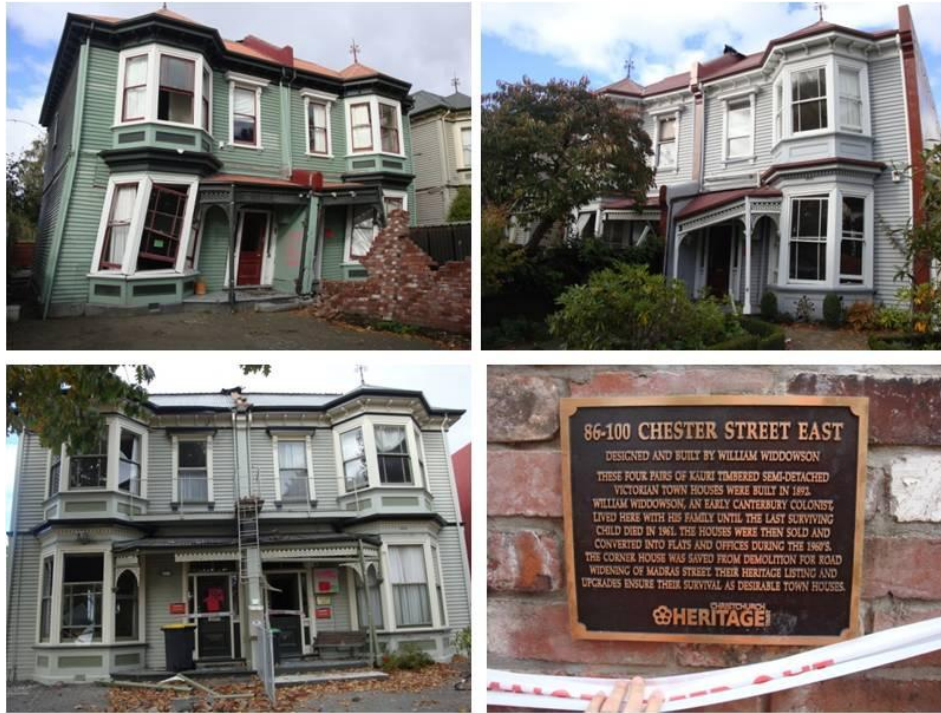
Figure 3.27. Historical wooden structures at Chester Street.

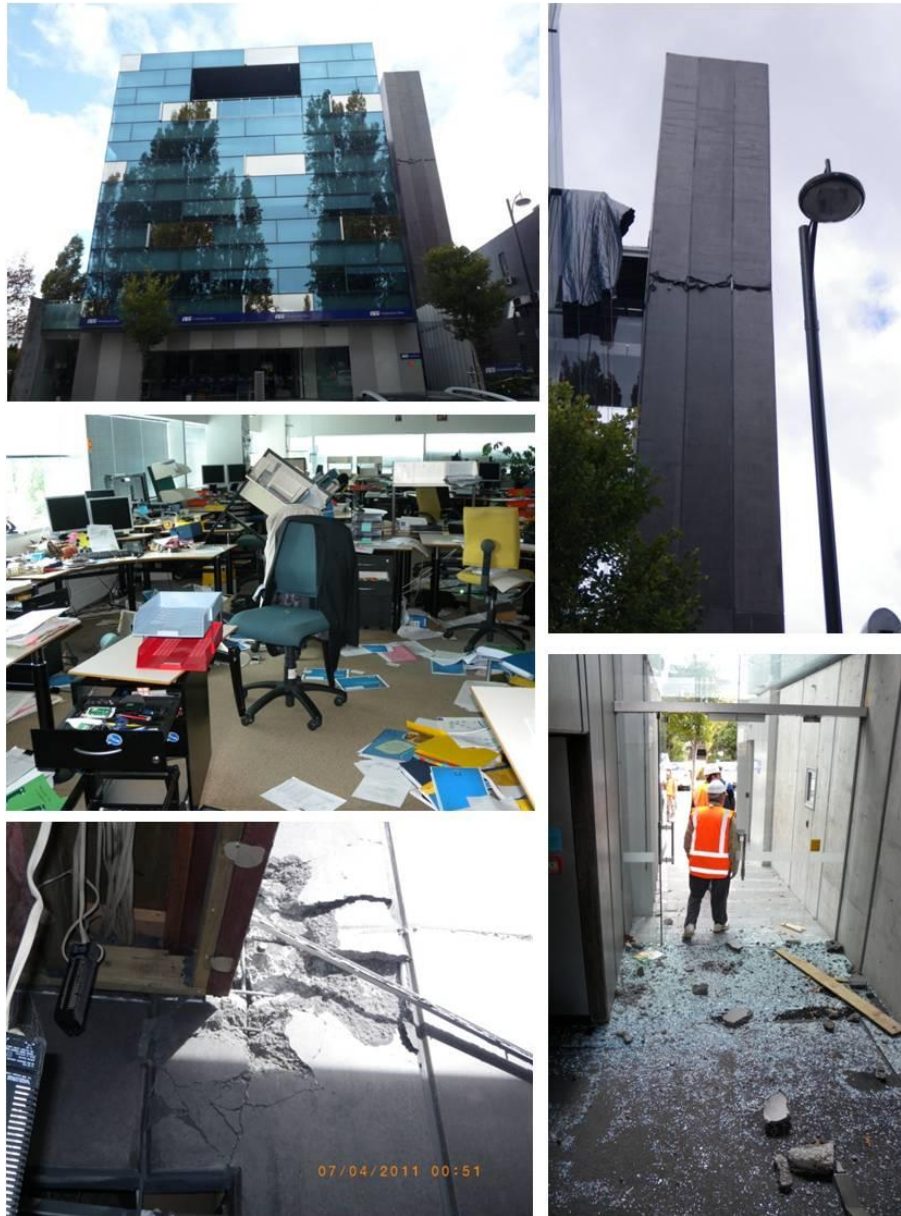
Figure 3.28. ACC building.

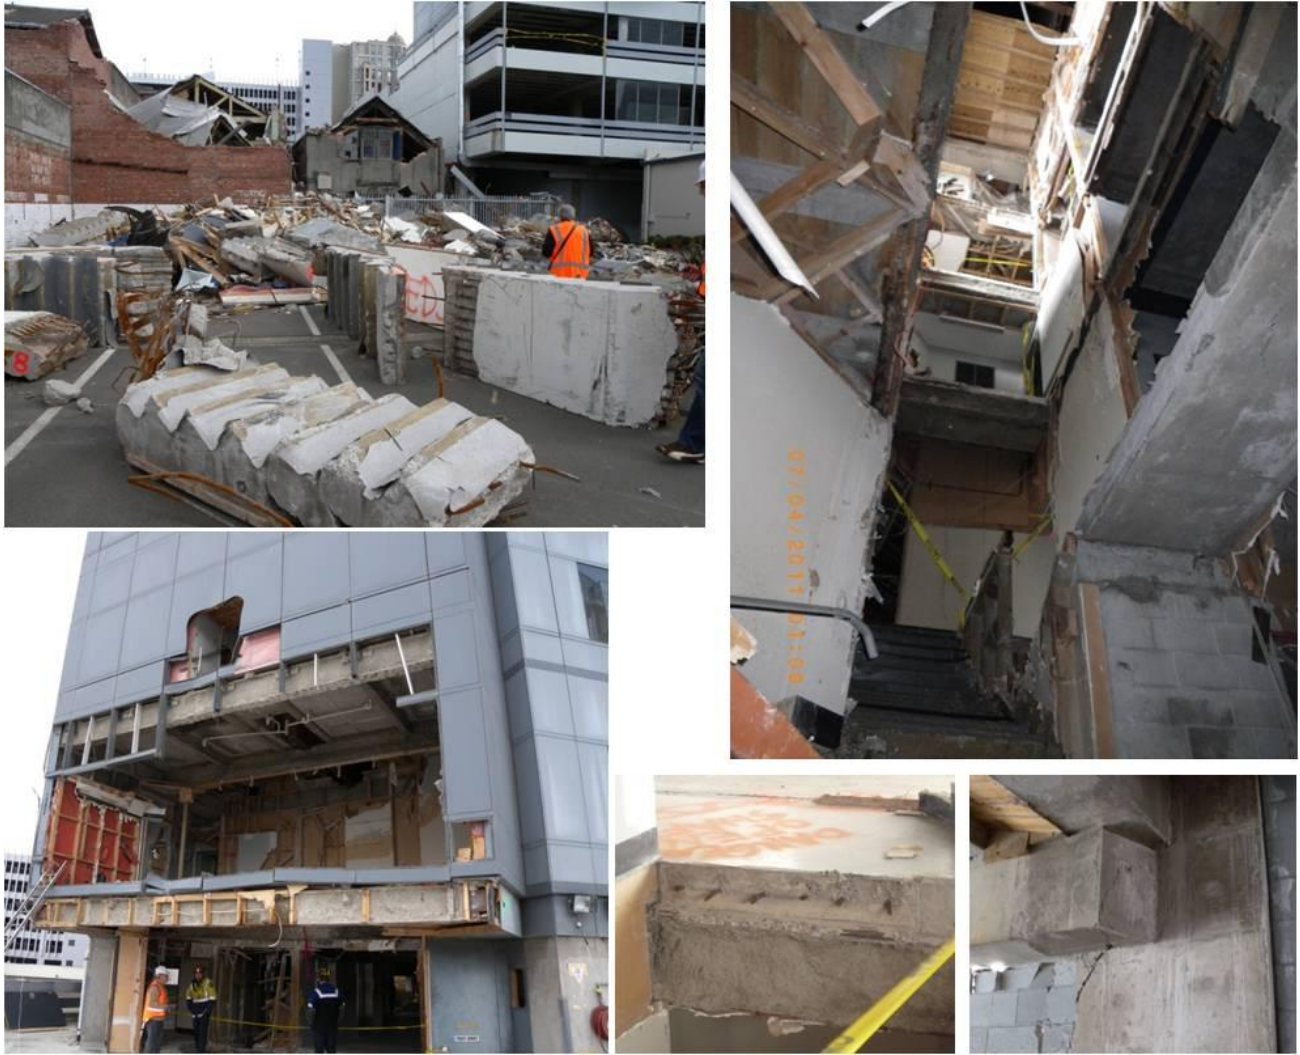
Figure 3.30. Damage in the Forsyth Barr Building and its collapsed stairs.

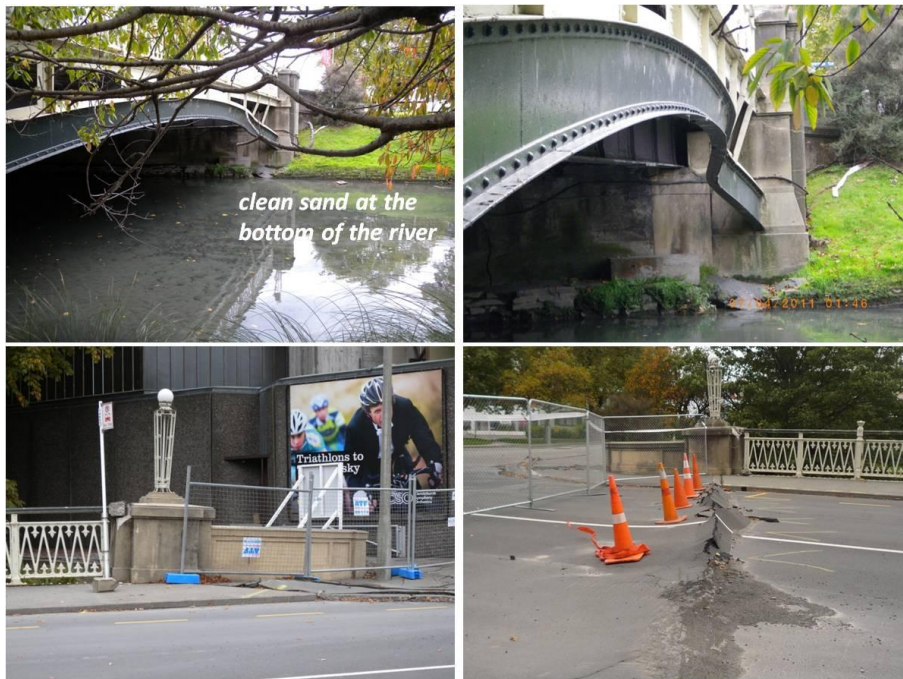
Figure 3.32. The old bridge at Colombo St and Oxford Terrace.

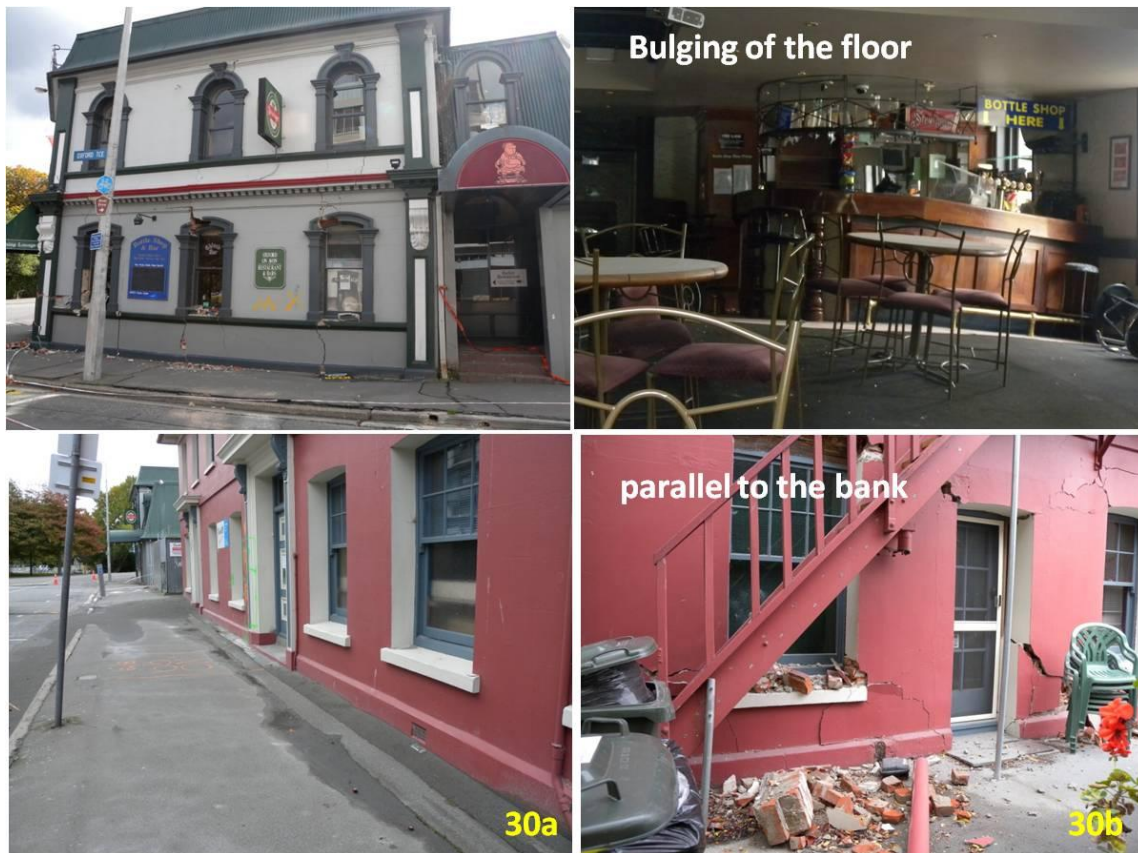
Figure 3.33. Building at Colombo St and Oxford Terrace (B30).

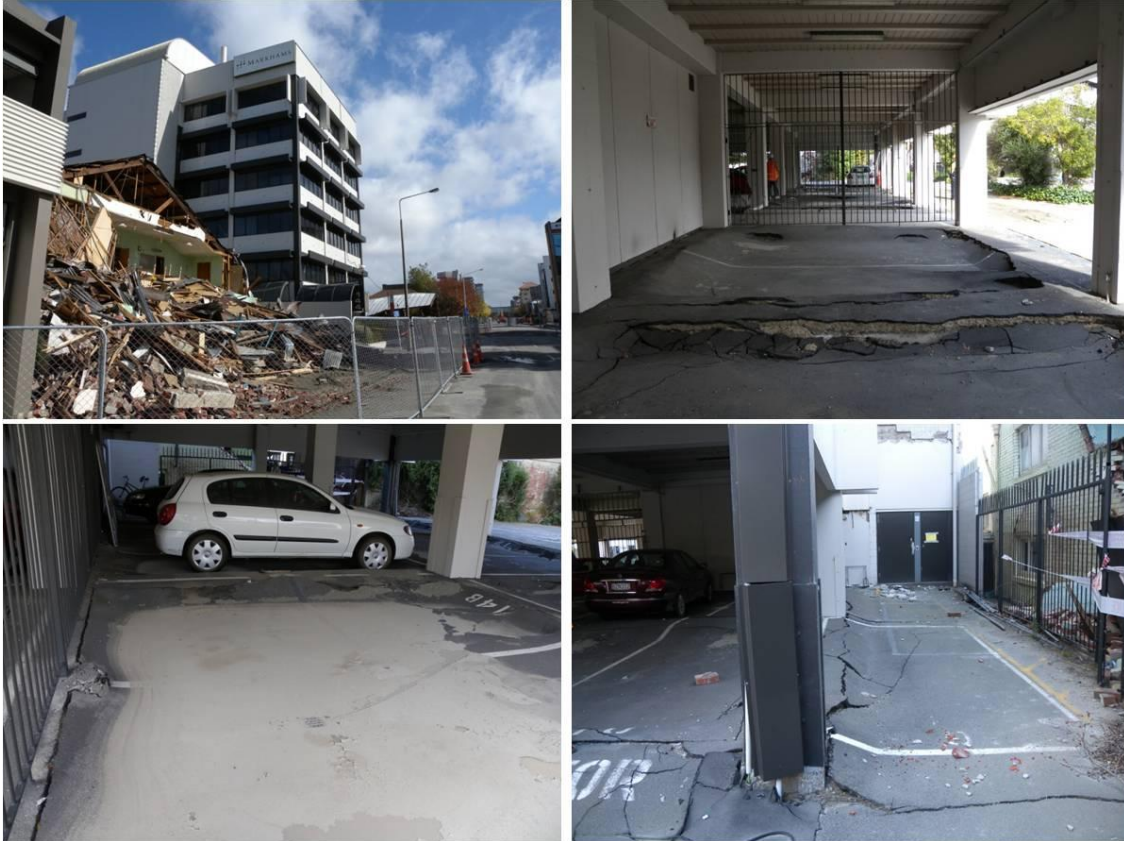
Figure 3.35. A RC building on piles (B33) with large soil settlements and insignificant damage.

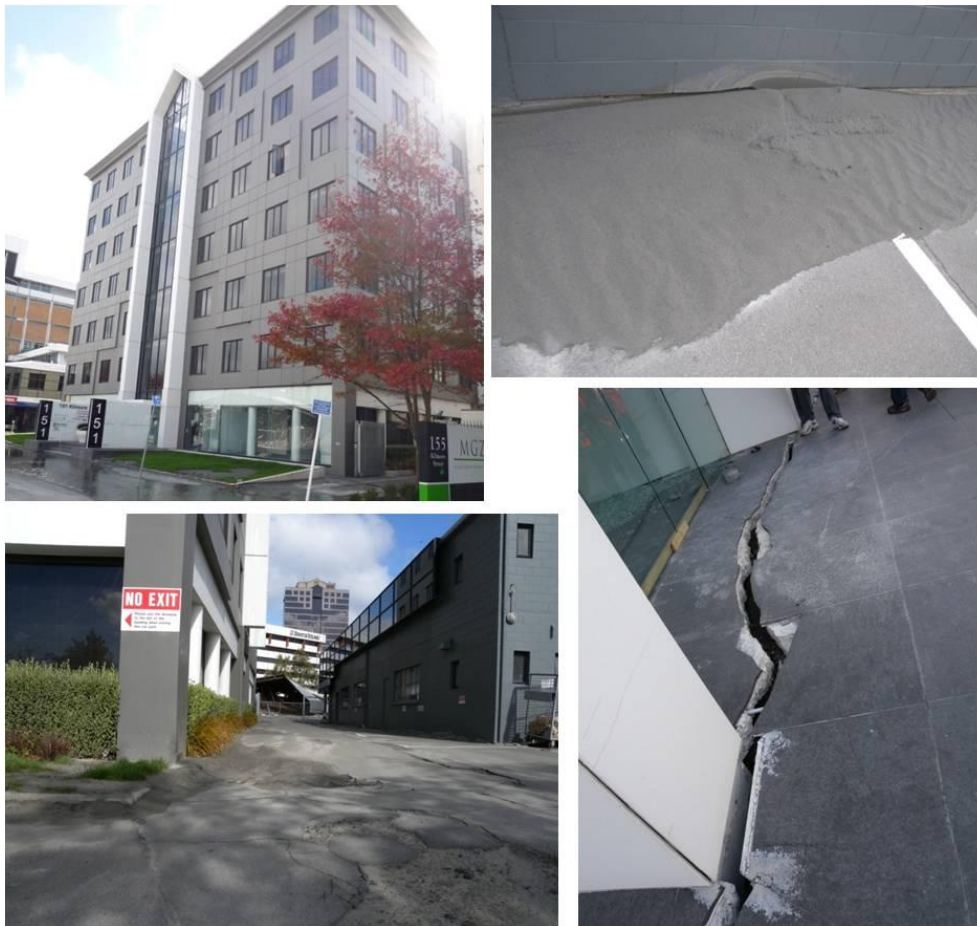
Figure 3.36. A modern RC building at Kilmore Street with raft foundation.

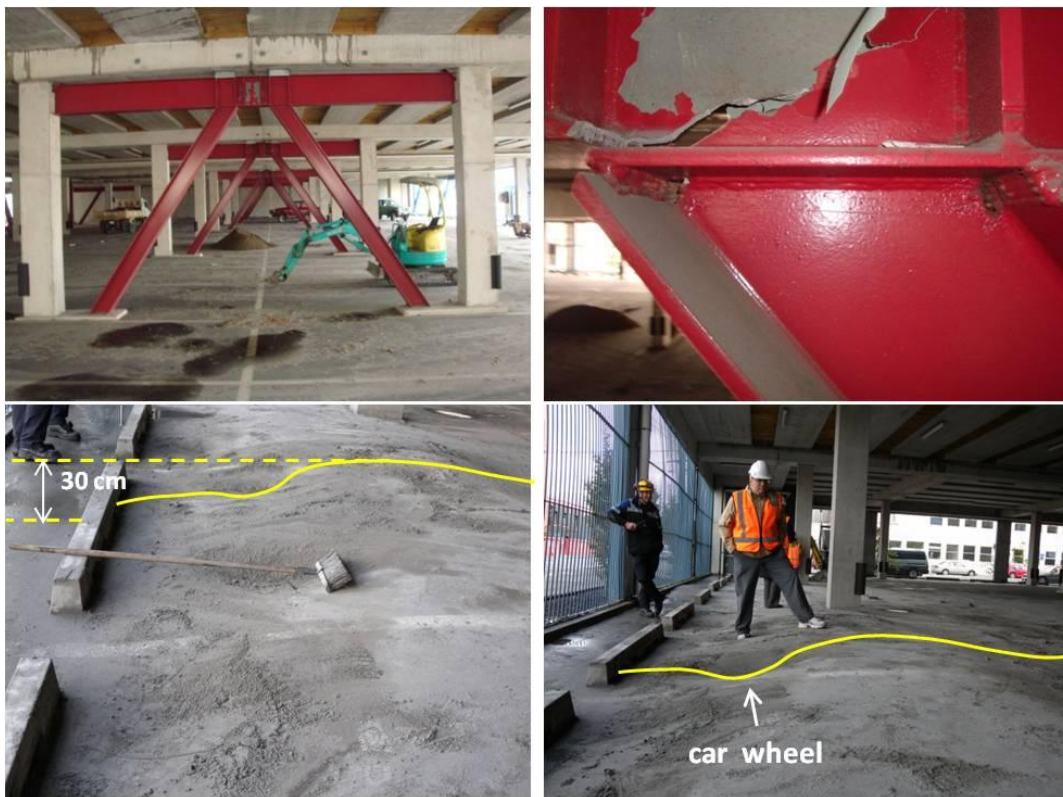
Figure 3.37. Hospital Staff Car Park (B34).

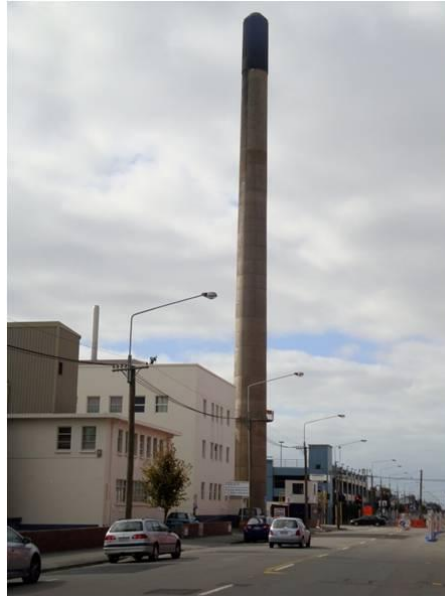
Figure 3.38. A tall RC chimney next to the CHHC recorder (B34).

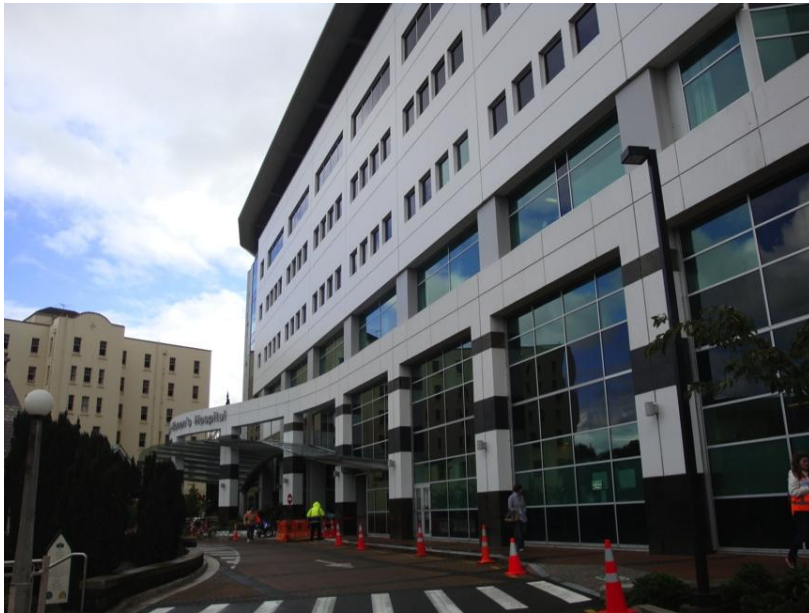
Figure 3.39. General view of the Women's Hospital

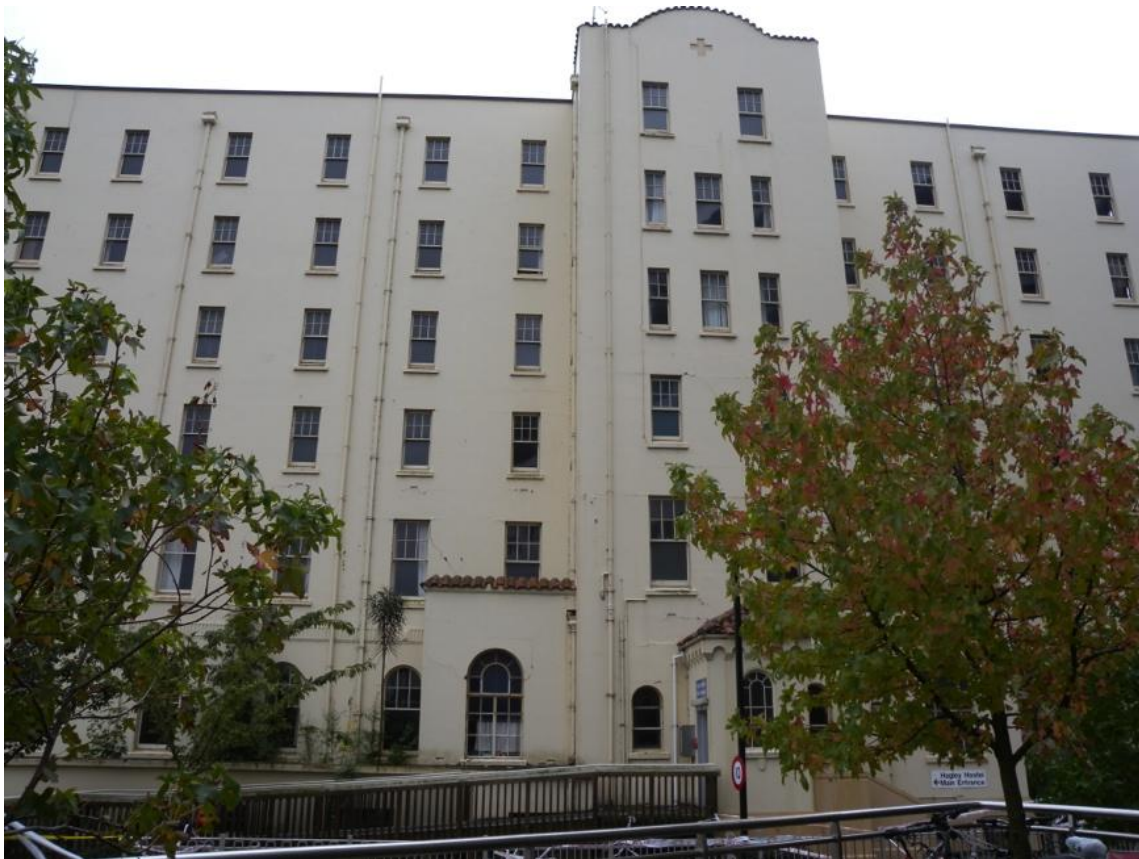
Figure 3.41. The old unreinforced masonry block for nurses, that has moderately damaged during the earthquake.

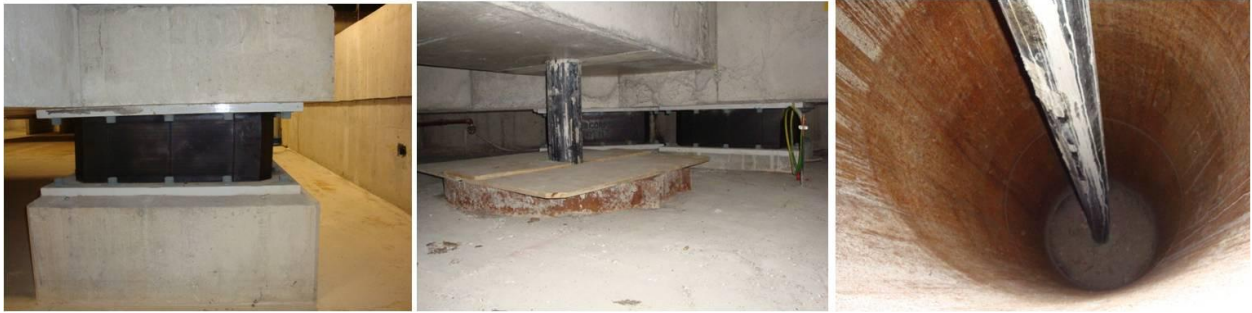
Figure 3.42. Rubber bearing (left) and the restraining ground anchorage.

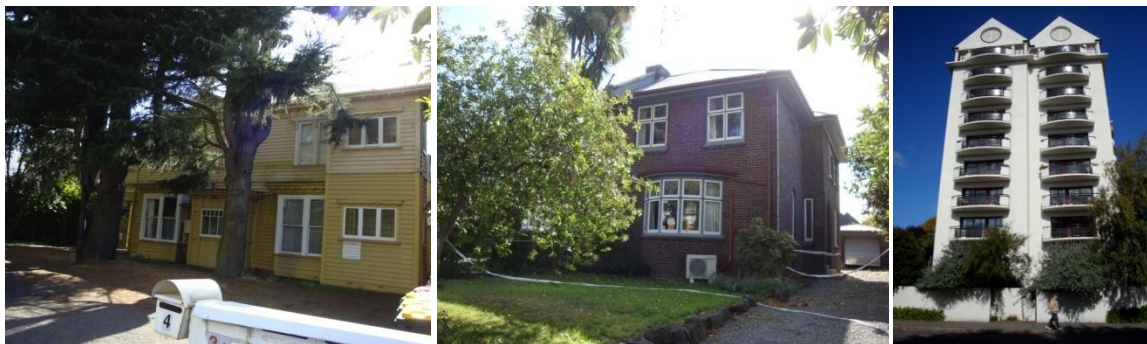
Figure 3.49. Characteristic timber (left), masonry (middle) and modern RC (right) structures outside of CBD.

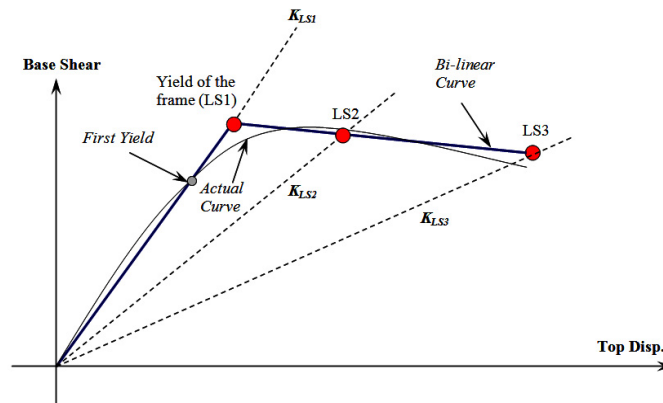
Figure 3.50. Structural response in base shear vs top displacement format, structural limit states and the bi-linearization process (by Bal et al., 2007).

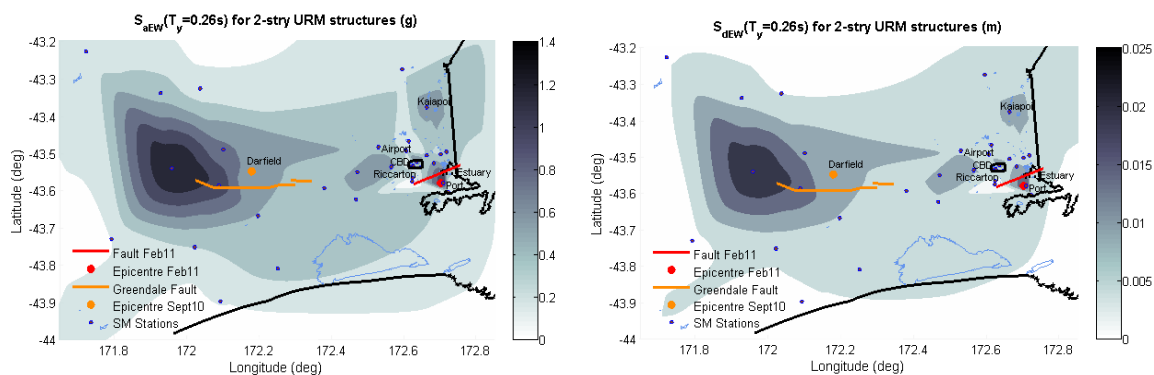
Figure 3.51. Spatial distribution of spectral accelerations (left) and displacements (right) for Darfield earthquake for yield period of 0.26sec (2-storey typical URM houses-EW direction).

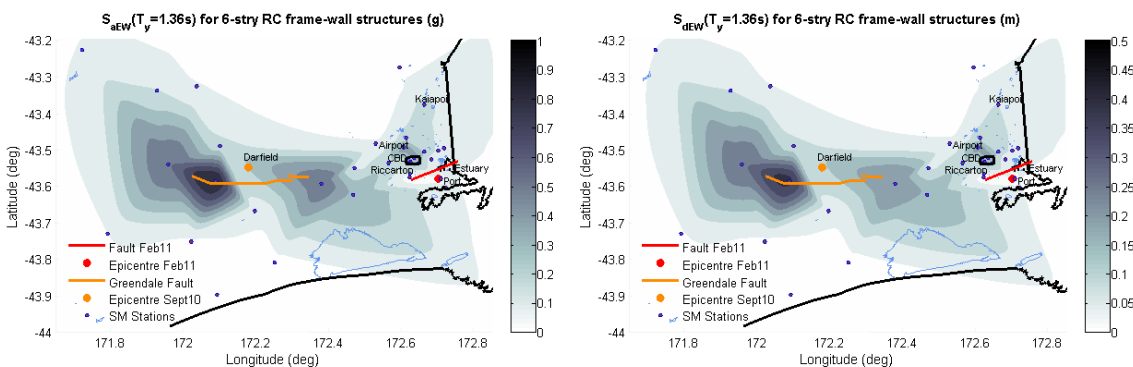
Figure 3.52. Spatial distribution of spectral accelerations (left) and displacements (right) for Darfield earthquake for yield period of 1.36sec (6-storey typical RC frame-wall structures - EW direction).

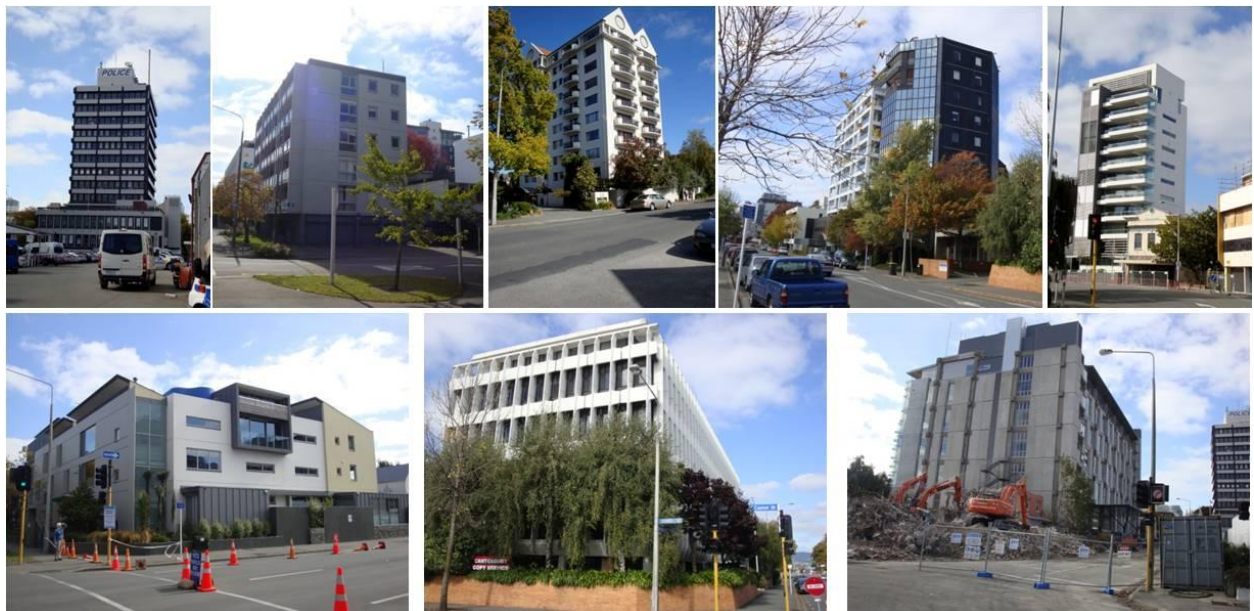
Figure 3.56. Modern RC buildings performing satisfactorily.

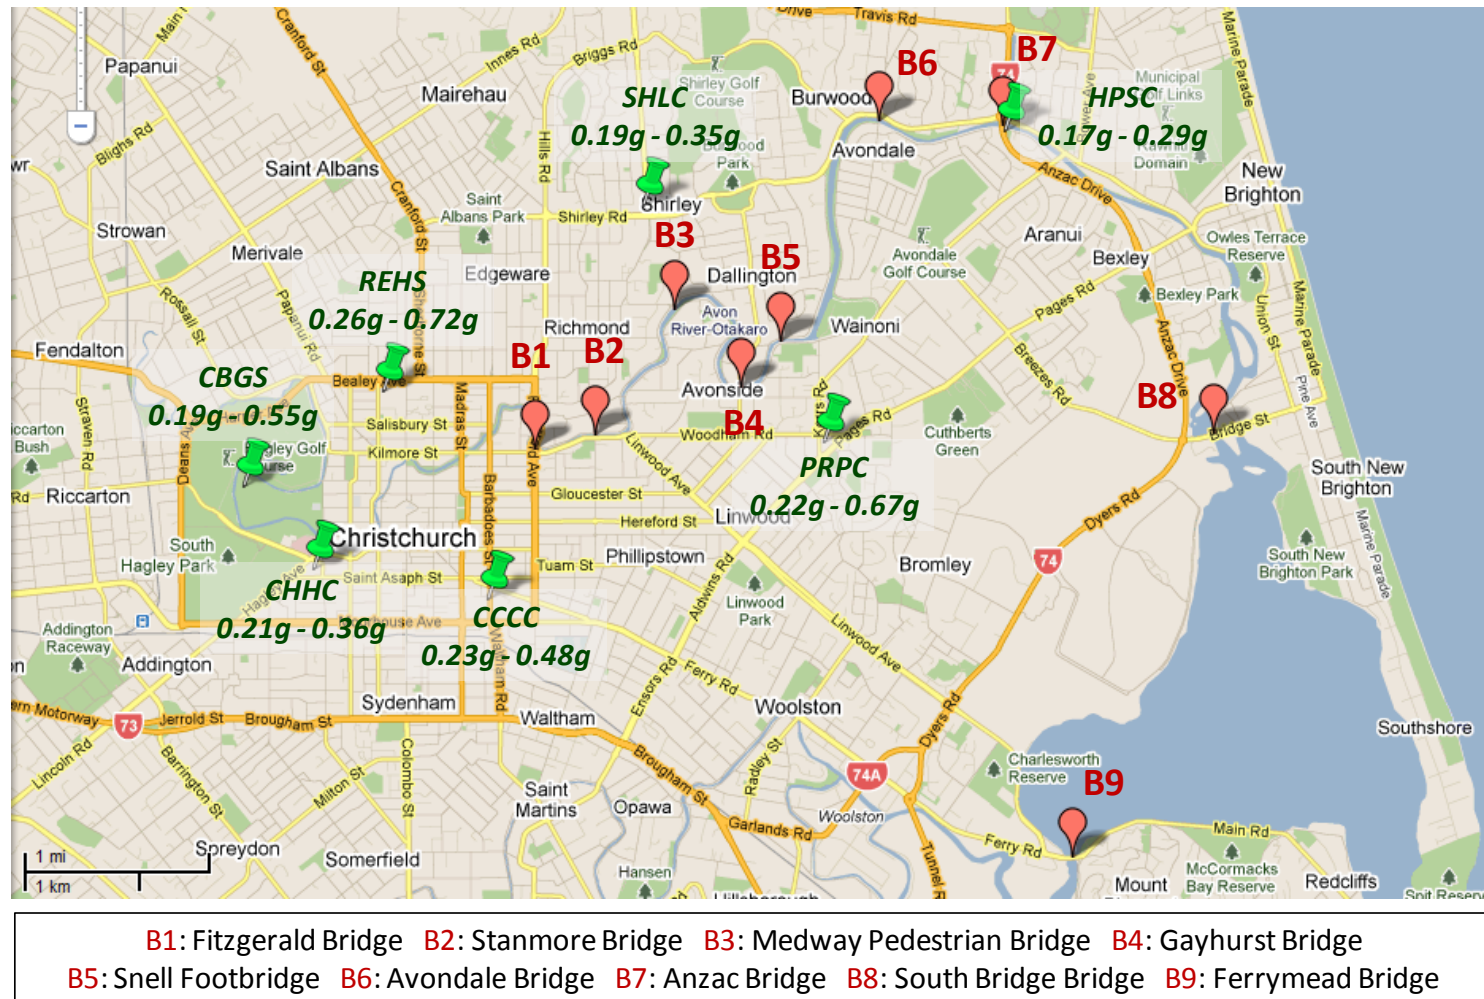
Figure 4.1. Map illustrating the location of the bridges (red signs under the names B1, B2 etc) and the seismic stations (green signs) with the corresponding recorded PGAs (1st and 2nd value correspond to Darfield and Christchurch earthquakes respectively) in the broader area occupied by the bridges.
