Geotechnical and Structural Field Observations from Christchurch, February 2011 Earthquake, in New Zealand

Research Report

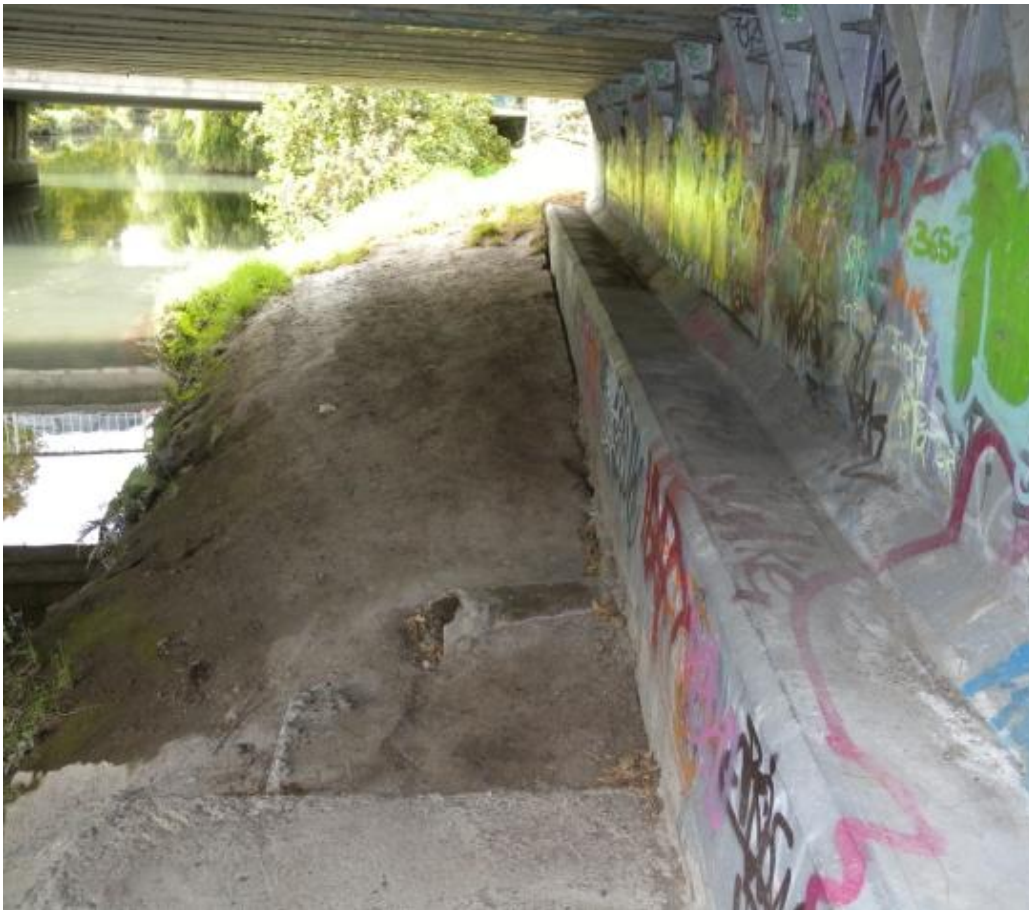
Figure 4.2. Fitzgerald Bridge (B1 on map of Figure 4.1). Performance of southern abutment after Christchurch earthquake. No signs of lateral ground deformation occurred at the southern abutments of the twin bridges. The soil is still attached to the abutment.

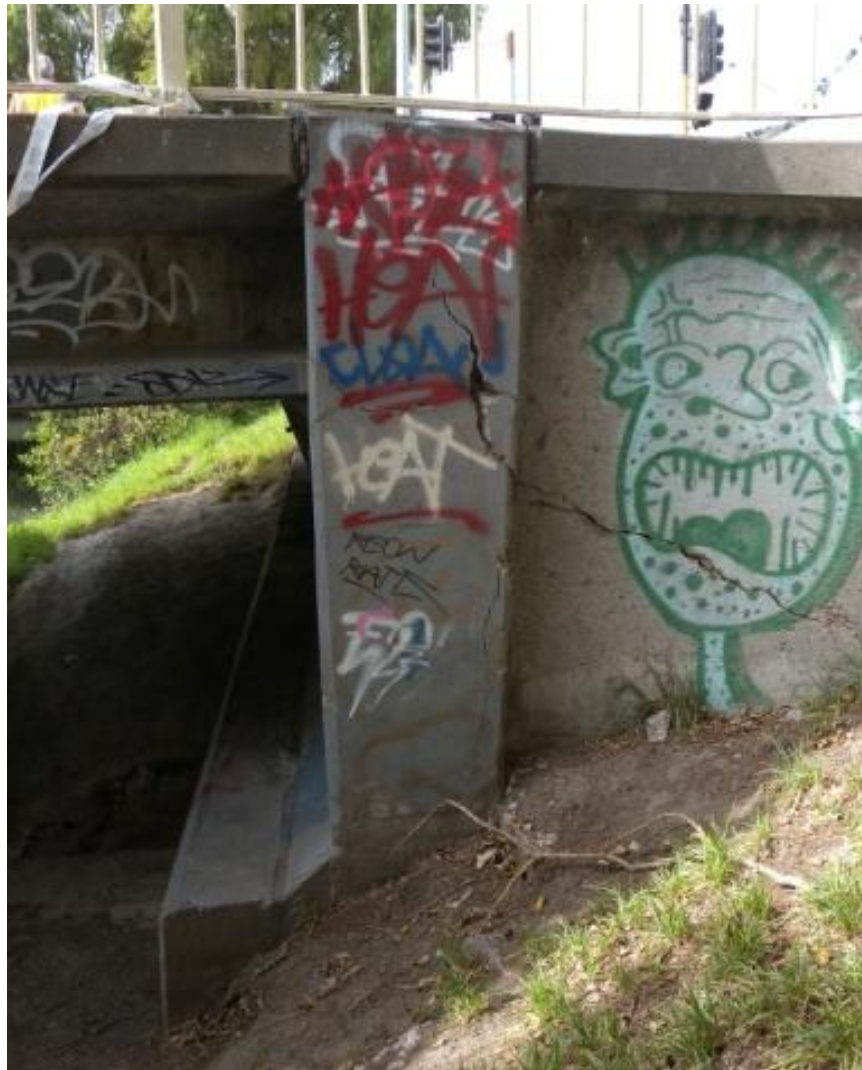
Figure 4.3. Fitzgerald Bridge (B1 on map of Figure 4.1). Performance of southern abutment after Christchurch earthquake. No lateral ground deformation occurred at the southern abutments of the twin bridges. Thus, there was no rotation of the abutment. However, the abutment suffered moderate cracks due to seismic and inertial load.

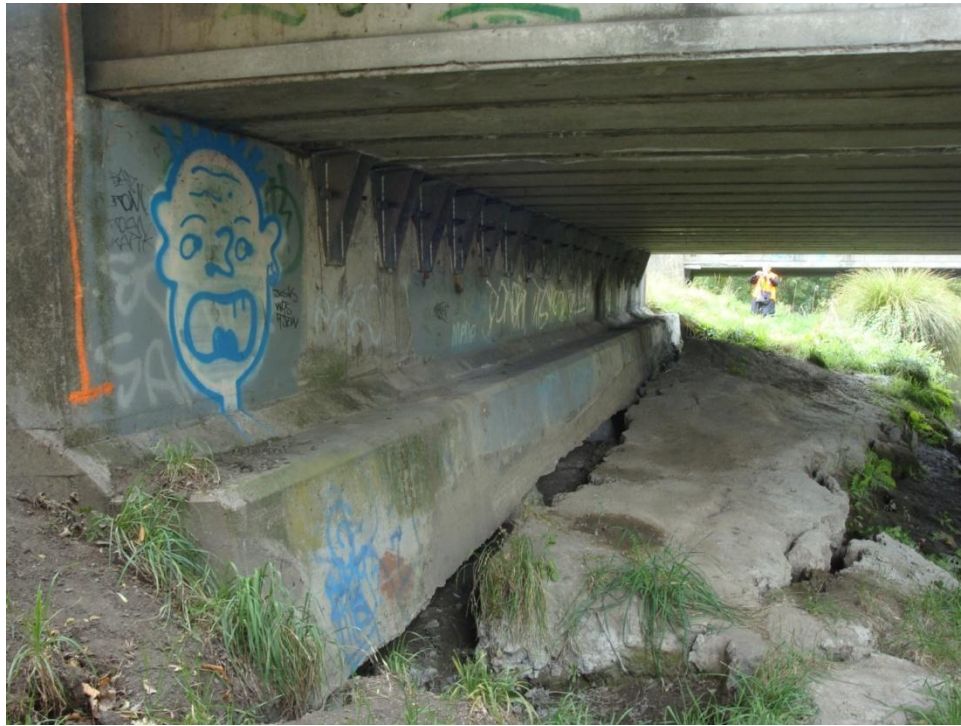
Figure 4.4. Fitzgerald Bridge (B1 on map of Figure 4.1). Performance of northern abutment after Christchurch earthquake. Lateral spreading of the ground has exposed the pile heads.

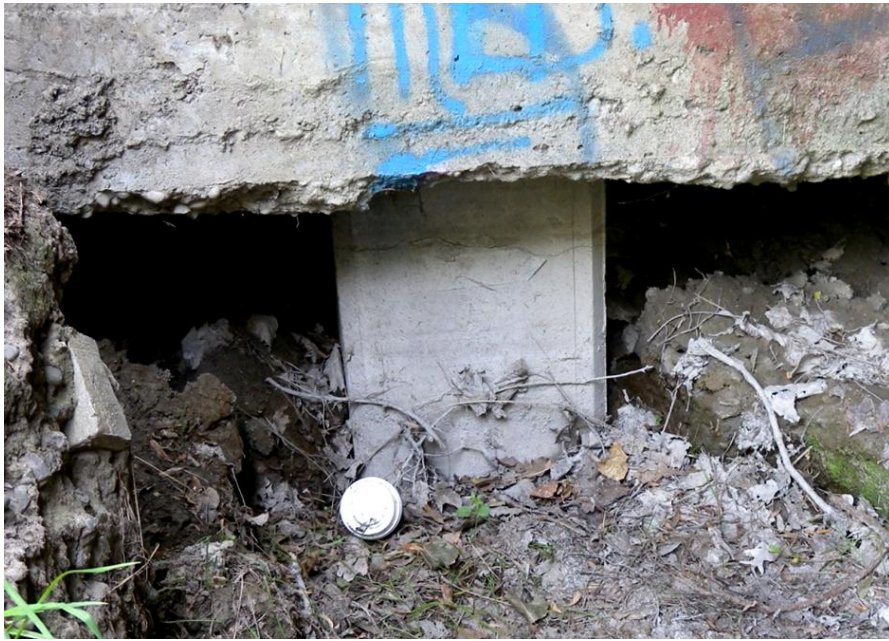
Figure 4.6. Fitzgerald Bridge (B1 on map of Figure 4.1). Rotation of northern abutment has caused tension cracks at the pile-tops.

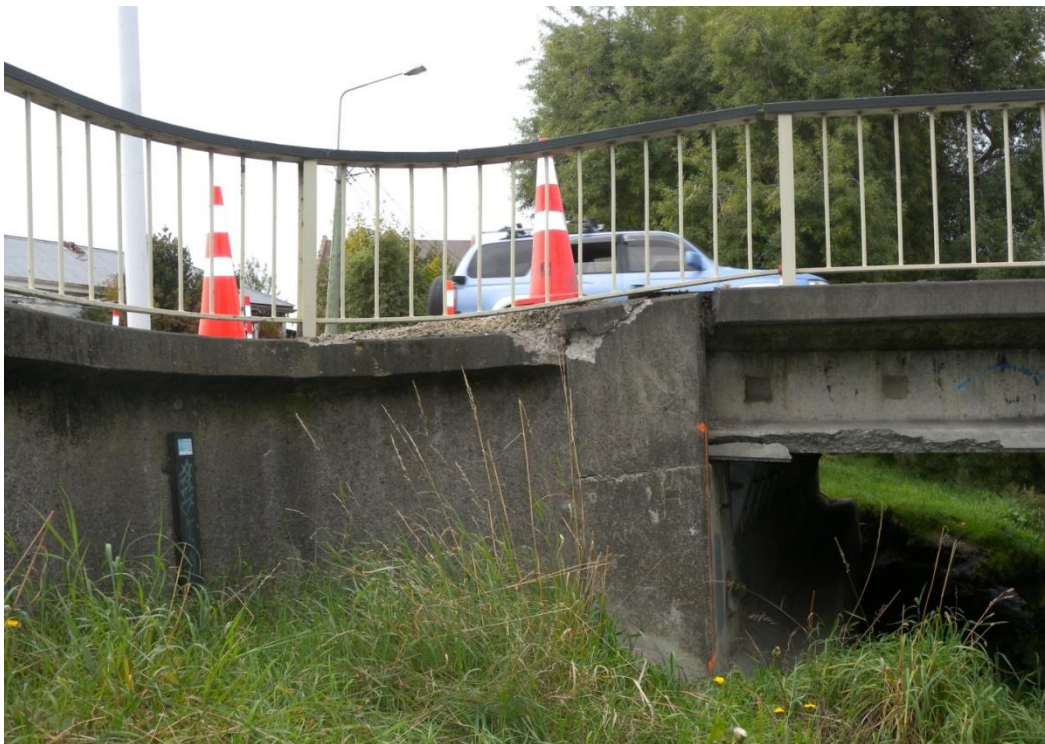
Figure 4.7. Fitzgerald Bridge (B1 on map of Figure 4.1). Performance of northern abutment of the twin bridge after Christchurch earthquake. Rotation of abutment and slump of the backfill occurred. Concrete spalling of the deck developed close to the abutment-seat.

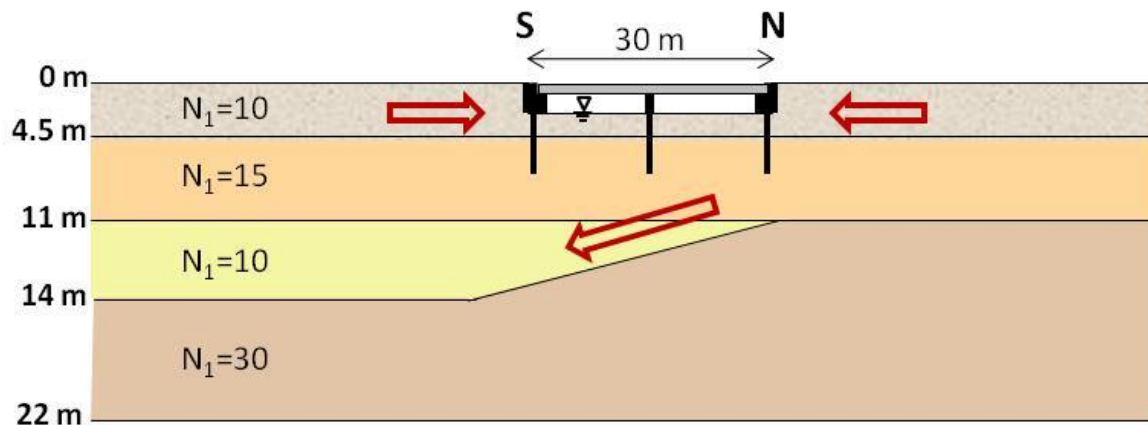
Figure 4.8. Soil profile geometry along Fitzgerald Bridge (B1 on map of Figure 4.1). The soil mainly consists of sandy gravel and sandy silt prone to liquefaction. The red arrows indicate the soil displacement due to lateral spreading.

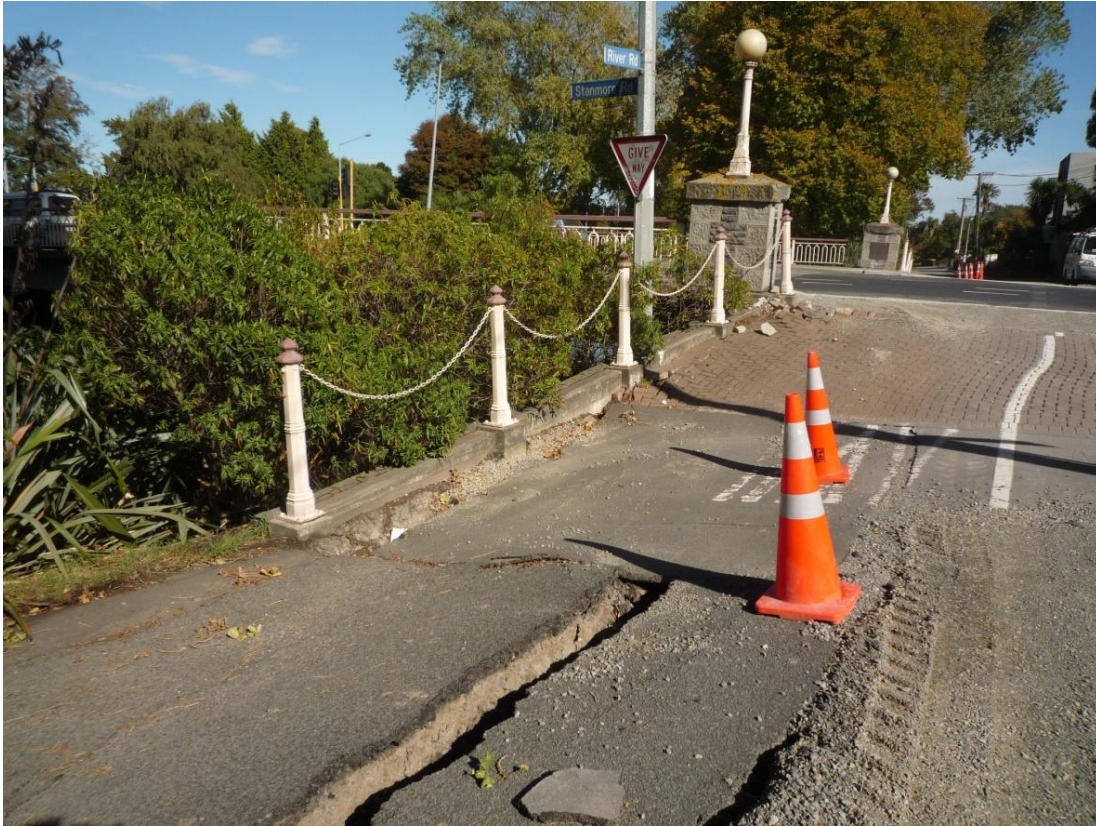
Figure 4.11. Stanmore Bridge (B2 on map of Figure 4.1). Rotation of the abutment around the deck. The street lighting column next to the abutment has rotated riverwards, following the lateral deformation of the ground, while the light column seated on the abutment indicates that the abutment has back rotated due to the deck constraint. Slump of the approach fill is not visible because at the time of our visit, the cracked asphalt between the two abutments had been replaced by new. However the large cracks in the road parallel to Avon river (in the order of 40 cm) due to lateral spreading were still there.

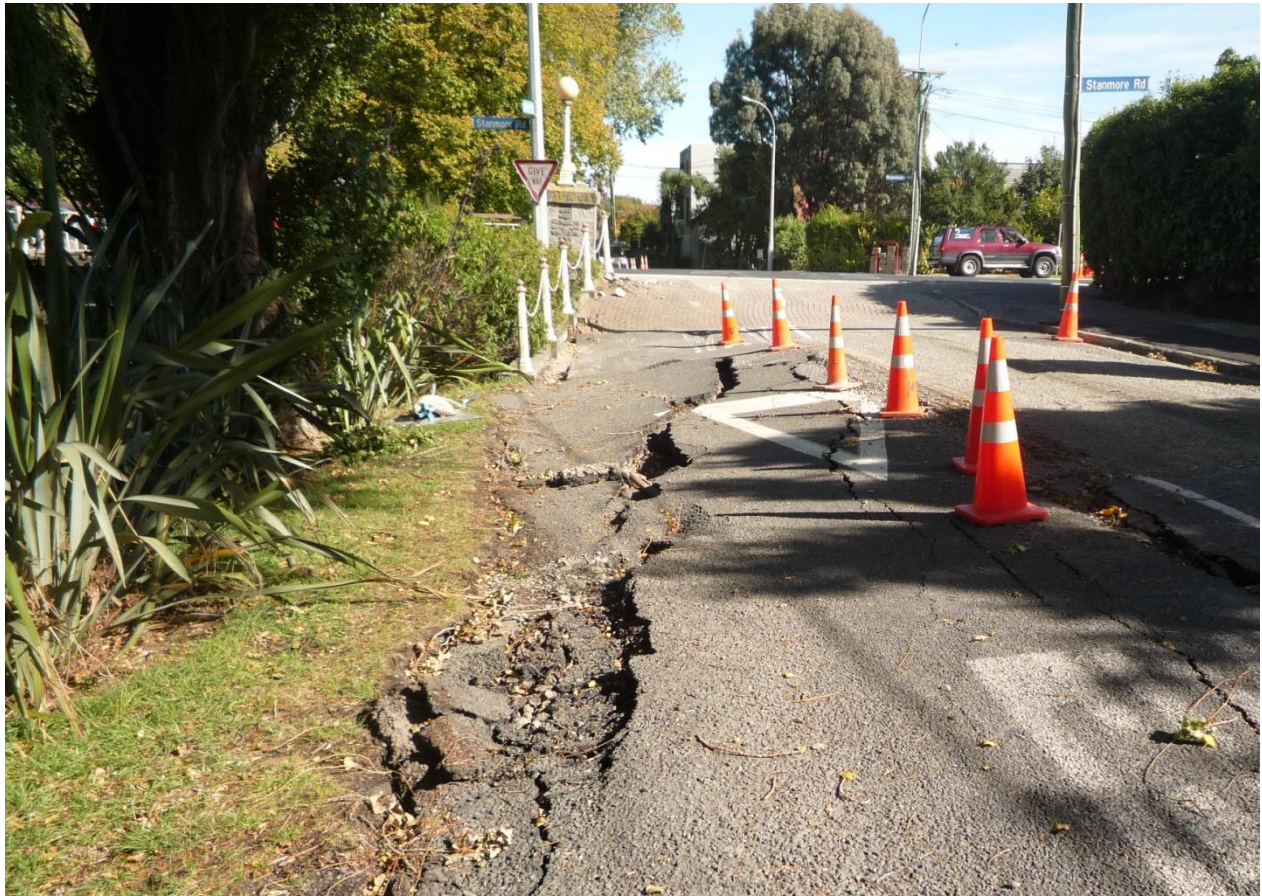
Figure 4.12. Stanmore Bridge (B2 on map of Figure 4.1). Large cracks in the asphalt due to significant lateral spreading in the free field (away from the bridge). The cracks tend to decrease towards the bridge, as the axial stiffness of the deck combined with the bending stiffness of piles limited the lateral ground deformation.

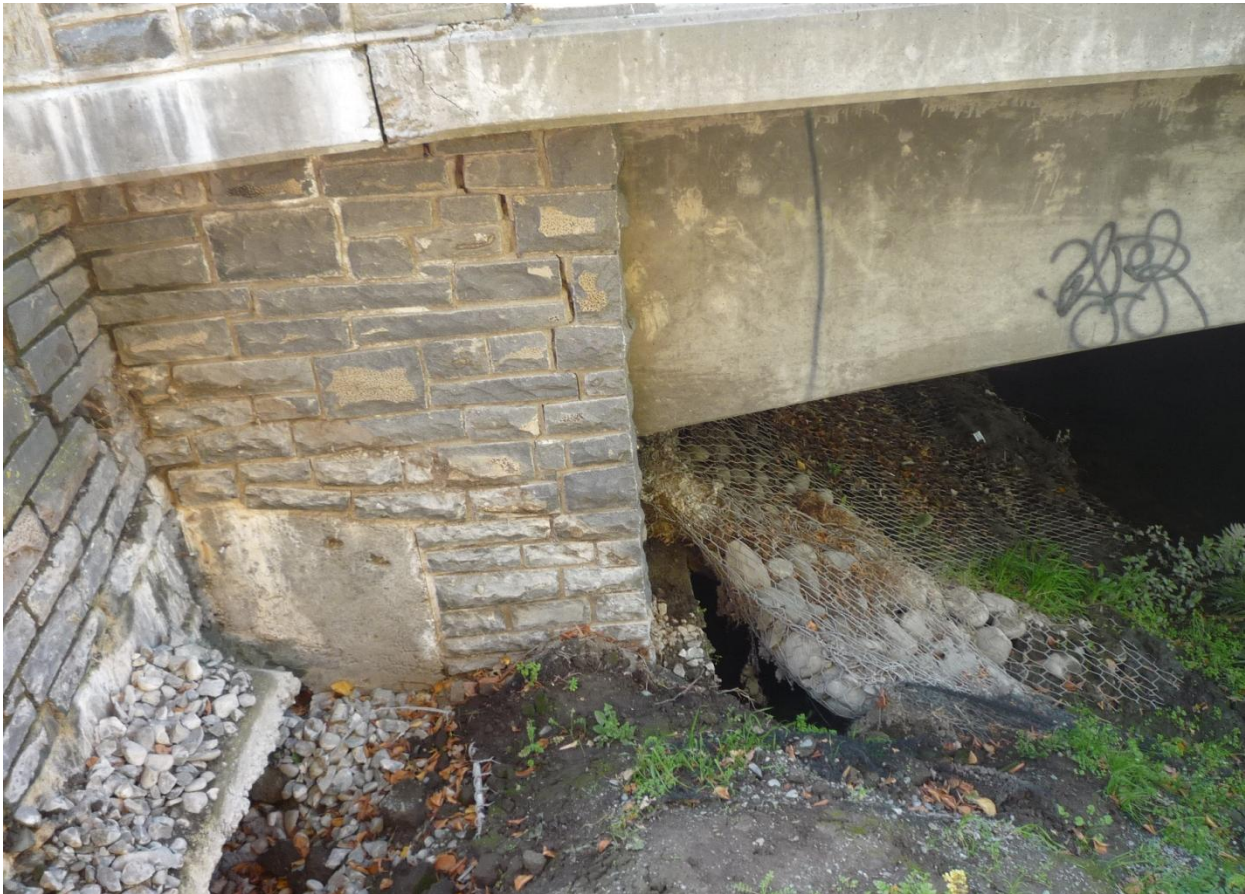
Figure 4.13. Stanmore Bridge (B2 on map of Figure 4.1). Cracks in the abutment and concrete spalling close to the joint with the deck. Gap opening between the abutment and the soil, tending to expose the foundation.

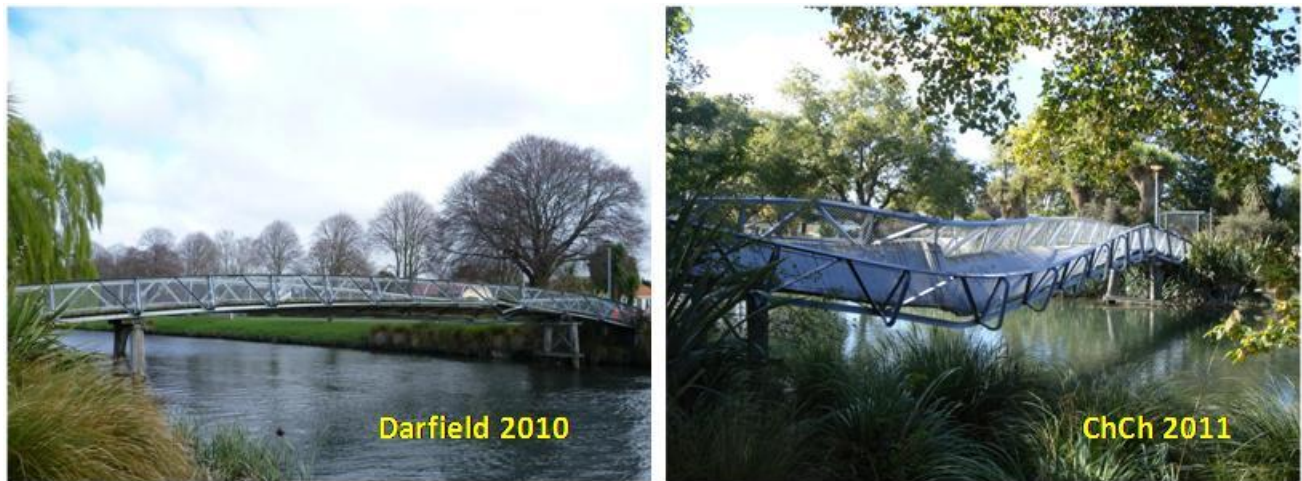
Figure 4.14. Medway Pedestrian Bridge (B3 on map of Figure 4.1). Comparison of bridge damage between Darfield and Christchurch earthquakes. Source: NHP- Bridge Research Group.

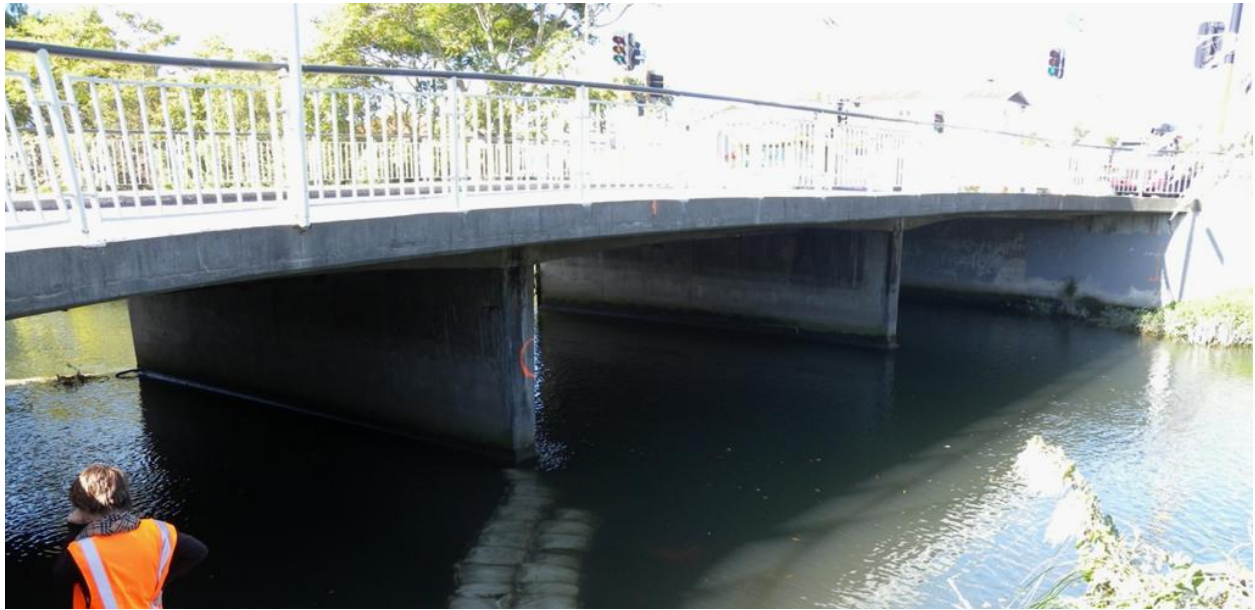
Figure 4.15. Gayhurst Bridge (B4 on map of Figure 4.1) after Christchurch earthquake. The southern abutment appears practically undamaged on the right side of the photo.

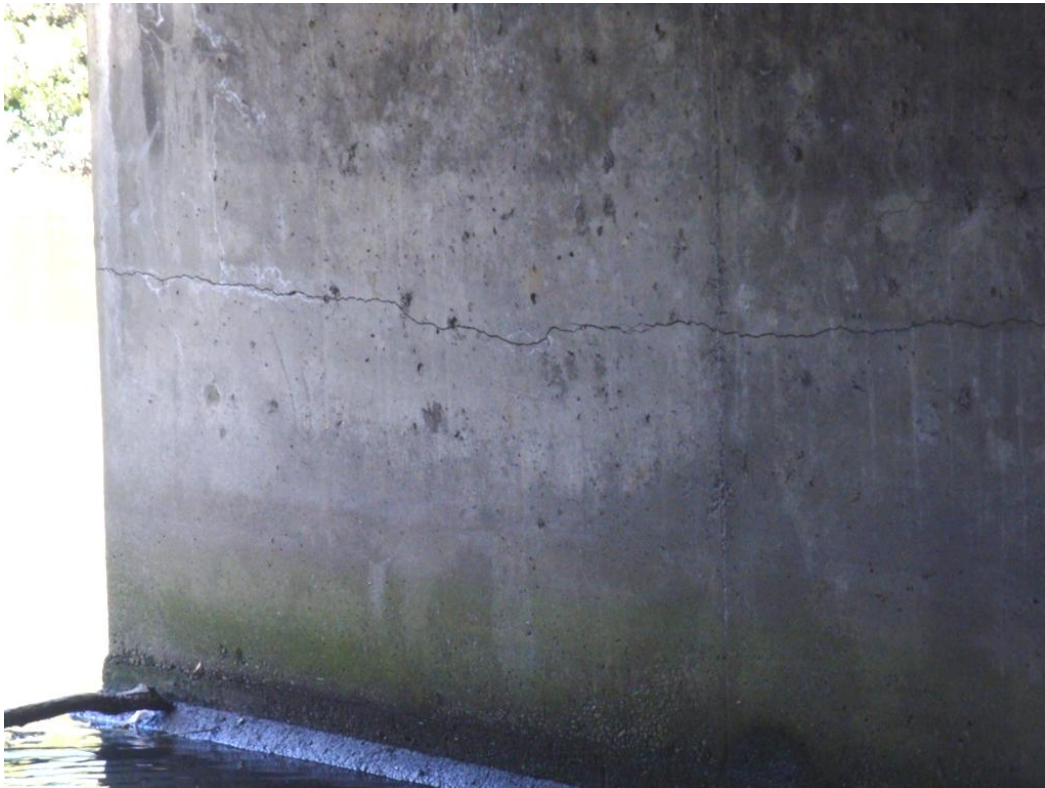
Figure 4.16. Gayhurst Bridge (B4 on map of Figure 4.1) The pier wall close to the northern abutment developed horizontal tension cracks, about 1 m below the deck due to intense shaking and lateral spreading.

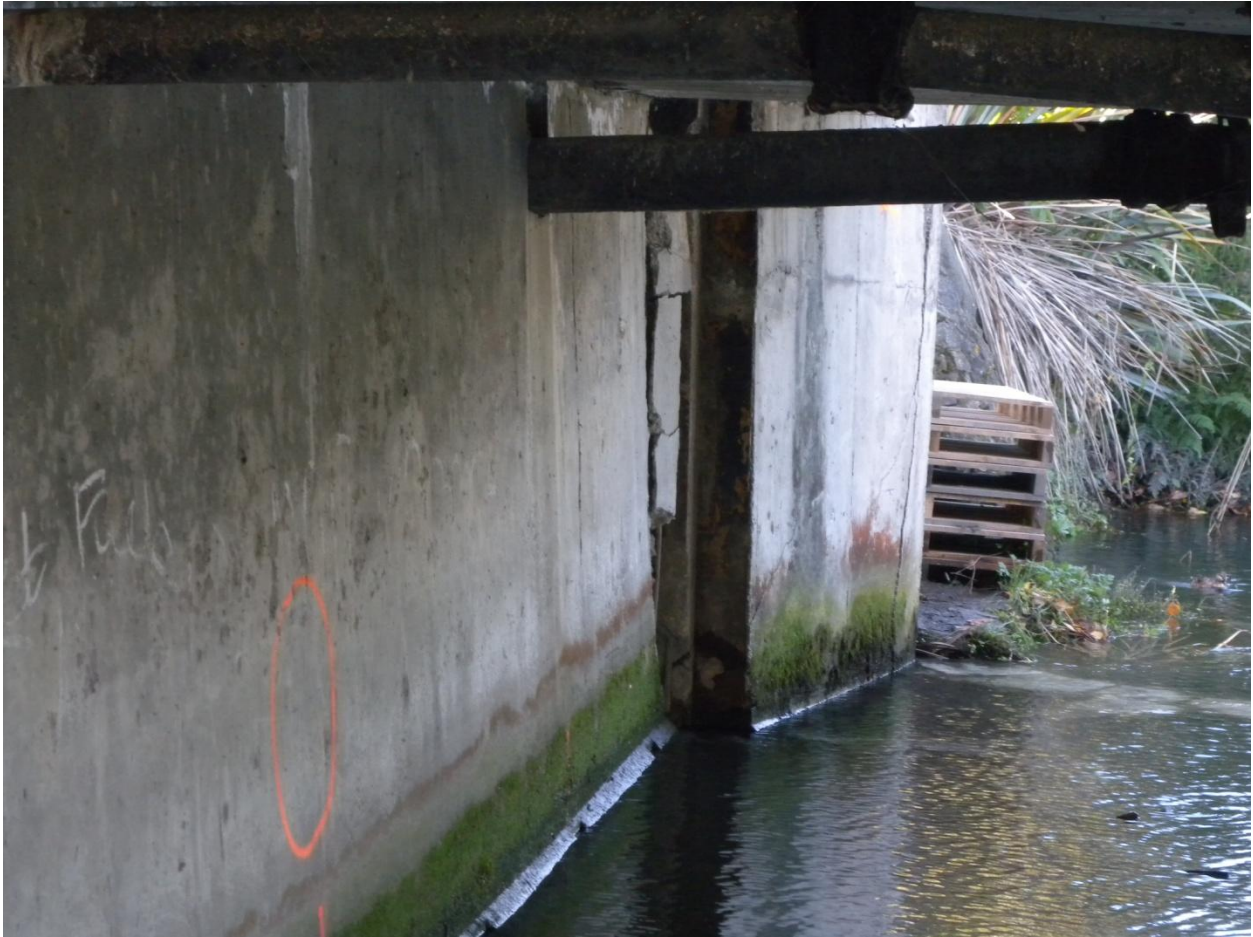
Figure 4.17. Northern abutment of Gayhurst Bridge (B4 on map of Figure 4.1). Rotation and differential riverward displacement (in the order of 70 cm and more) of the eastern wingwall relative to the abutment caused concrete spalling and cracking at the joint of the abutment with the wingwalls.

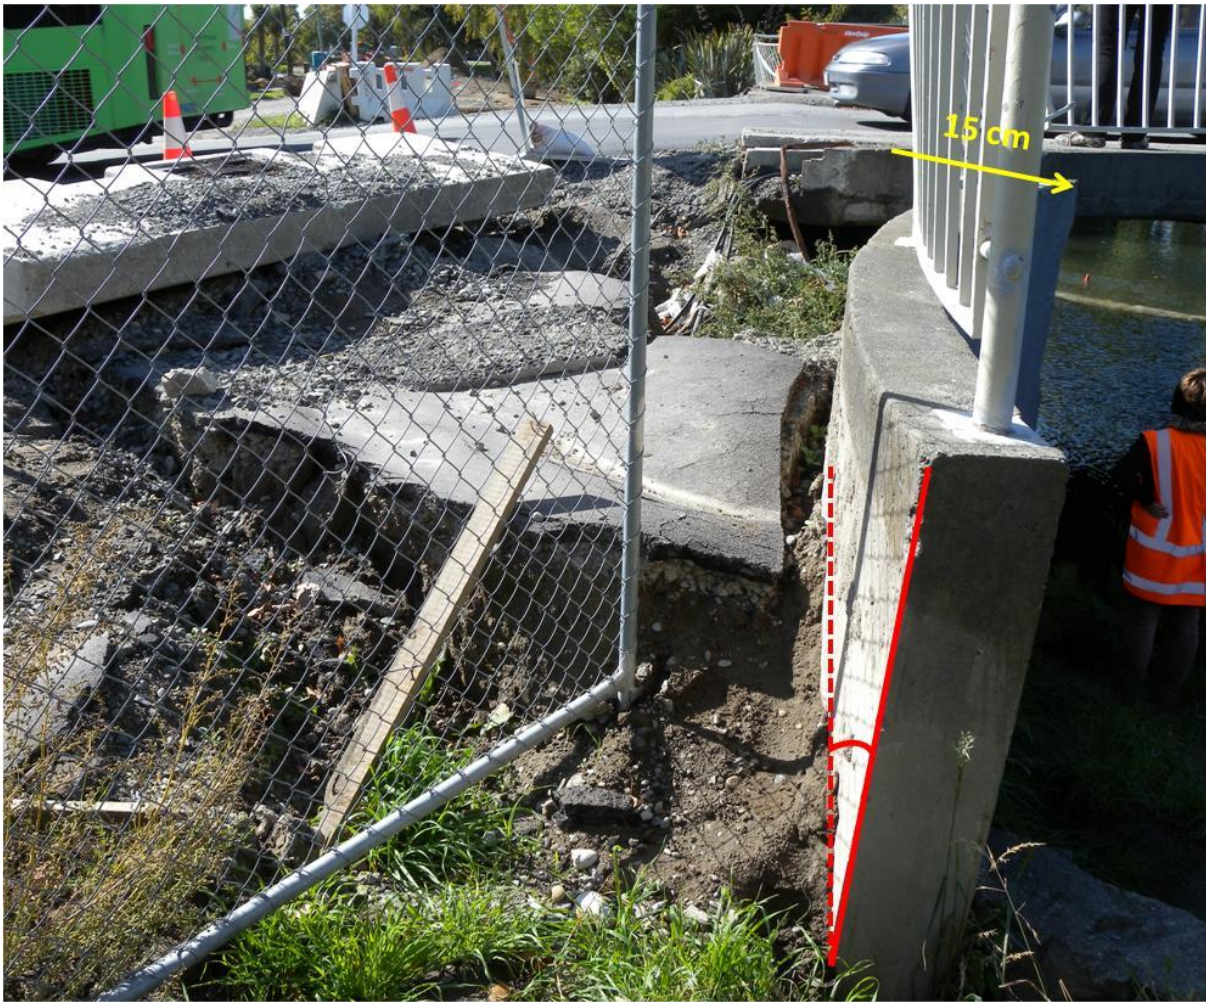
Figure 4.18. Northern abutment of Gayhurst Bridge (B4 on map of Figure 4.1). Rotation and displacement of the western wingwall not only riverwards but also away from the abutment (15 cm approximately at the top) perpendicular to the deck.

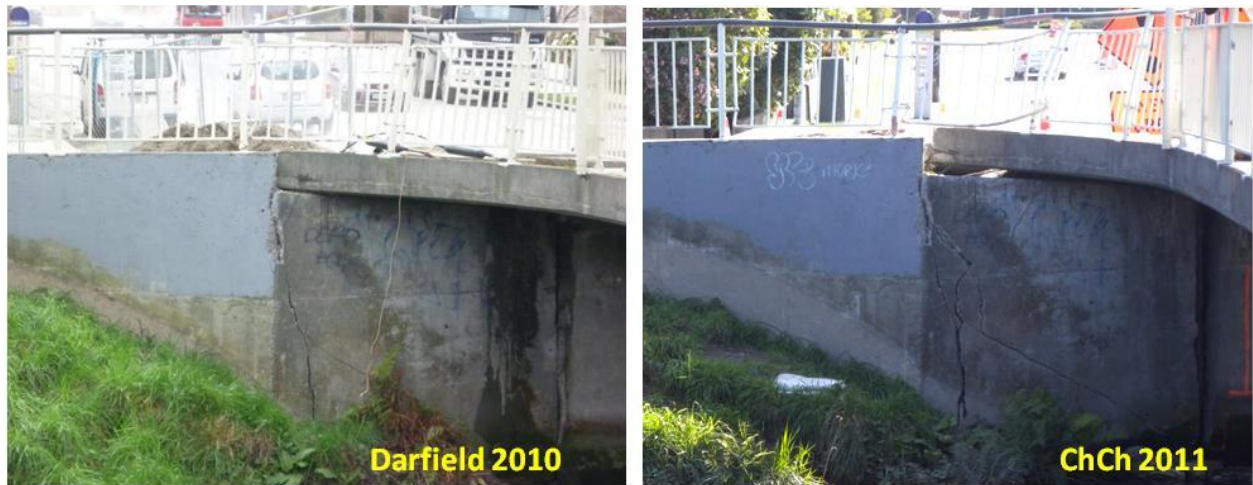
Figure 4.19. Western side of the northern abutment of Gayhurst Bridge (B4 on map of Figure 4.1). Comparison of damage between Darfield and Christchurch shaking events. The cracks have widened and extended, while the differential lateral riverward displacement of the abutment and wingwalls relative to the deck has increased after Christchurch earthquake. Source: NHP-Bridge Research Group.

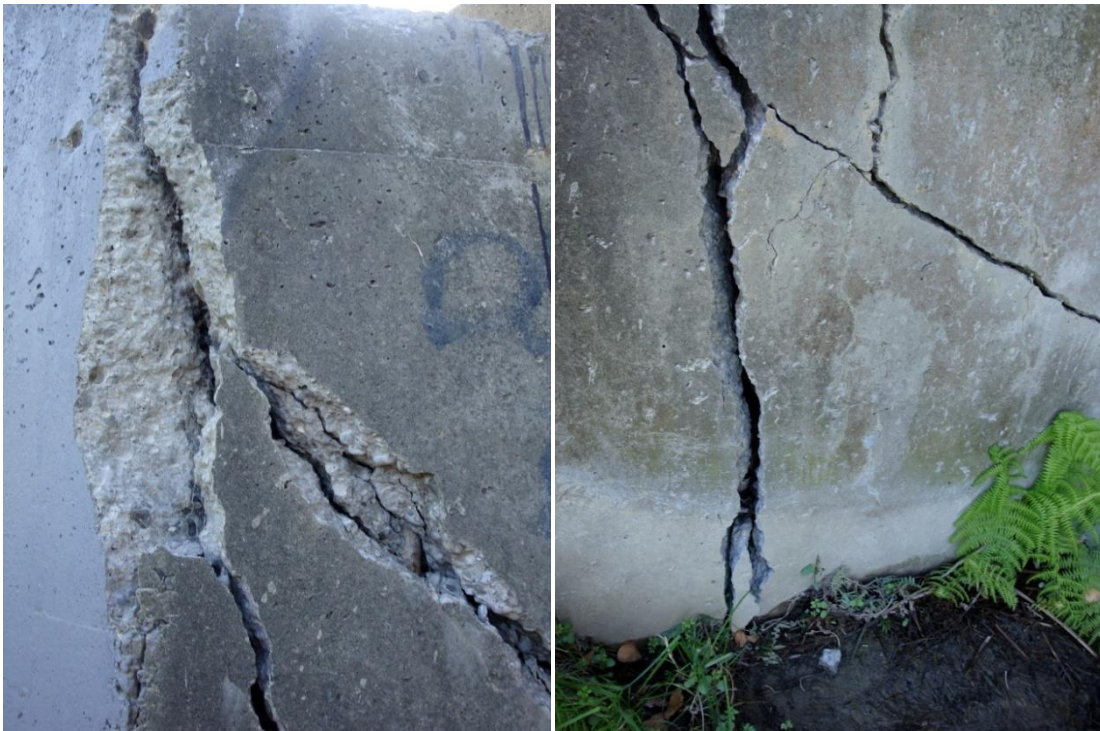
Figure 4.20. Closer look on the cracks of the western wingwall at the northern part of Gayhurst Bridge (B4 on map of Figure 4.1). The cracks have widened and deepened, while concrete spalling had occurred during Christchurch earthquake.

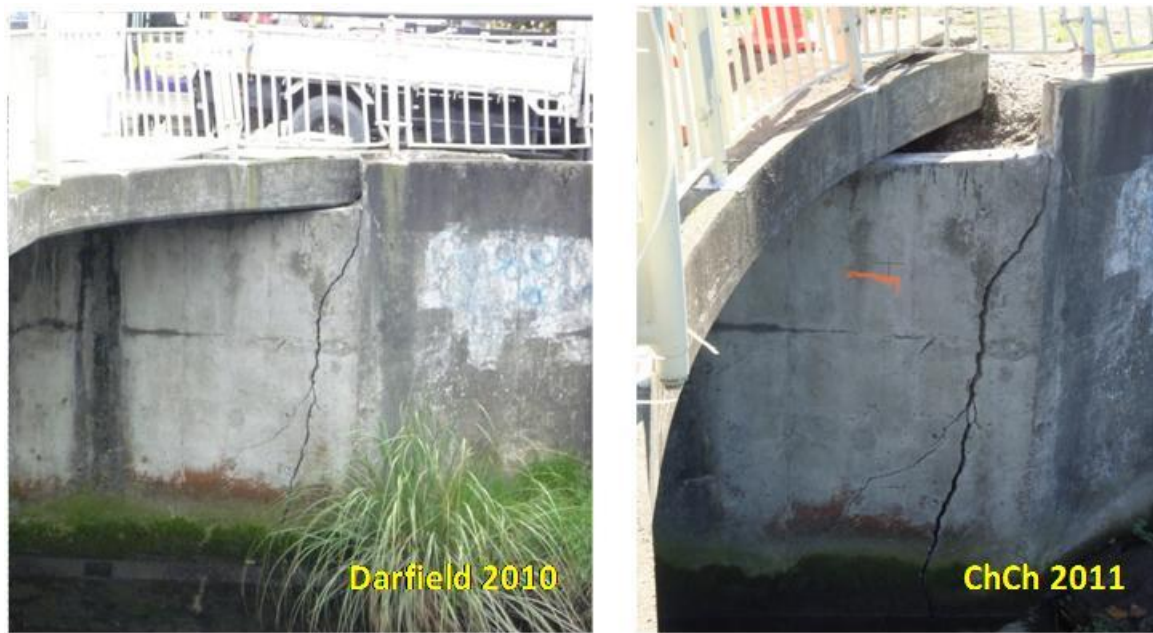
Figure 4.21. Eastern side of the northern abutment of Gayhurst Bridge (B4 on map of Figure 4.1). Comparison of damage between Darfield and Christchurch shaking events. The cracks have widened and the differential lateral riverward displacement of the abutment and wingwalls relative to the deck has increased after Christchurch earthquake. SOURCE.

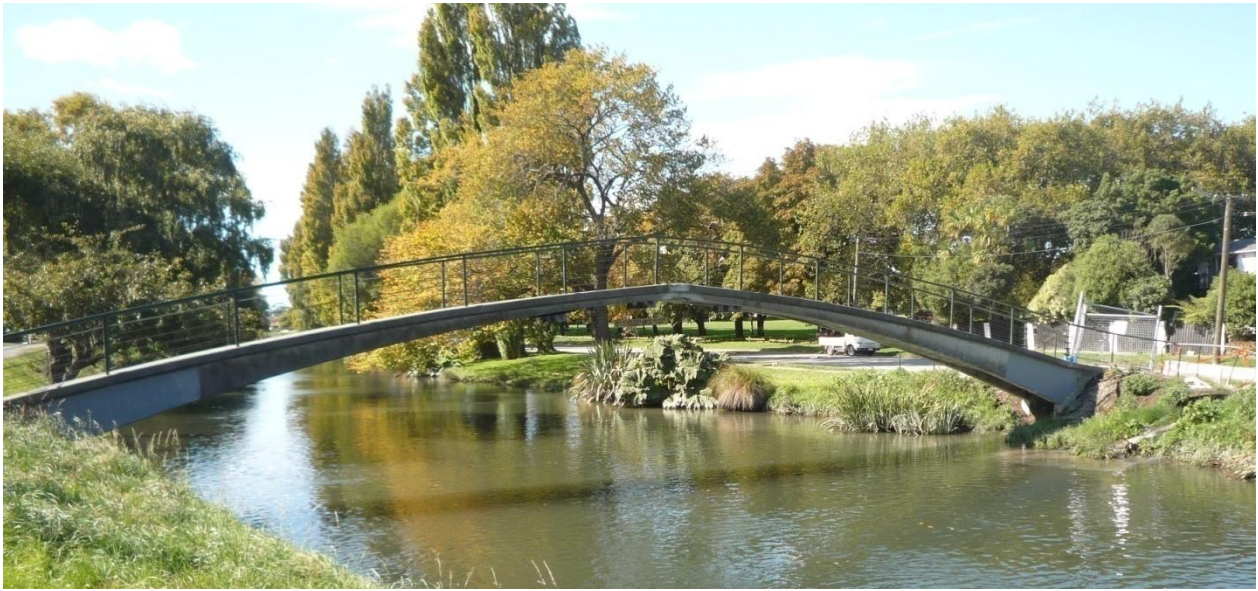
Figure 4.22. Snell Footbridge (B5 on map of Figure 4.1) after Christchurch earthquake.

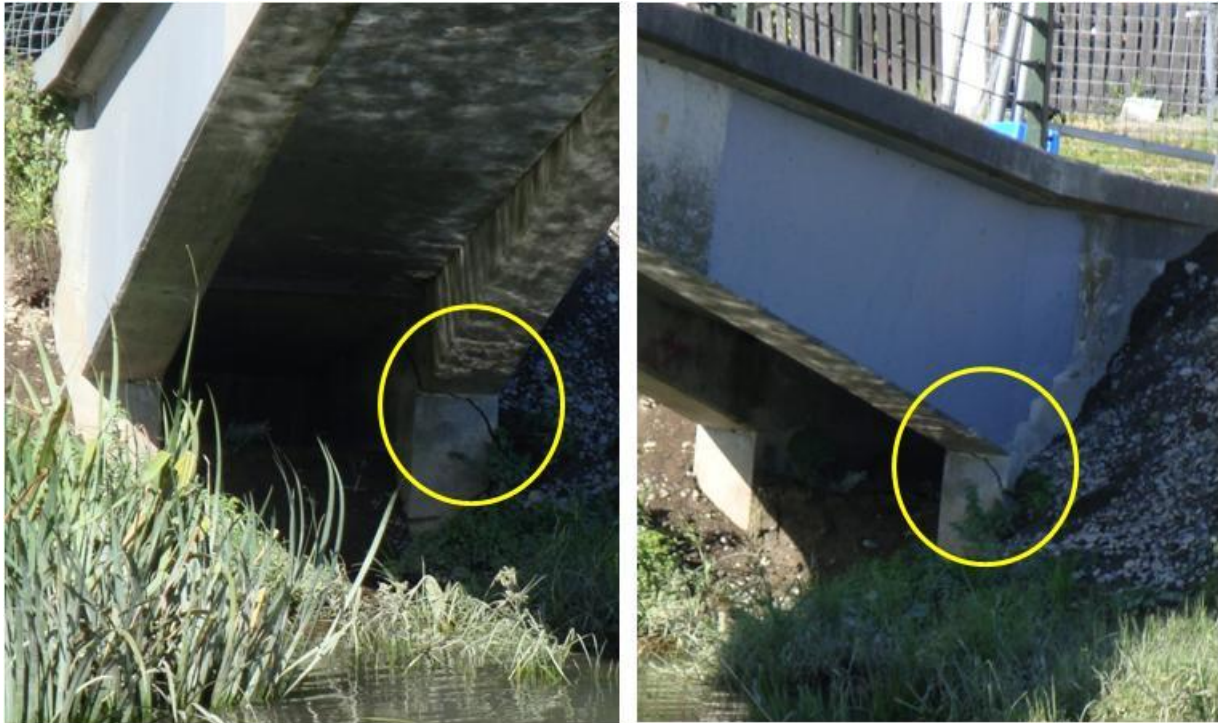
Figure 4.22. Snell Footbridge (B5 on map of Figure 4.1) after Christchurch earthquake. Cracks on the abutments.

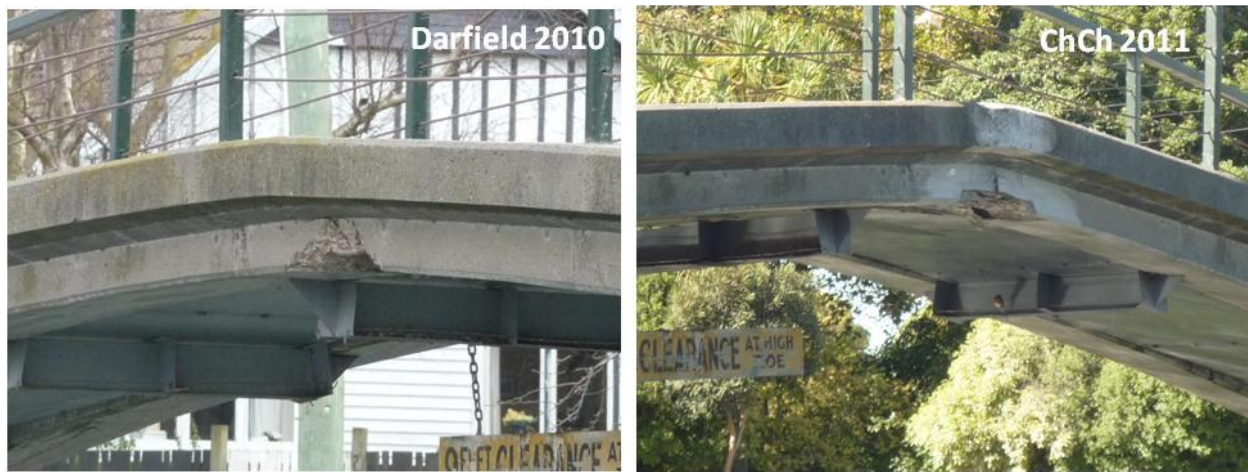
Figure 4.23. Snell Footbridge (B5 on map of Figure 4.1) after Christchurch earthquake. Comparison of damage between Darfield and Christchurch shaking events. The cracks have widened and extended at the mid-point. Source: NHP- Bridge Research Group.

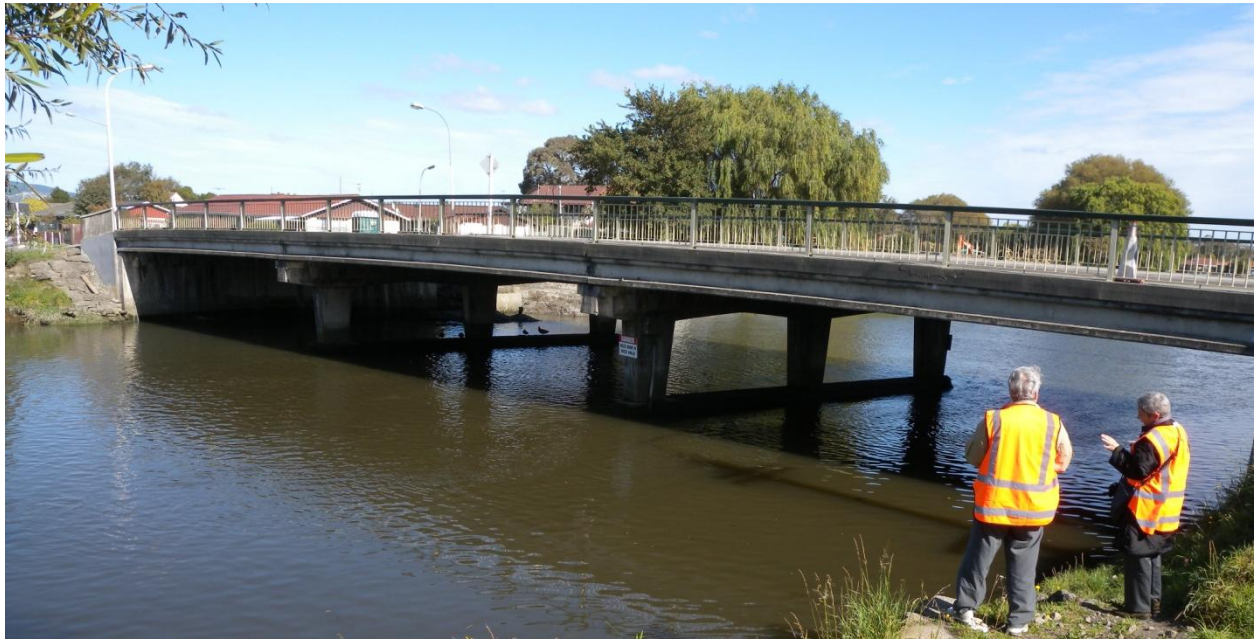
Figure 4.24. Avondale Bridge (B6 on map of Figure 4.1) after Christchurch earthquake.

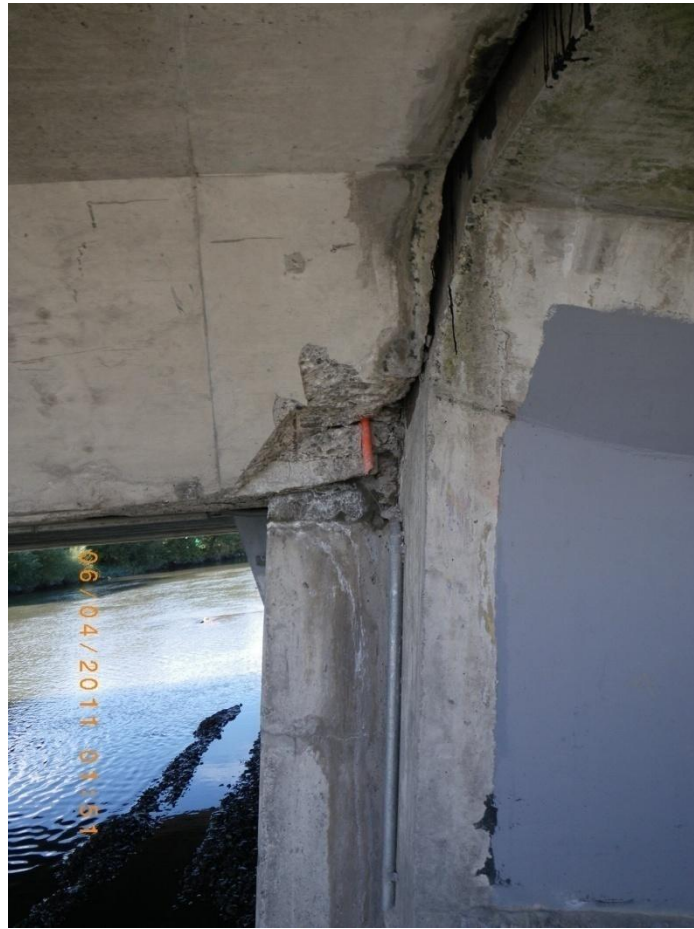
Figure 4.26. Southern abutment of Avondale Bridge (B6 on map of Figure 4.1) after Christchurch earthquake. Concrete spalling and gap opening at the joint of the deck with the abutment.

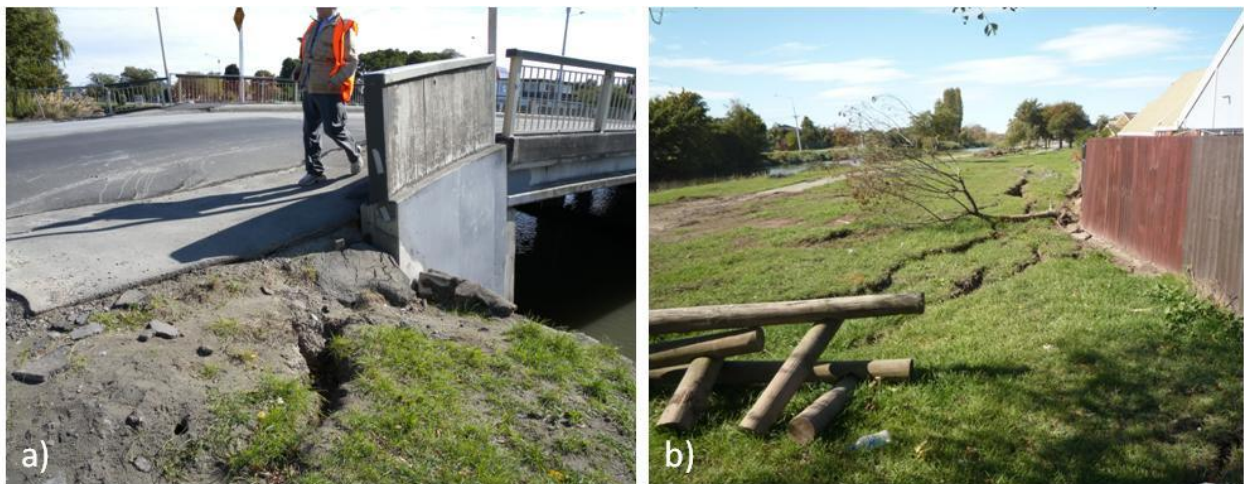
Figure 4.27. a) Back rotation of southern abutment of Avondale Bridge (B6 on map of Figure 4.1), cracks in the backfill, b) Large lateral spreading cracks in the south coast parallel to the river extending in a great distance at both sides of the southern abutment.

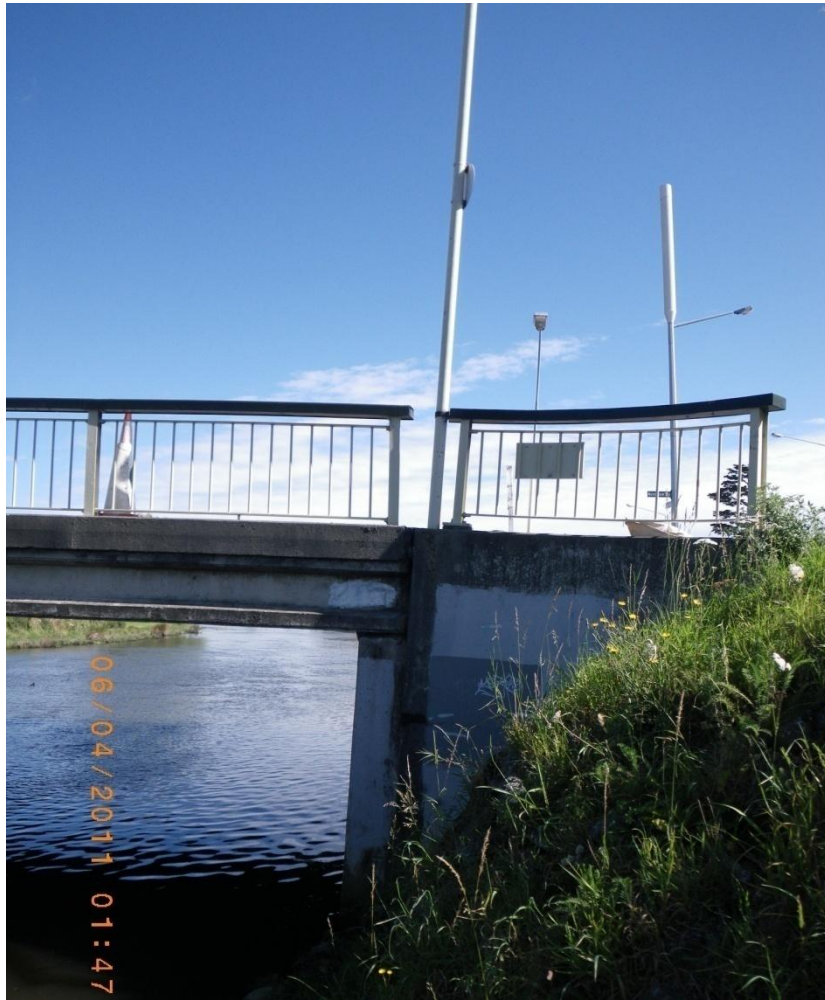
Figure 4.28. Northern abutment of Avondale Bridge (B6 on map of Figure 4.1) after Christchurch earthquake. Moderate back rotation (4 degrees) with only slight settlement of the backfill.

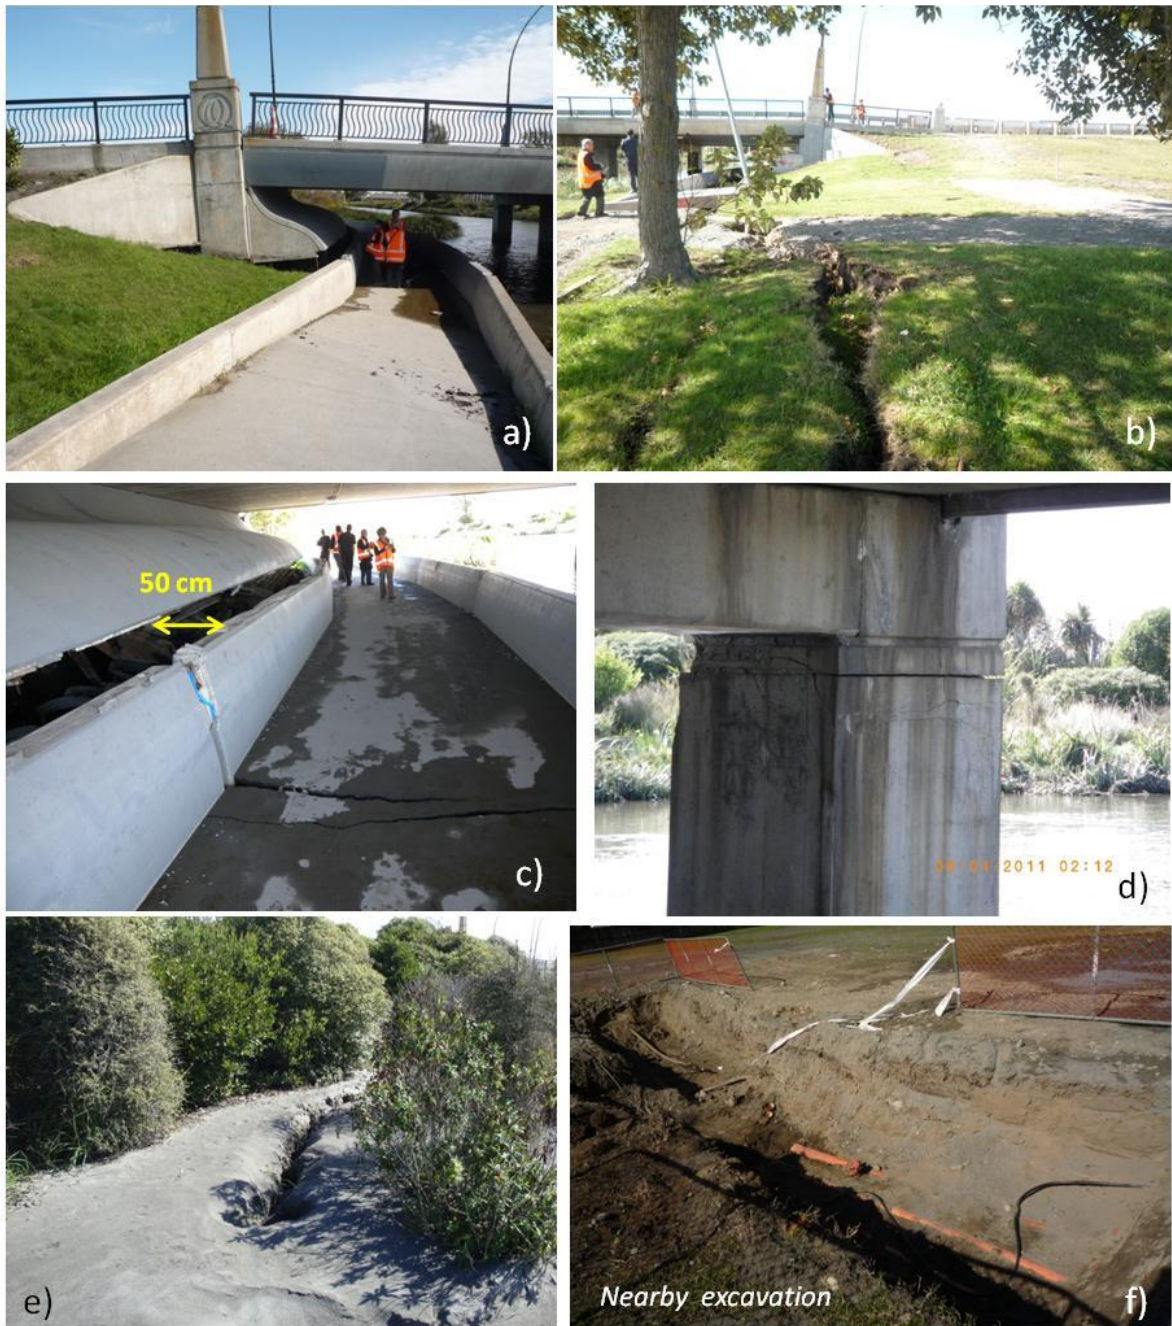
Figure 4.29. Avondale Bridge (B7 on map of Figure 4.1) after Christchurch earthquake. a) Back rotation of the abutments and slump of the approach fill, b) Large lateral spreading cracks in the ground parallel to Avon river coast extending in a great distance from the abutments indicating horizontal ground displacement more than 1, c) Riverward ground displacement in front of the abutments forming a gap of 50 cm, exposing the top of the piles, d) Concrete spalling and cracks at the top of the pier-column due to intense shaking and lateral spreading, e) Significant quantity of sand ejecta close to the bridge, f) Nearby shallow excavation shows a top crust of clay containing thin beds of sand.
