Geotechnical and Structural Field Observations from Christchurch, February 2011 Earthquake, in New Zealand

Research Report

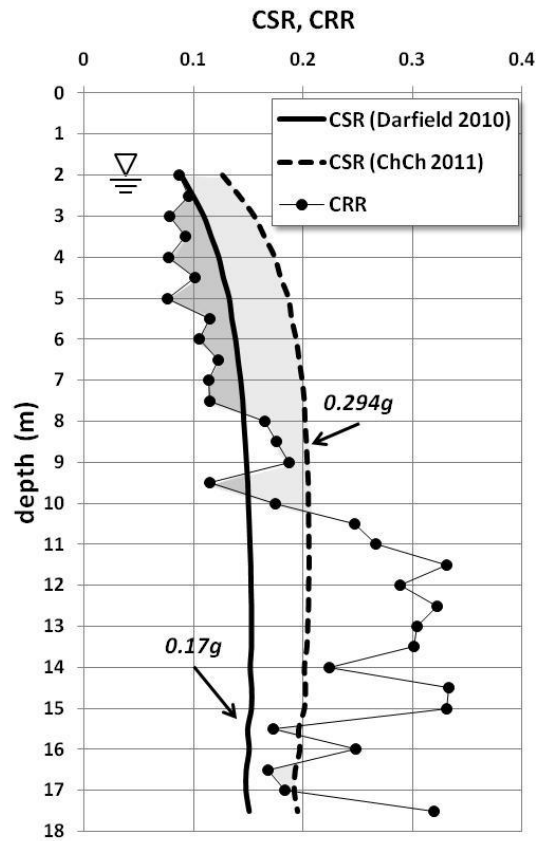
Figure 4.30. Avondale Bridge (B7 on map of Figure 4.1) The graph depicts the distribution of CRR with depth of a site between the HPSC station and Anzac Bridge compared with the CSR one during Darfield and Christchurch earthquakes. The shadowed areas indicate liquefaction susceptibility.

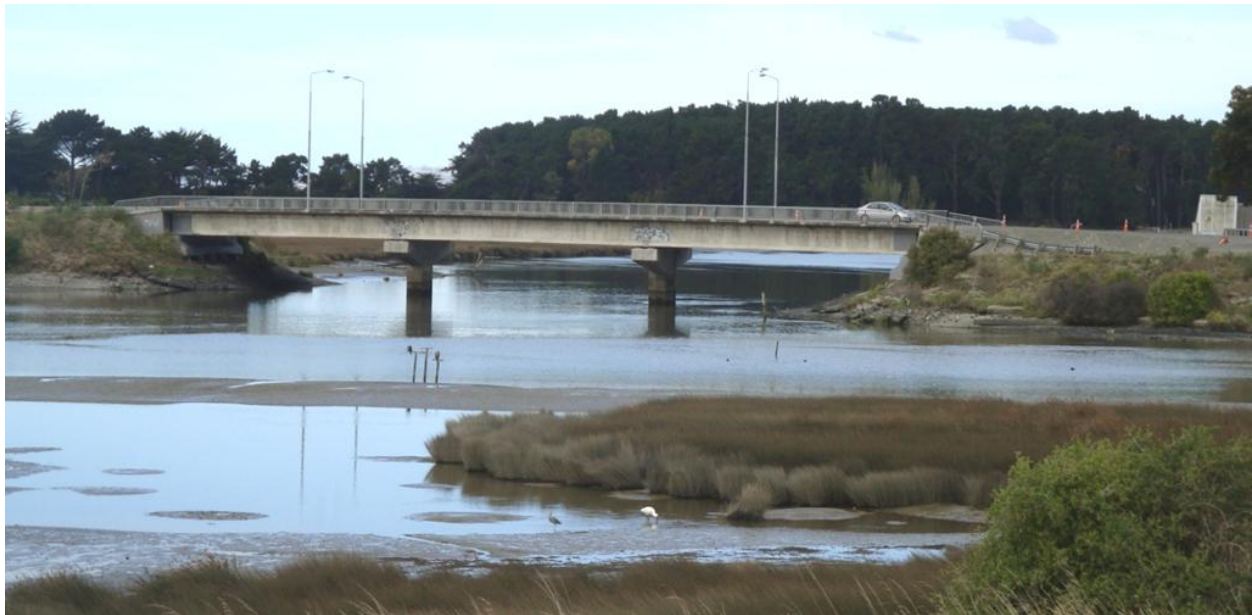
Figure 4.31. South Bridge Road Bridge (B8 on map of Figure 4.1) after Christchurch earthquake.

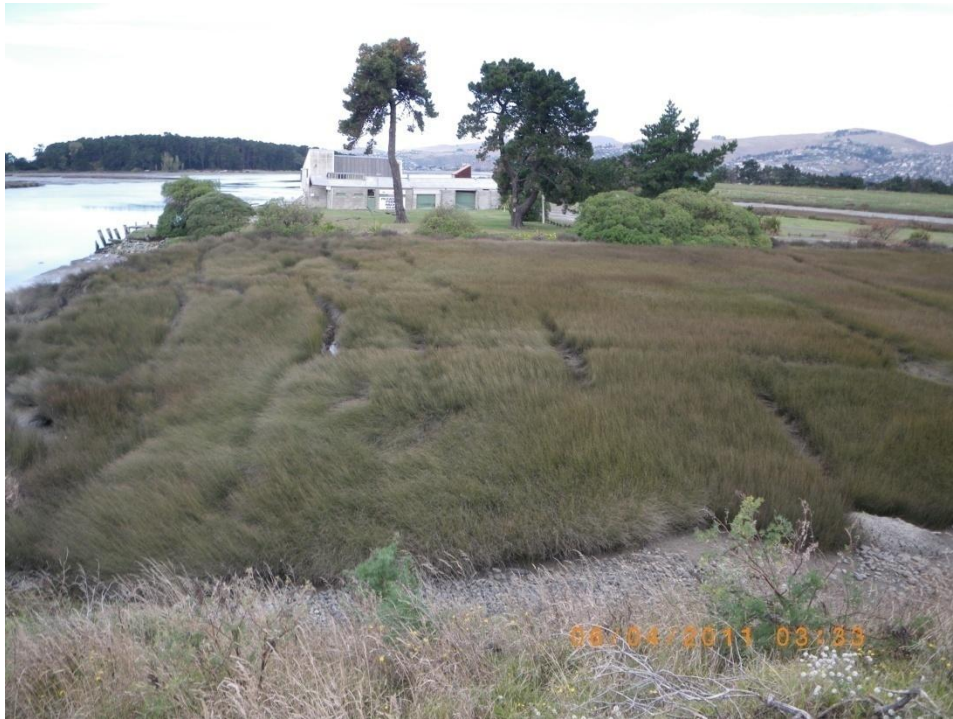
Figure 4.32. South Bridge Road Bridge (B8 on map of Figure 4.1) after Christchurch earthquake. Large lateral spreading cracks in the ground parallel to the coast and adjacent to the abutments extending at a great distance inland.

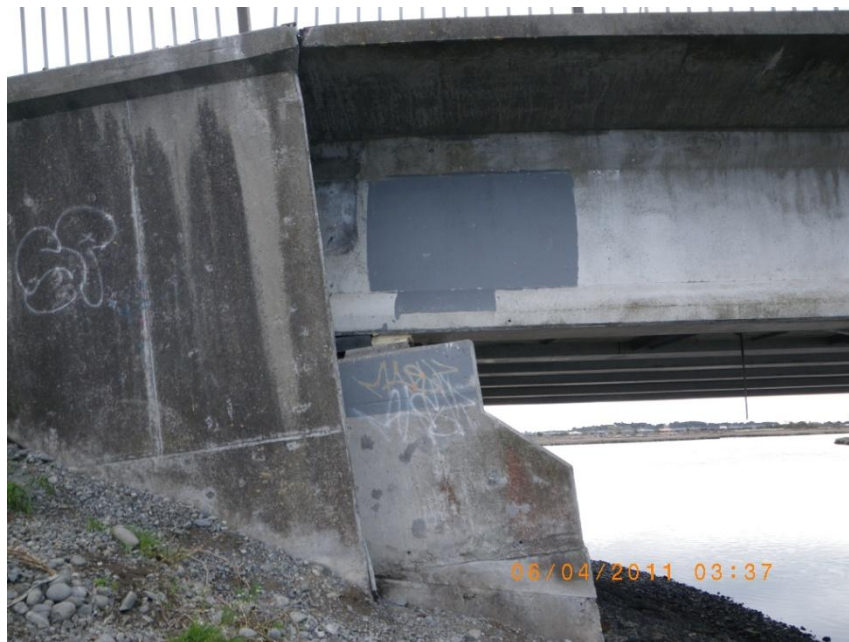
Figure 4.33. Western abutment of South Bridge Road Bridge (B8 on map of Figure 4.1) after Christchurch earthquake. Back rotation of the abutment around the deck and slump of the approach fill.

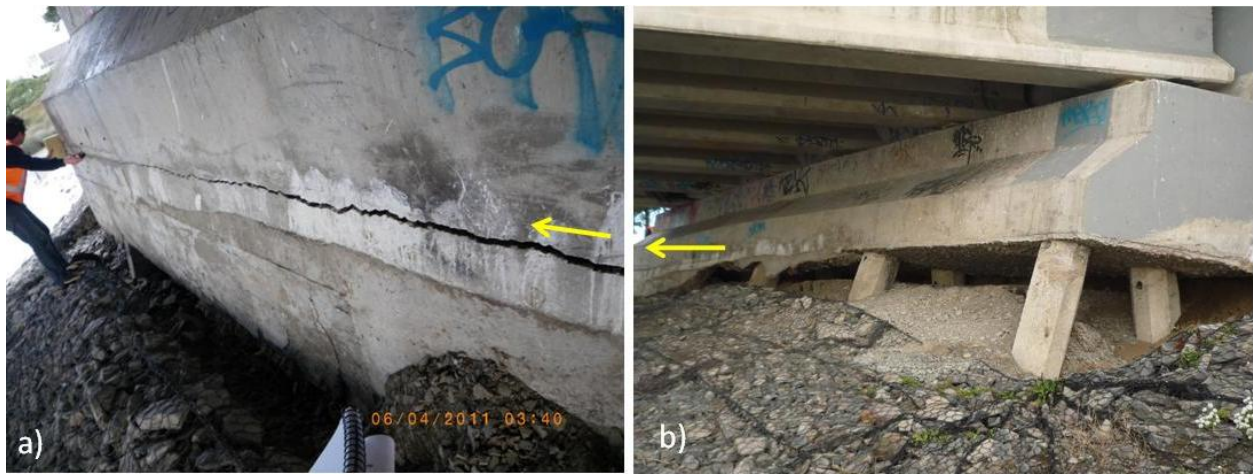
Figure 4.34. Western abutment of South Bridge Road Bridge (B8 on map of Figure 4.1) after Christchurch earthquake. a) Large tension horizontal crack at the base of the abutment, b) The gabion mat used for erosion protection in front of the abutment has laterally and vertically moved so that a great part of the pile heads has been exposed.

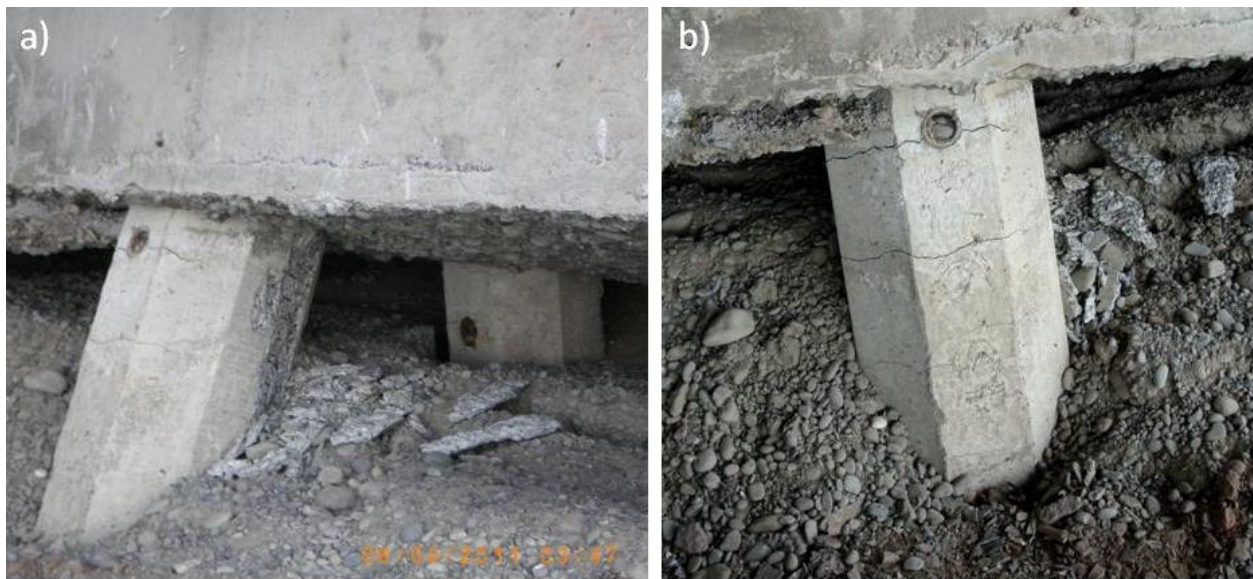
Figure 4.35. Western abutment of South Bridge Road Bridge (B8 on map of Figure 4.1) after Christchurch earthquake. a) Concrete spalling exposing the pile reinforcement, b) Flexural cracks developed at the top of the piles indicating plastic hinging.

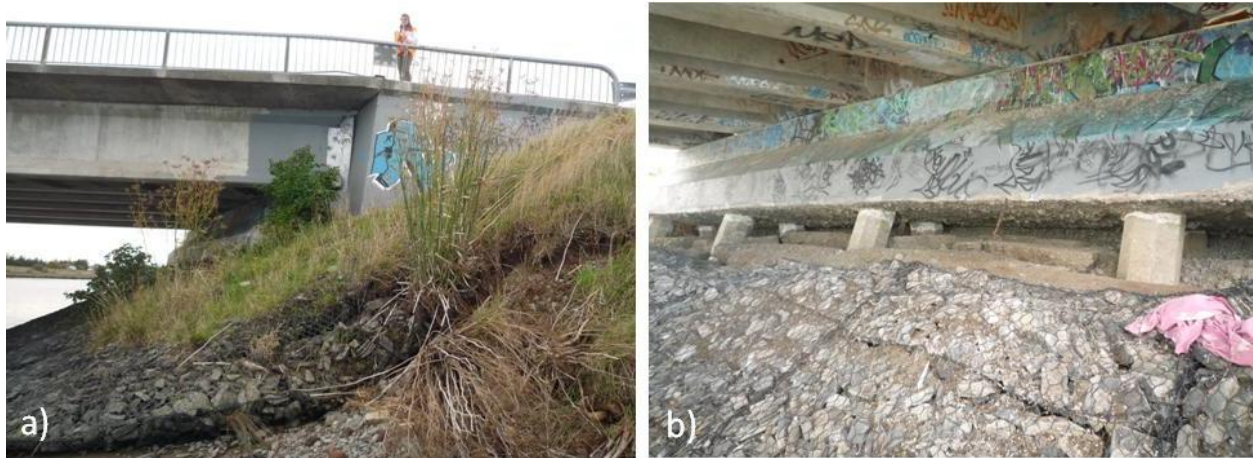
Figure 4.36. Eastern abutment of South Bridge Road Bridge (B8 on map of Figure 4.1) after Christchurch earthquake. a) Back rotation of the abutment around the deck and slump of the approach fill, b) the soil underneath the abutments has moved riverwards exposing both rows of piles.

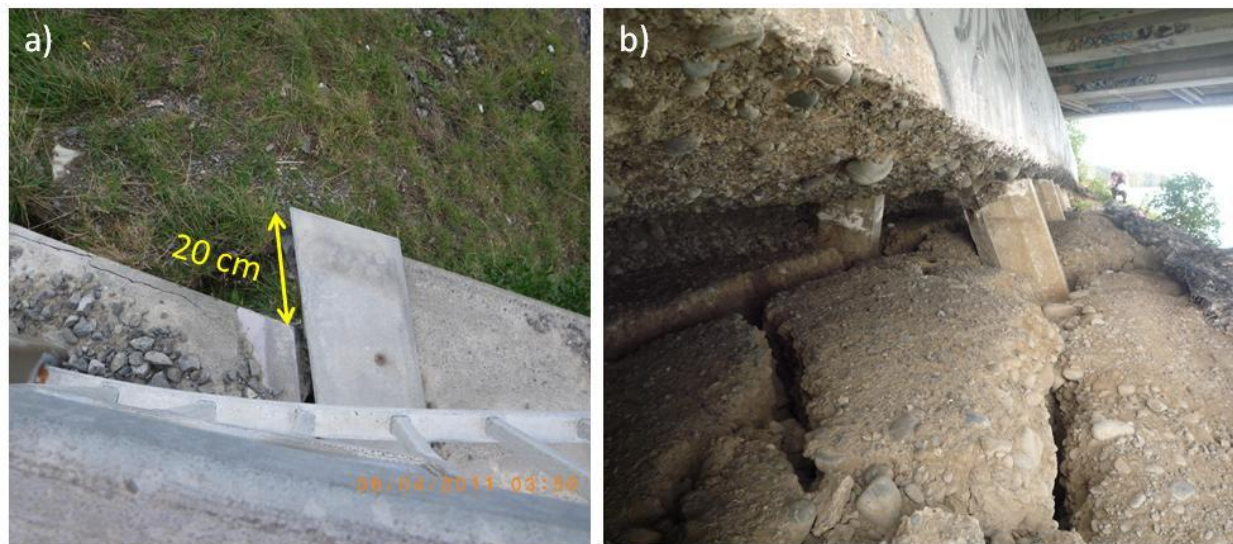
Figure 4.37. Eastern abutment of South Bridge Road Bridge (B8 on map of Figure 4.1) after Christchurch earthquake. a) Differential movement of abutments relative to the deck in the skew line direction is up to 20 cm accumulatively, b) the soil underneath the abutments has moved riverwards opening large cracks in the superficial crust and crating gaps in the front side of the piles.

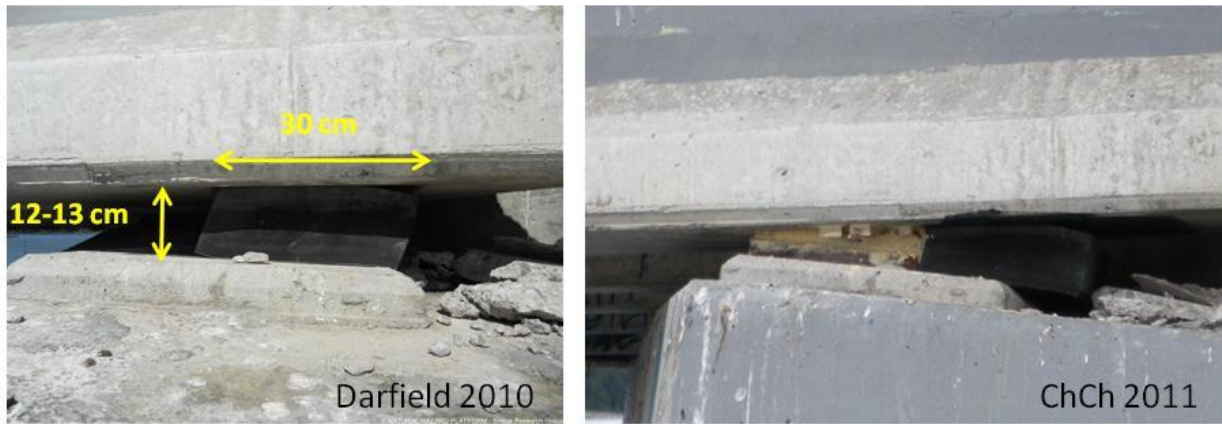
Figure 4.38. Western abutment of South Bridge Road Bridge (B8 on map of Figure 4.1). Differences between Darfield and Christchurch shaking events. The rubber bearing pad had sheared and slid laterally in Darfield earthquake. After Christchurch earthquake the rubber pad has deformed and displaced even more. The timber pad, used as a stop probably has been placed after Darfield earthquake, because it seems to have sustained certain deformation. Source: NHP- Bridge Research Group..

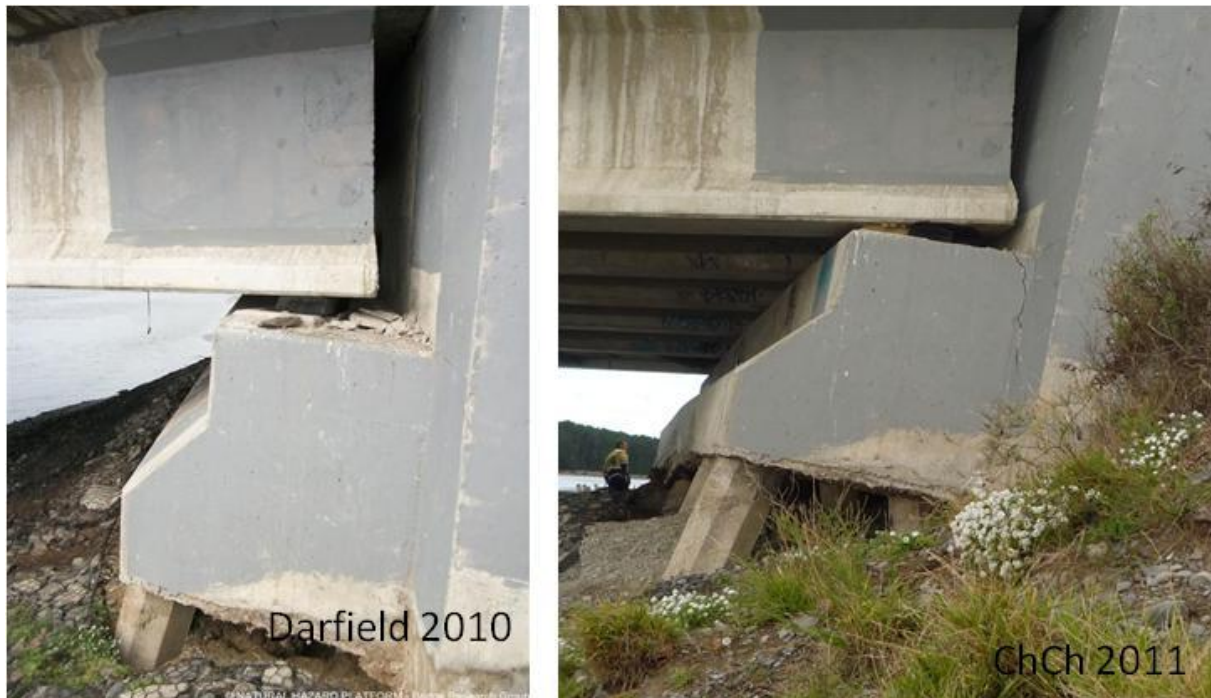
Figure 4.39. Western abutment of South Bridge Road Bridge (B8 on map of Figure 4.1). Differences between Darfield and Christchurch shaking events. After Christchurch earthquake the piles have been more exposed due to greater lateral spreading of the soil and some cracks have been developed in the abutment. Source: NHP- Bridge Research Group.

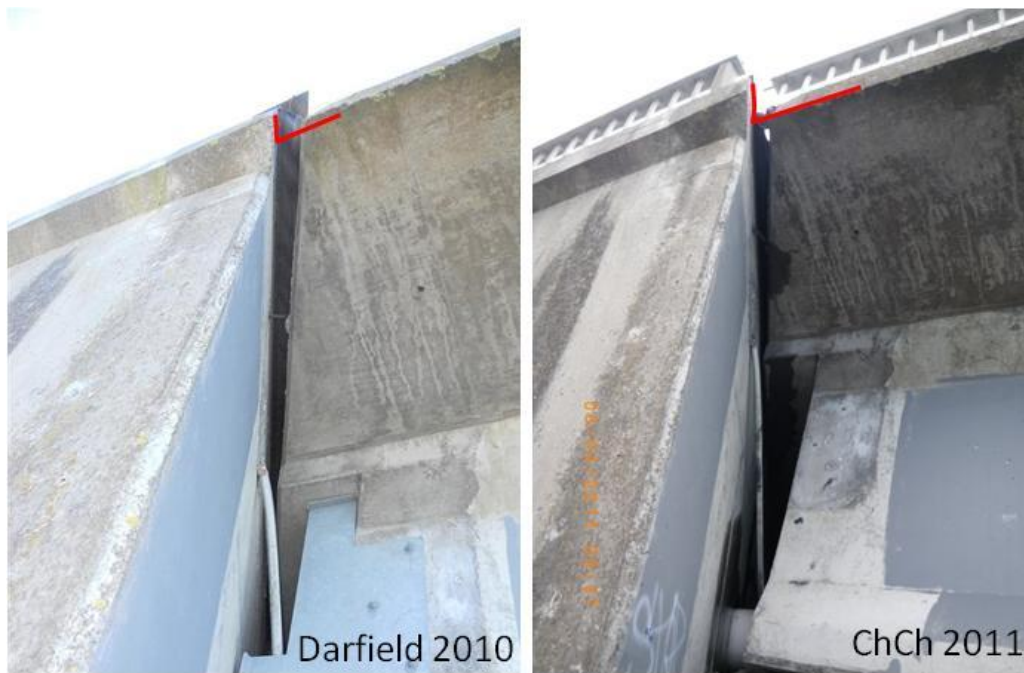
Figure 4.40. Western abutment of South Bridge Road Bridge (B8 on map of Figure 4.1). Slight differences between Darfield and Christchurch shaking events in terms of differential displacement of the abutment relative to the deck in the skew line direction. Source: NHP-Bridge Research Group.

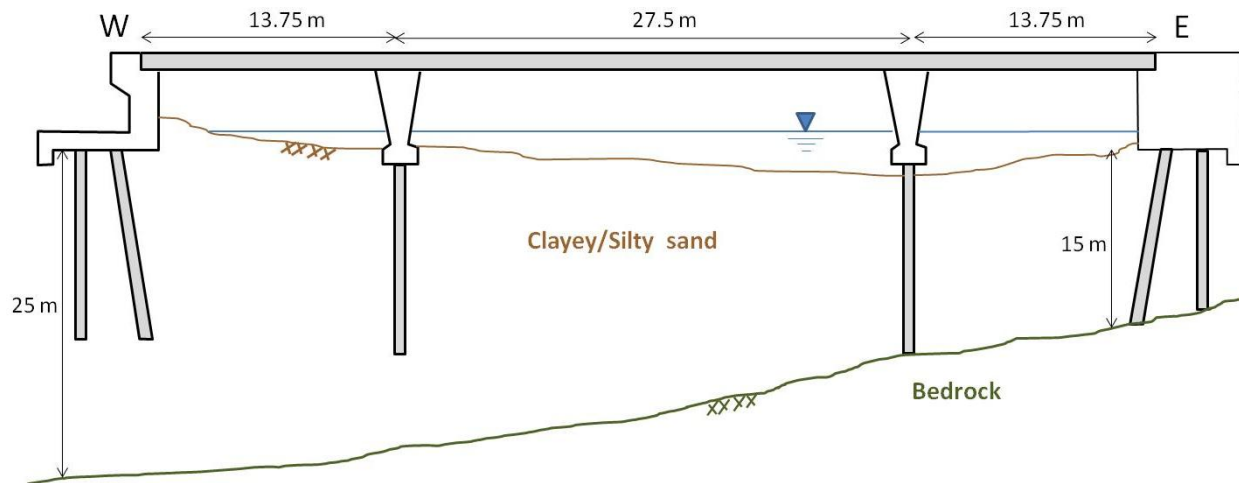
Figure 4.42 Sketch of Ferrymead Bridge and soil geometry (B8 on map of Figure 4.1). The rear sections of the abutments do not appear in the sketch.

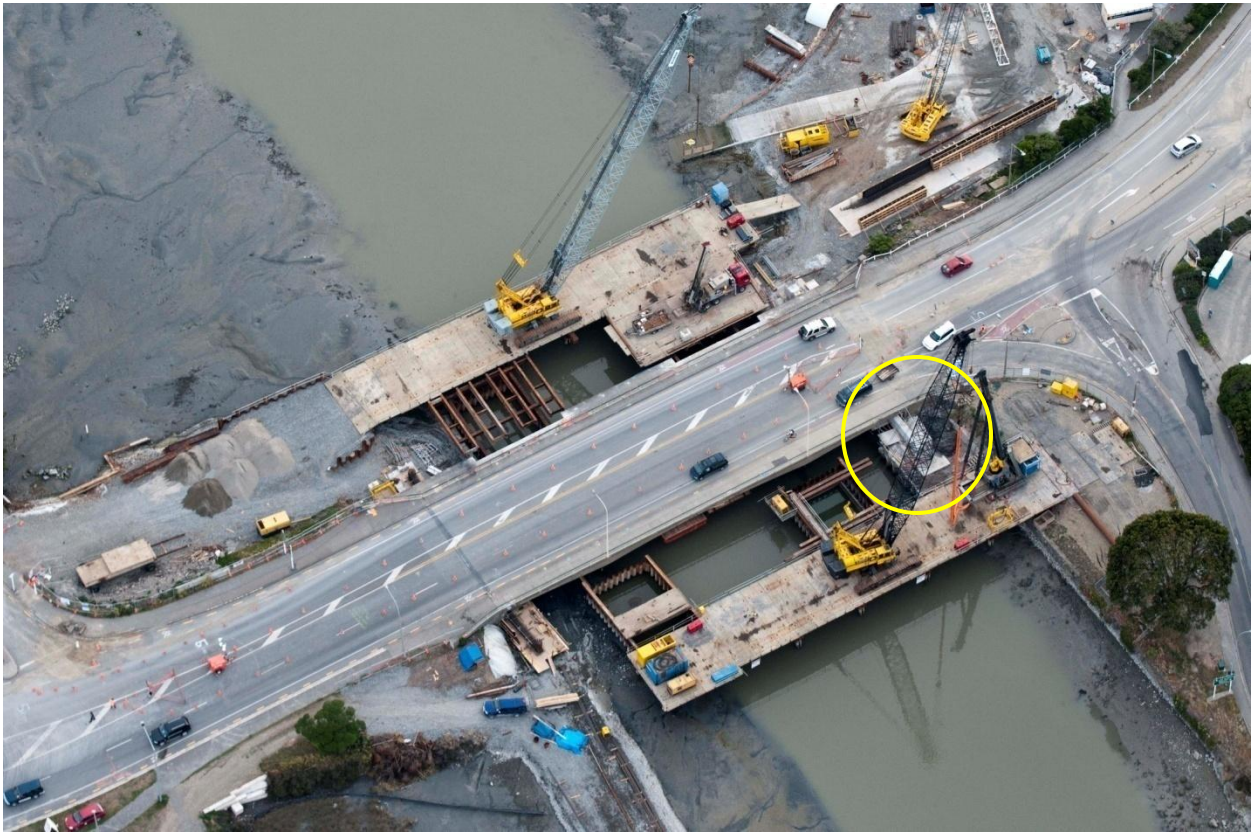
Figure 4.43. Ferrymead Bridge (B8 on map of Figure 4.1). Construction site in the process of strengthening and widening of the bridge. Photo taken after Christchurch earthquake. The new east abutment, in the yellow circle, was built one month before the shaking event.

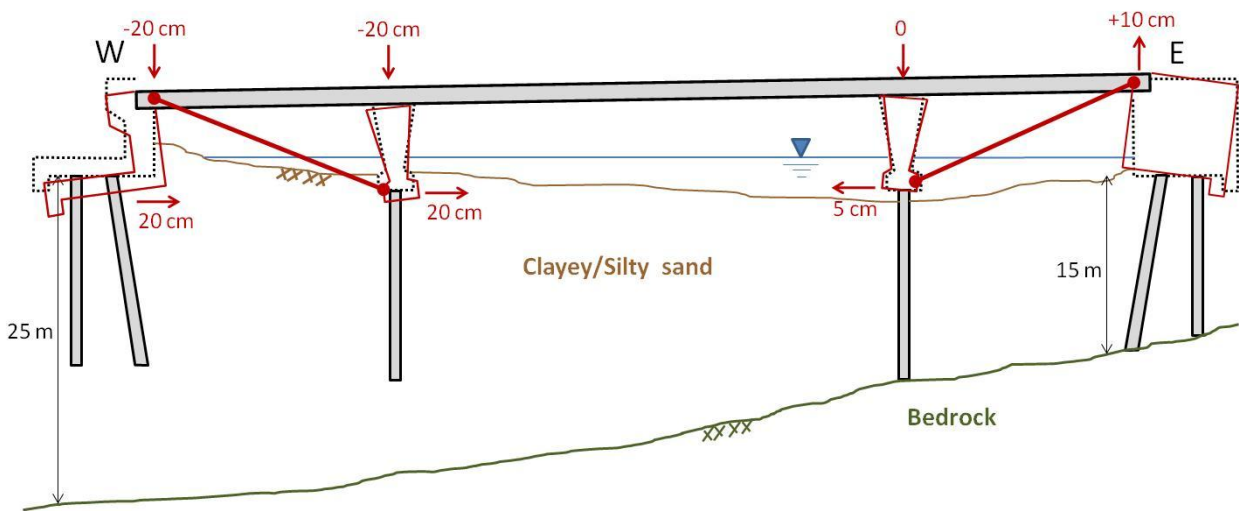
Figure 4.44. Sketch of Ferrymead Bridge deformation after Christchurch earthquake (B8 on map of Figure 4.1). The base of the piers has been tied to the deck edges after Christchurch earthquake in order to keep them in place and restrain any further inward movement until the strengthening project of the bridge is completed.

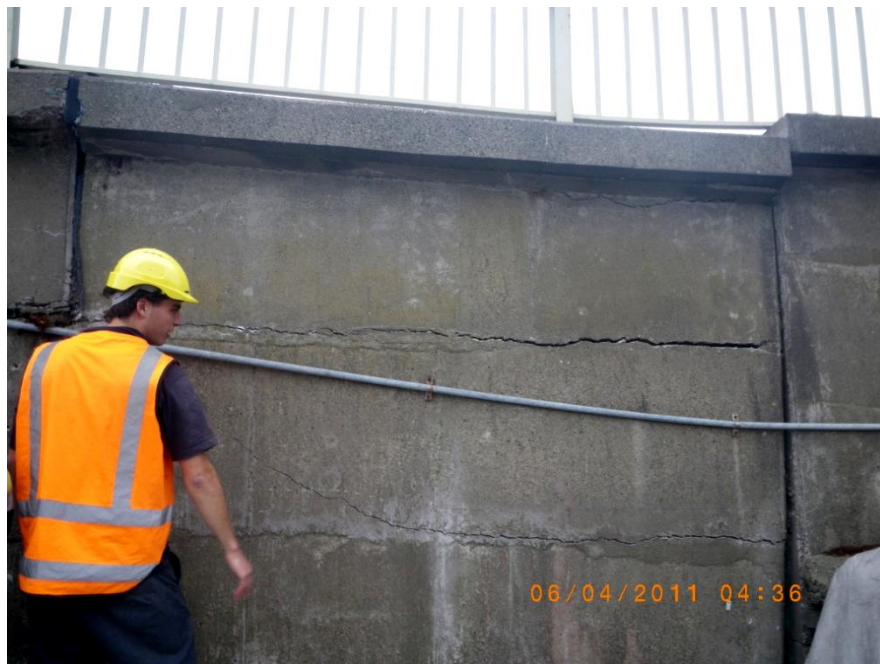
Figure 4.46. East abutment of Ferrymead Bridge after Christchurch earthquake (B8 on map of Figure 4.1). Horizontal cracks in the abutment wall have developed. The major crack is located at the height of the lower part of the deck.

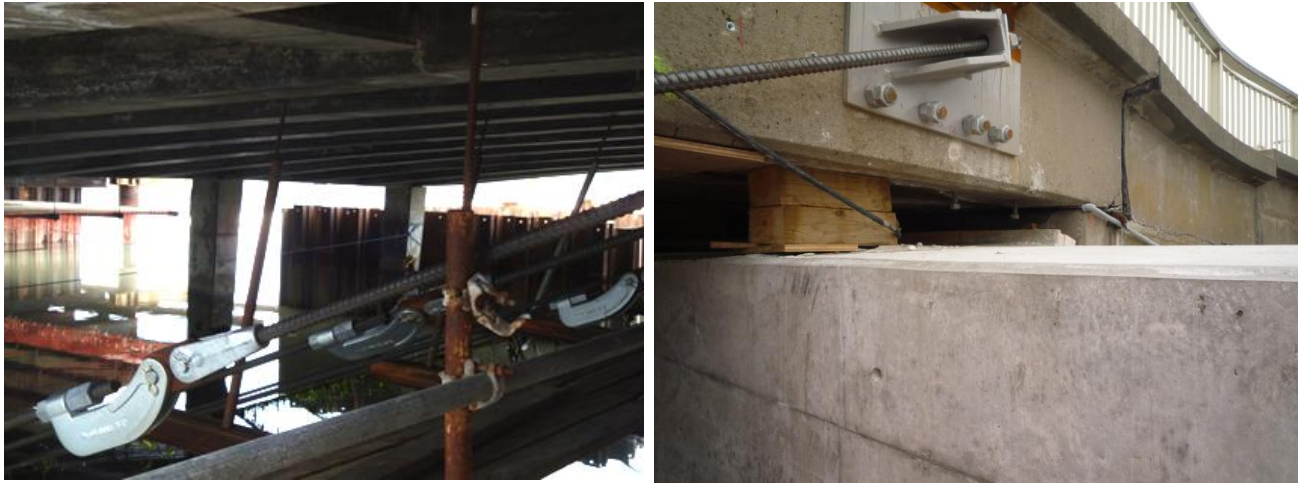
Figure 4.47. East abutment and pier of Ferrymead Bridge after Christchurch earthquake (B8 on map of Figure 4.1). The base of the piers has been tied with tendons to the edges of the deck in order to keep and restrain any inward movement (left). Timber pads have been placed between the new abutment and the deck after the earthquake (right).

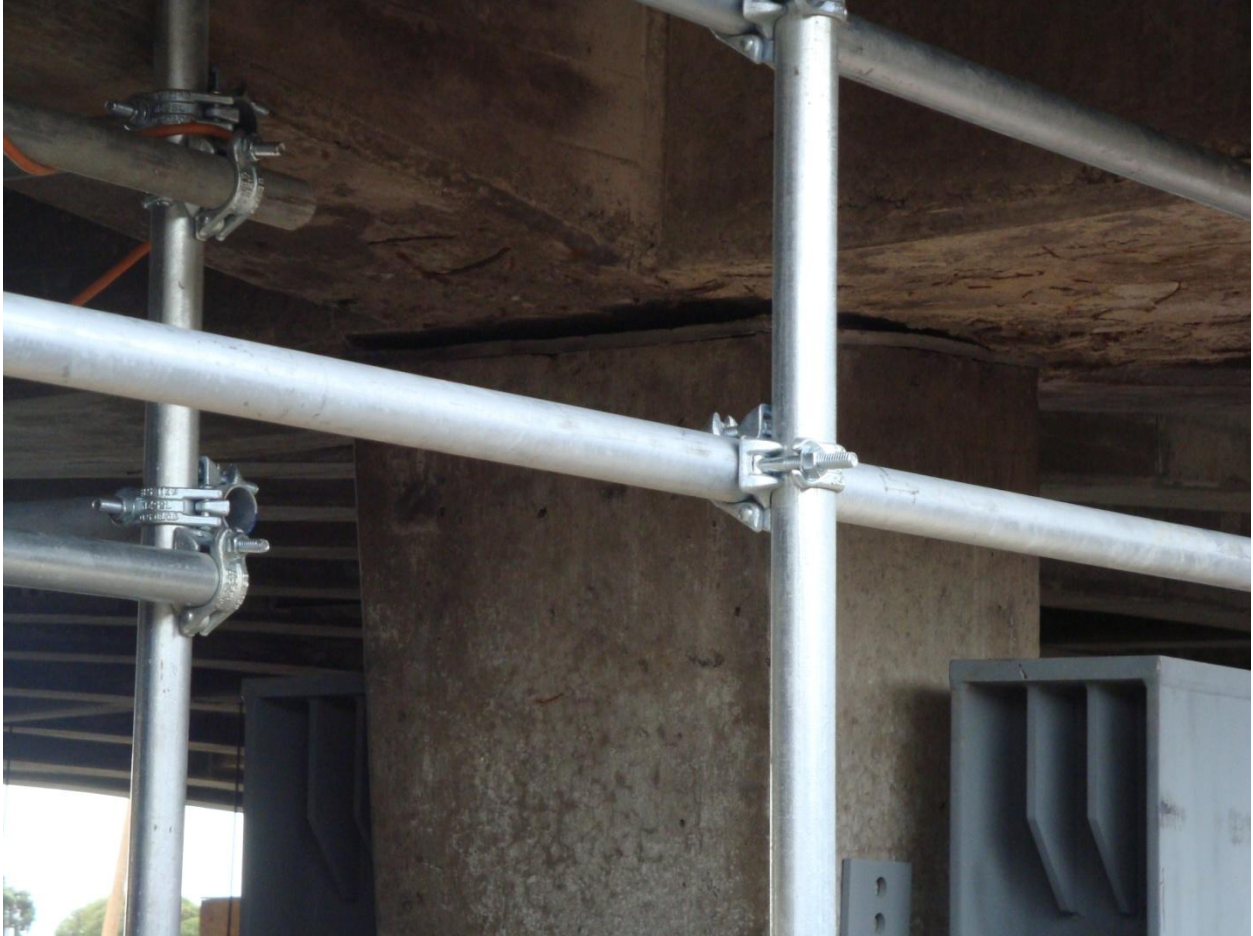
Figure 4.49. West pier of Ferrymead Bridge after Christchurch earthquake (B8 on map of Figure 4.1). The gap opening between the top of the pier and the deck was caused by the inward movement at the base of the pier.

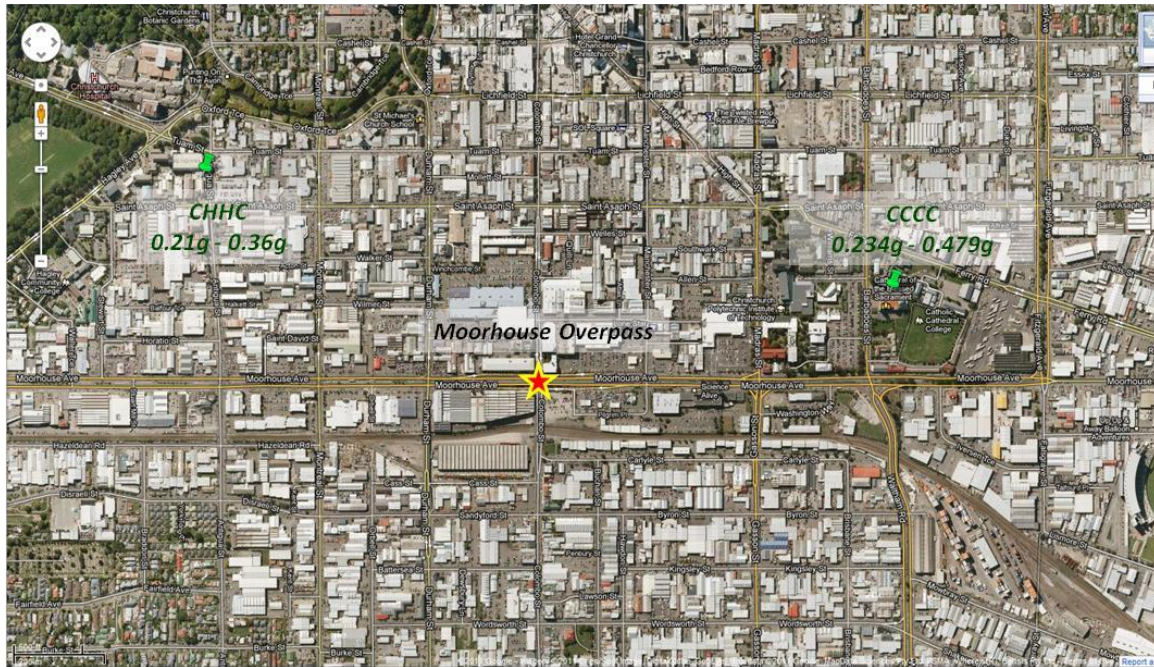
Figure 4.50. Location of Moorhouse Overpass.

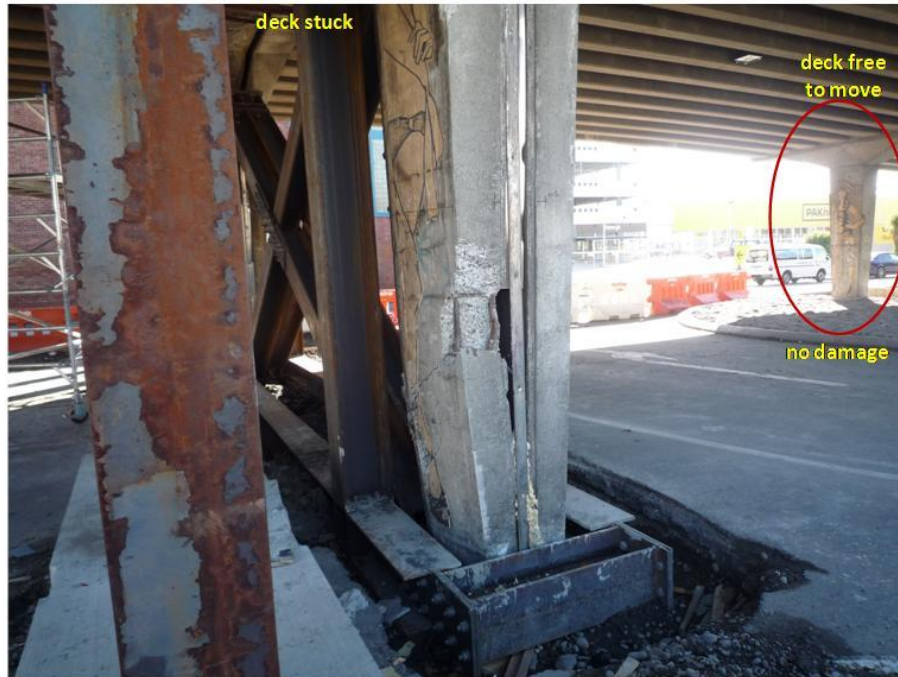
Figure 4.52. Failure of the pier due to shear and then buckling of the rebar under axial loads.

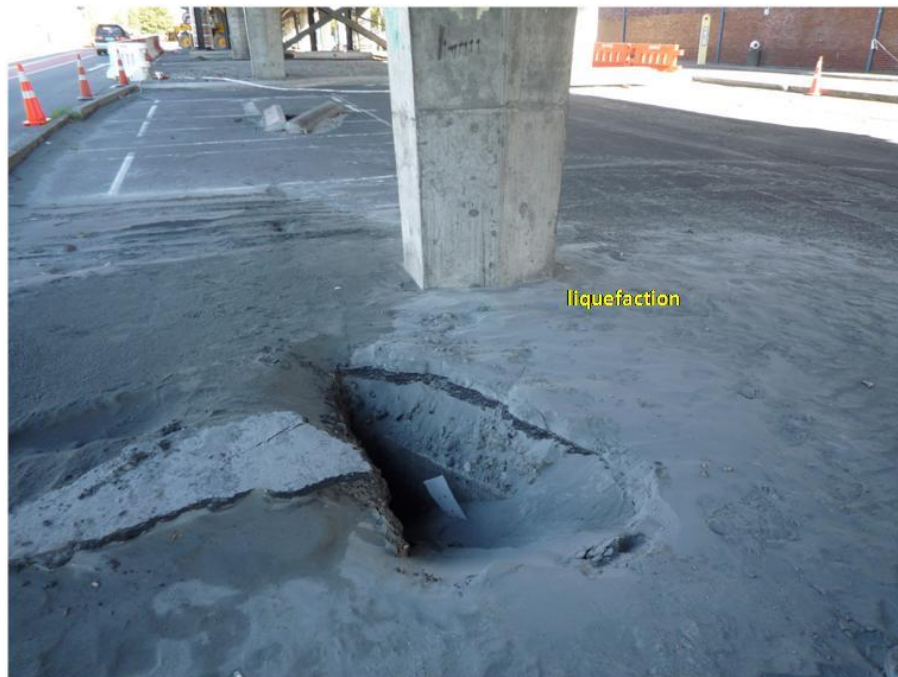
Figure 4.53. Sand-boils indicating liquefaction.

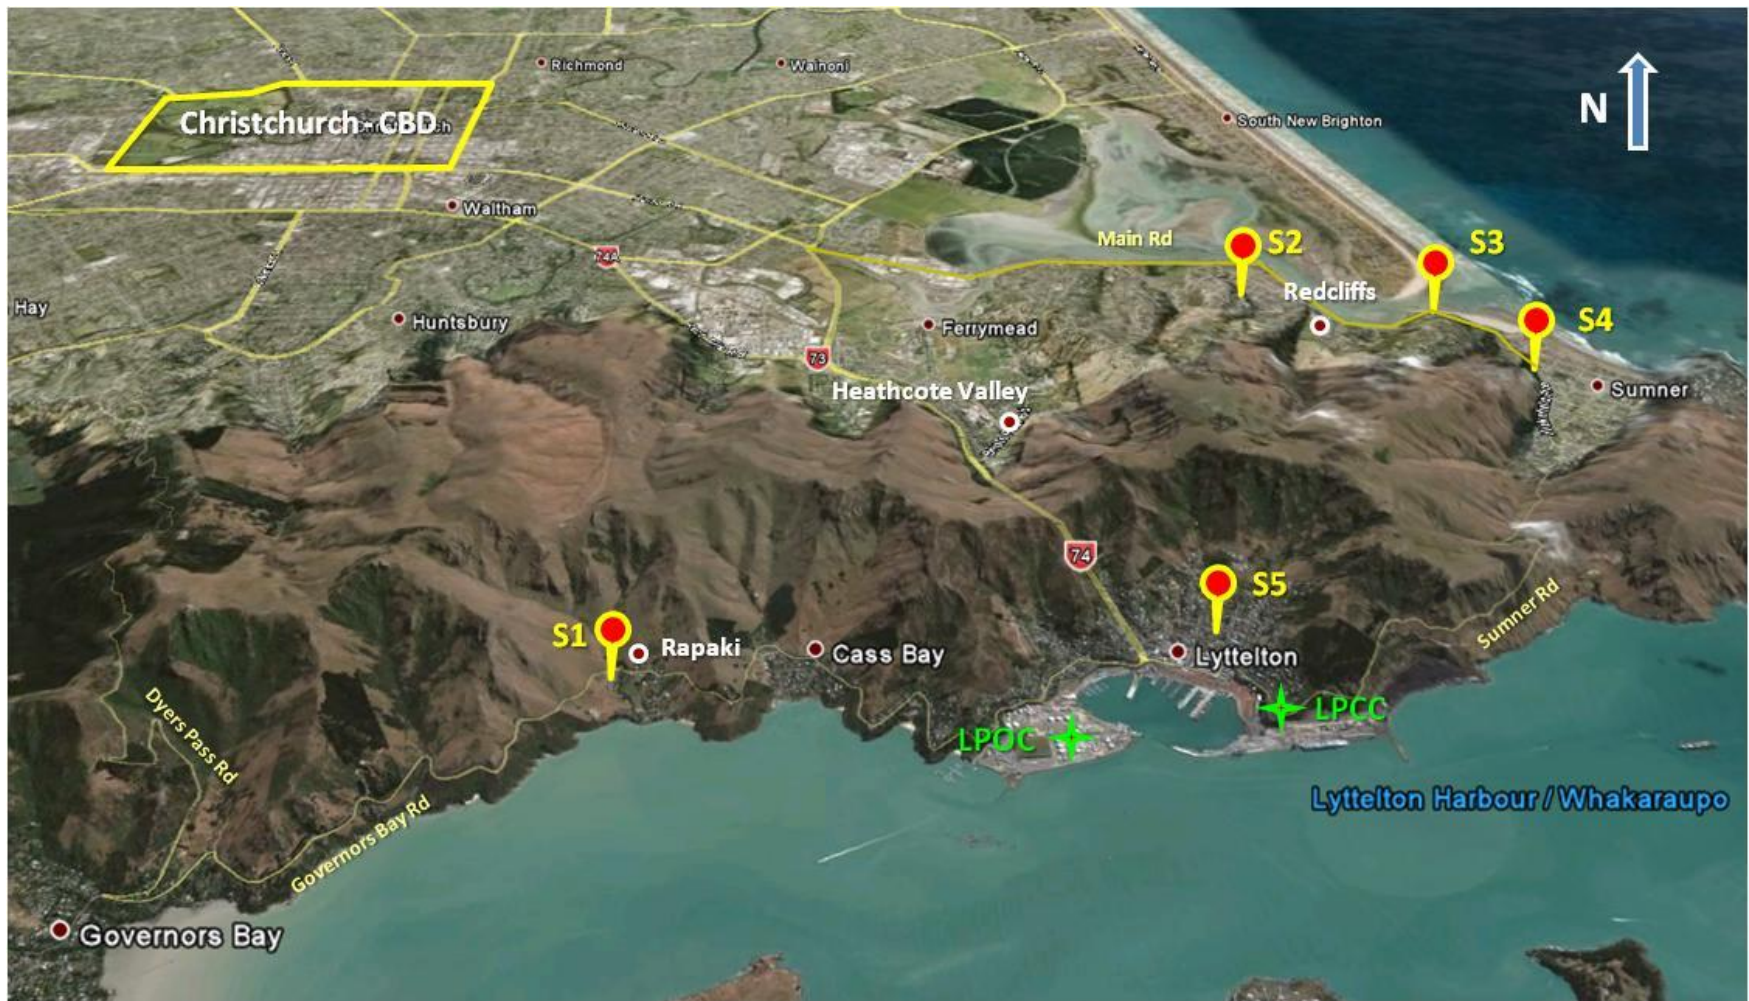
Figure 5.1. Map of Port Hills and Lyttelton Port located 6 km south of Christchurch - CBD (obtained from Google Earth). Reconnaissance sites are shown in the map with the yellow-reddish symbols under the names S1, S2, S3, S4 and S5. Seismic stations LPCC and LPOC situated at Lyttelton Port are also illustrated on the map.

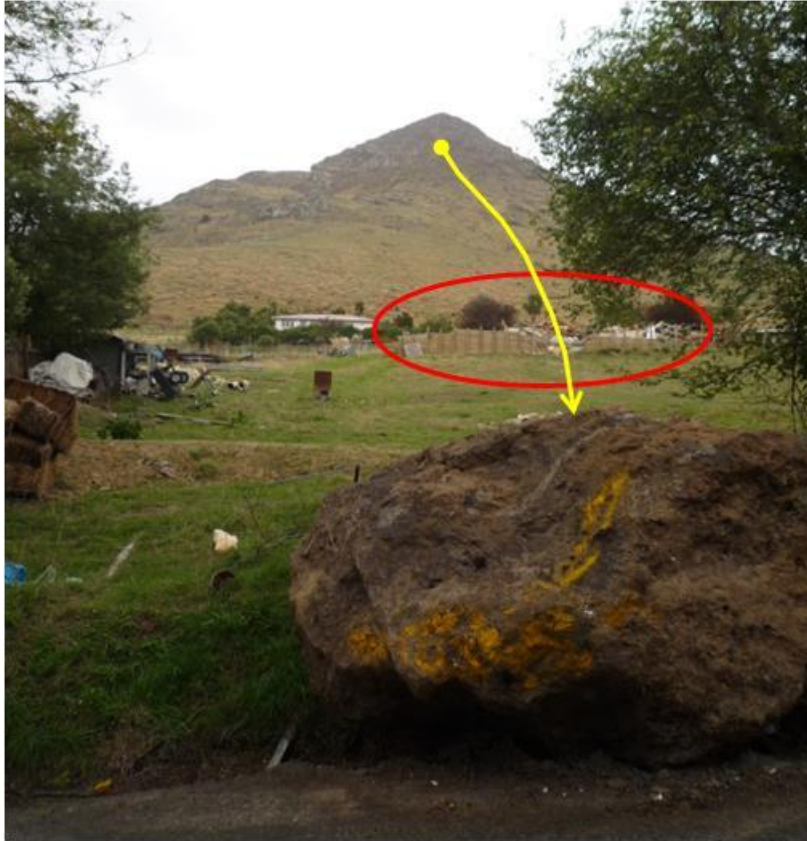
Figure 5.2. Boulder struck through a house at 241 Governors Bay Road in Rapaki (site S1 in the map of Figure 5.1).

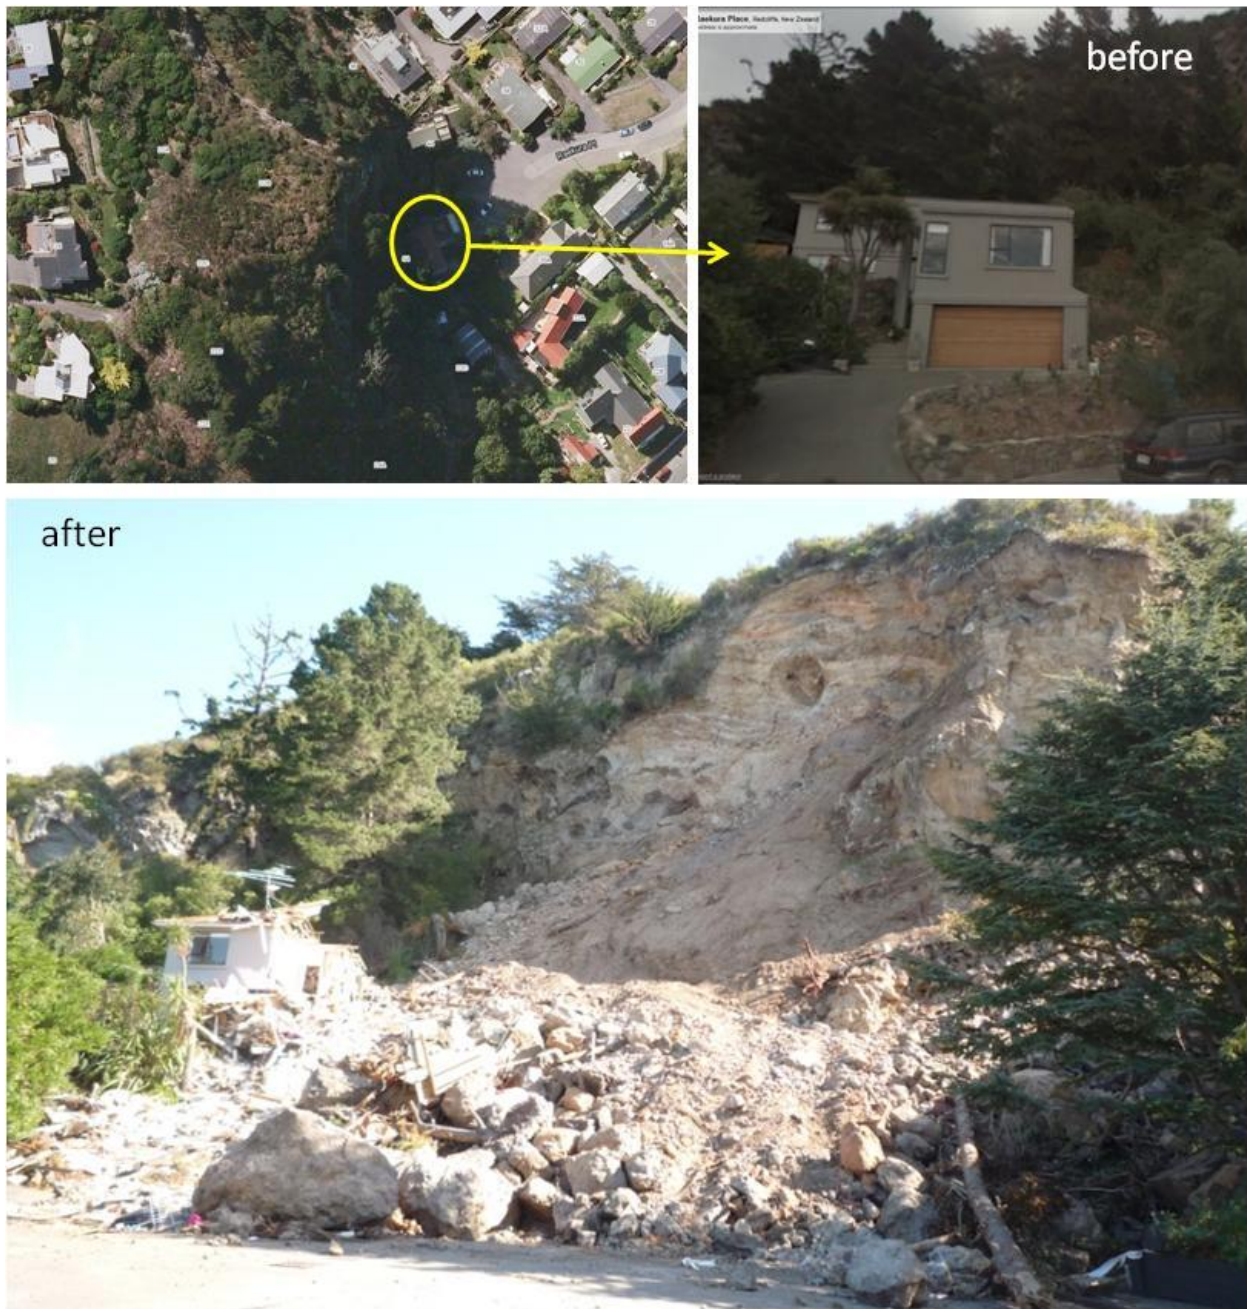
Figure 5.3. House collapsed by rock fall at Reakura Pl. in Redcliffs (site S2 in the map of Figure 5.1).

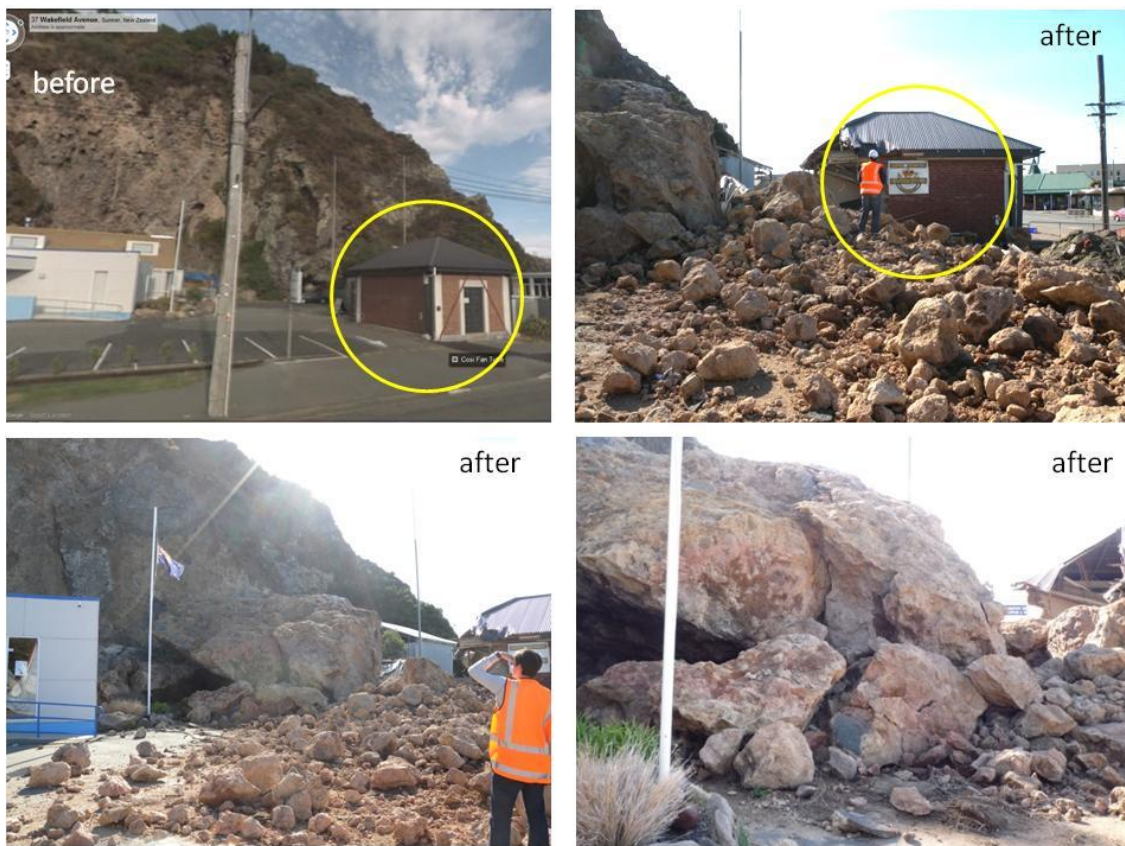
Figure 5.5. Extensive rock fall behind the RSA building at 34 Wakefield Ave, in Sumner (site S4 in the map of Figure 5.1).

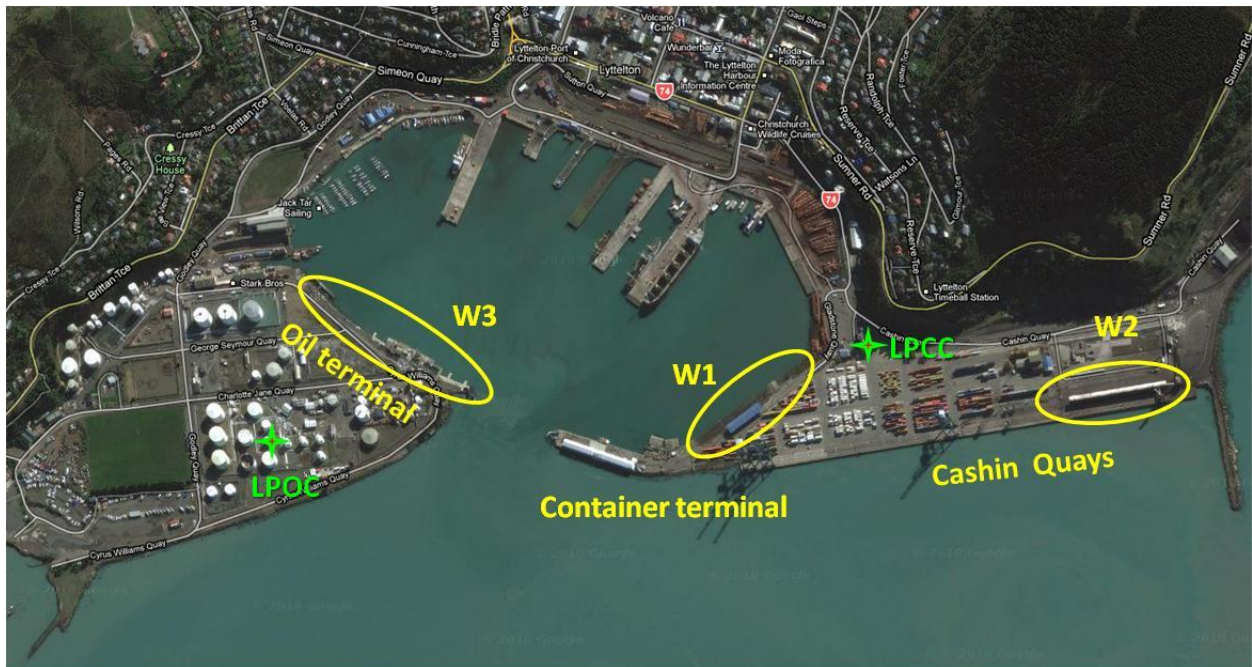
Figure 5.6. Map of Lyttelton Port of Christchurch (site S5 in the map of Figure 5.1). The inspected sites are pointed in the yellow circle. LPCC and LPOC are the seismic stations.

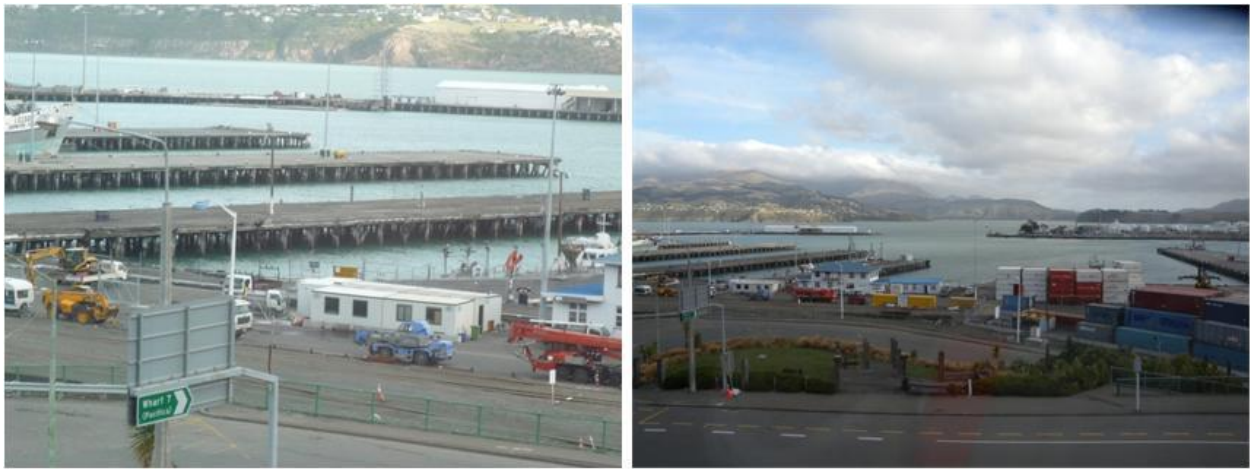
Figure 5.8. View of Lyttelton Port from the office facilities of Lyttelton Port Company.

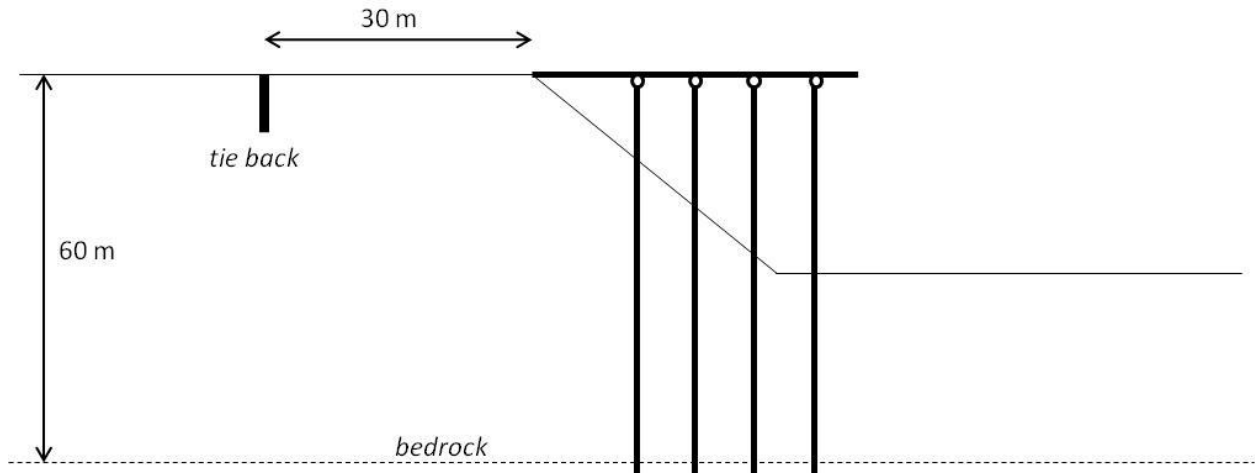
Figure 5.9. TYPE A pile configuration of Cashin Quays: piles founded on bedrock.

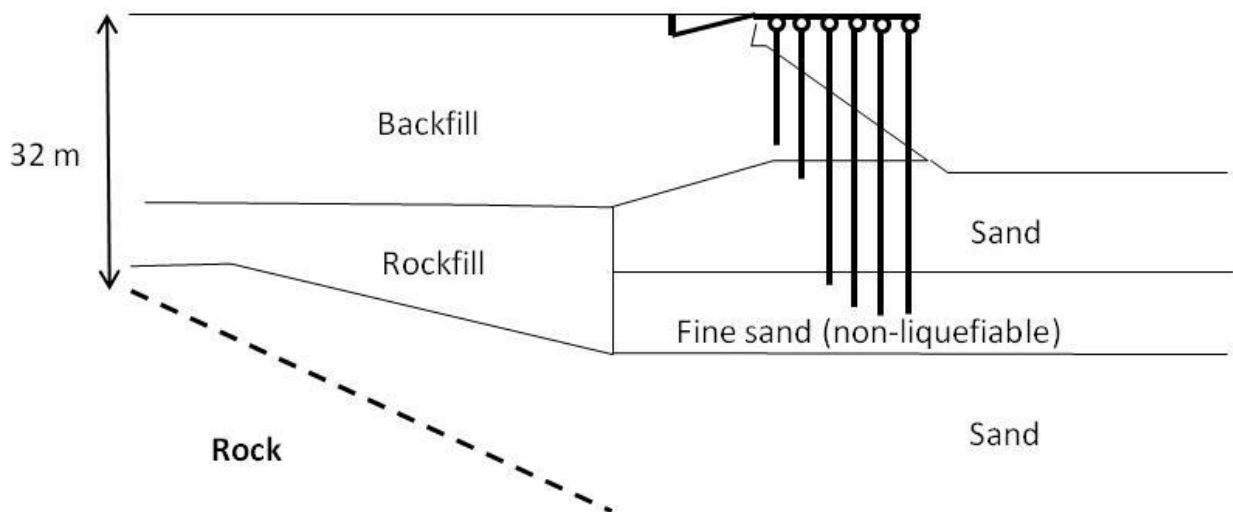
Figure 5.10. TYPE B pile configuration of Cashin Quays: skin-friction piles.
