Geotechnical and Structural Field Observations from Christchurch, February 2011 Earthquake, in New Zealand

Research Report

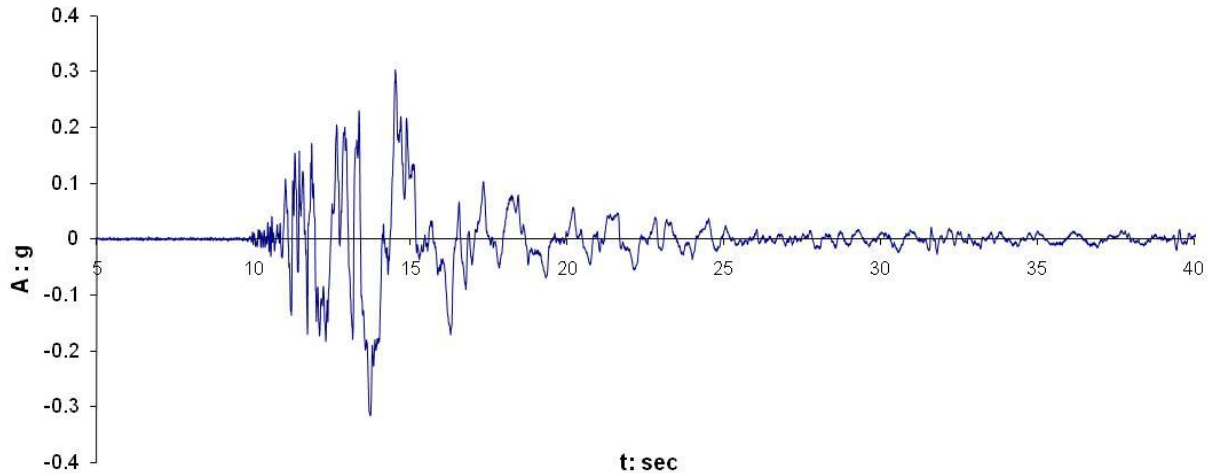
Figure 5.11. Acceleration time history in horizontal direction, x , recorded at LPOC station.

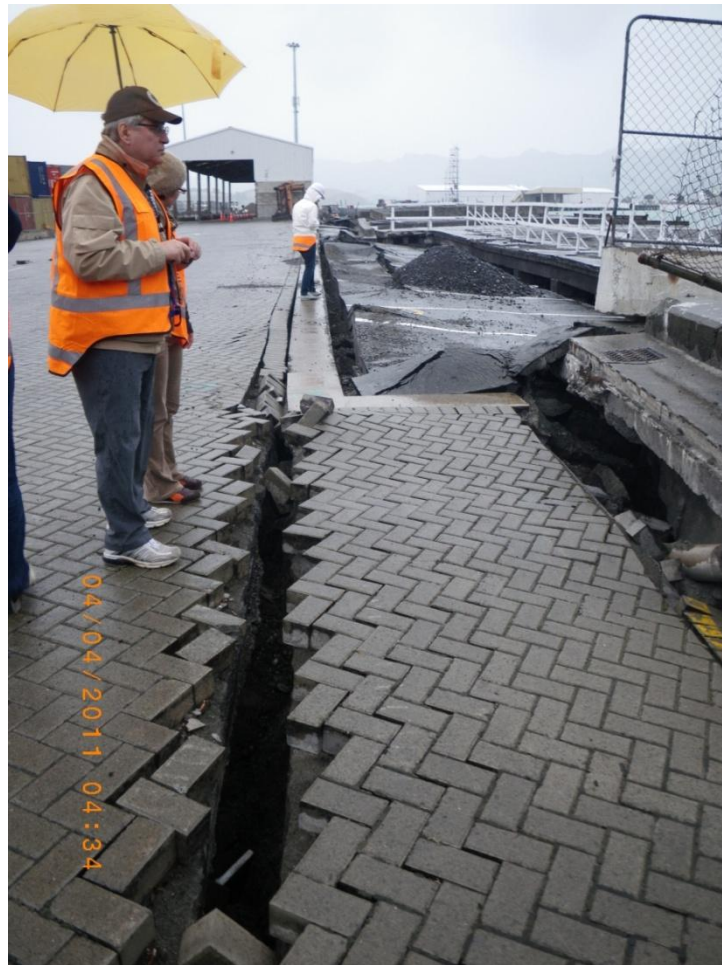
Figure 5.15. Huge cracks in the pavement in the order of 50 cm due to outward lateral movement of the quay (site W2 pointed in the map of Figure 5.6).

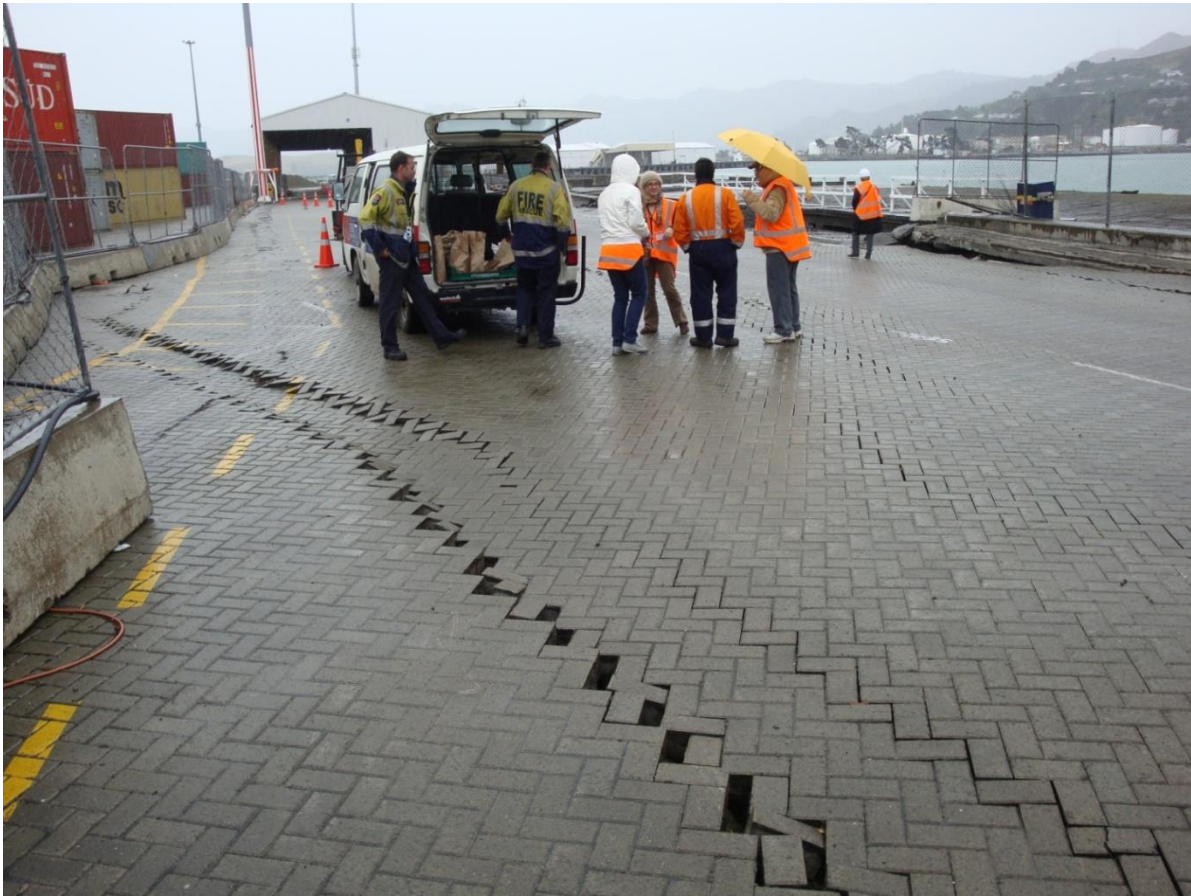
Figure 5.16. Cracks in the pavement due to lateral spreading continue to develop several meters behind the quay (site W2 pointed in the map of Figure 5.6).

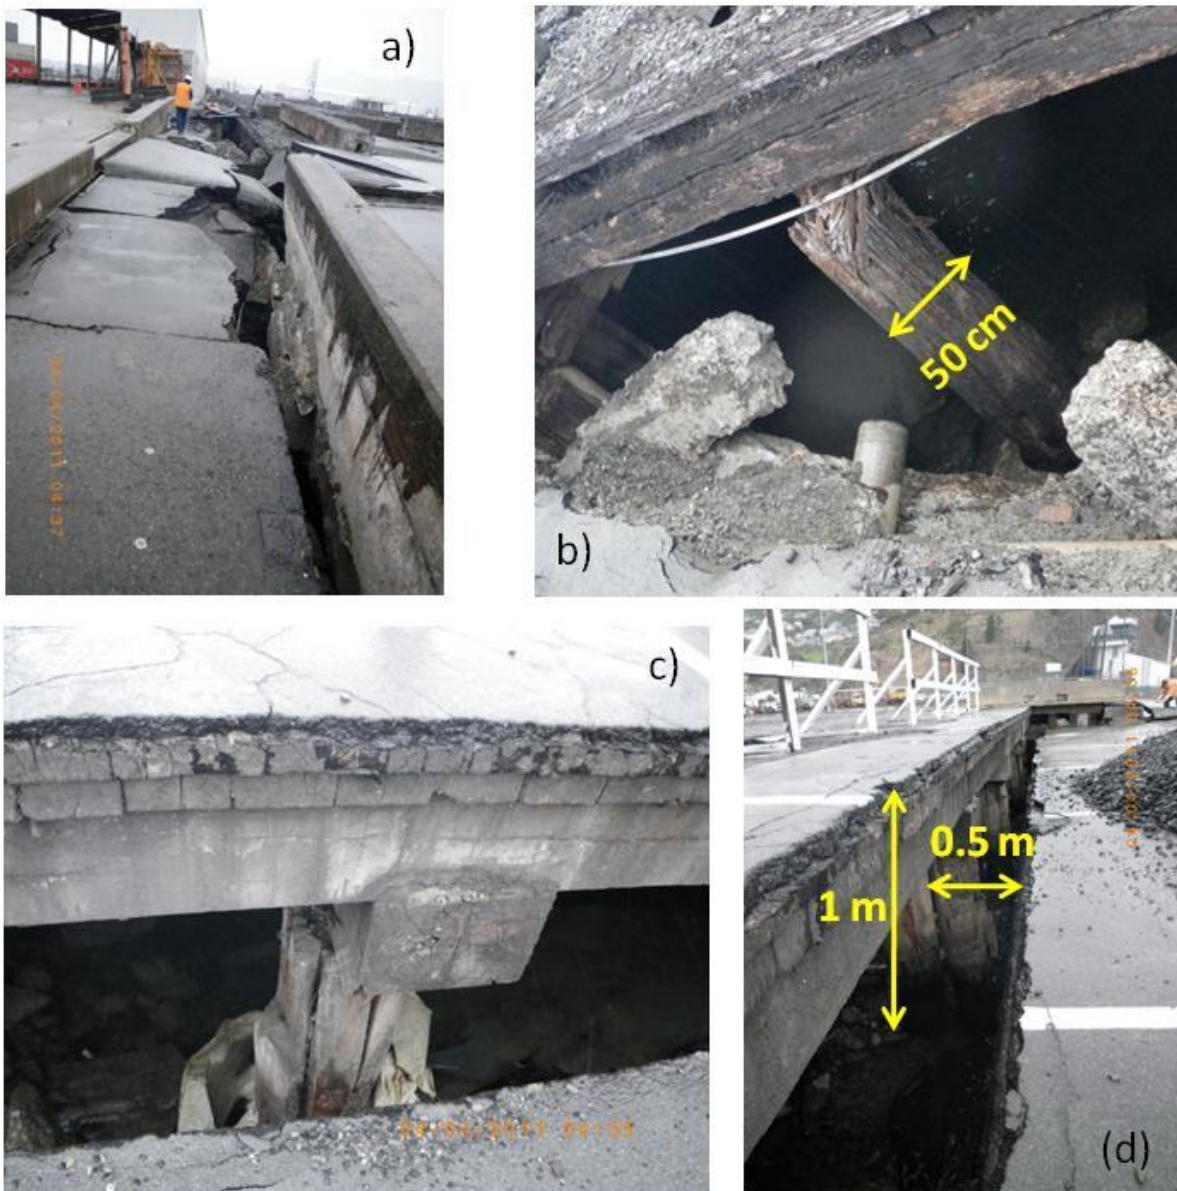
Figure 5.17. Damage of the container terminal quay (site W2 pointed in the map of Figure 5.6): a) Crack opening and distortion of the asphalt connecting the terminal with the wharves, b) Plastic hinging at the top of a timber pile of 50 cm diameter, c) Relative movement of the deck to the pile, d) Separation of the wharf to the backfill due to 1 m settlement of the backfill and outward movement of the wharf up to 50 cm.

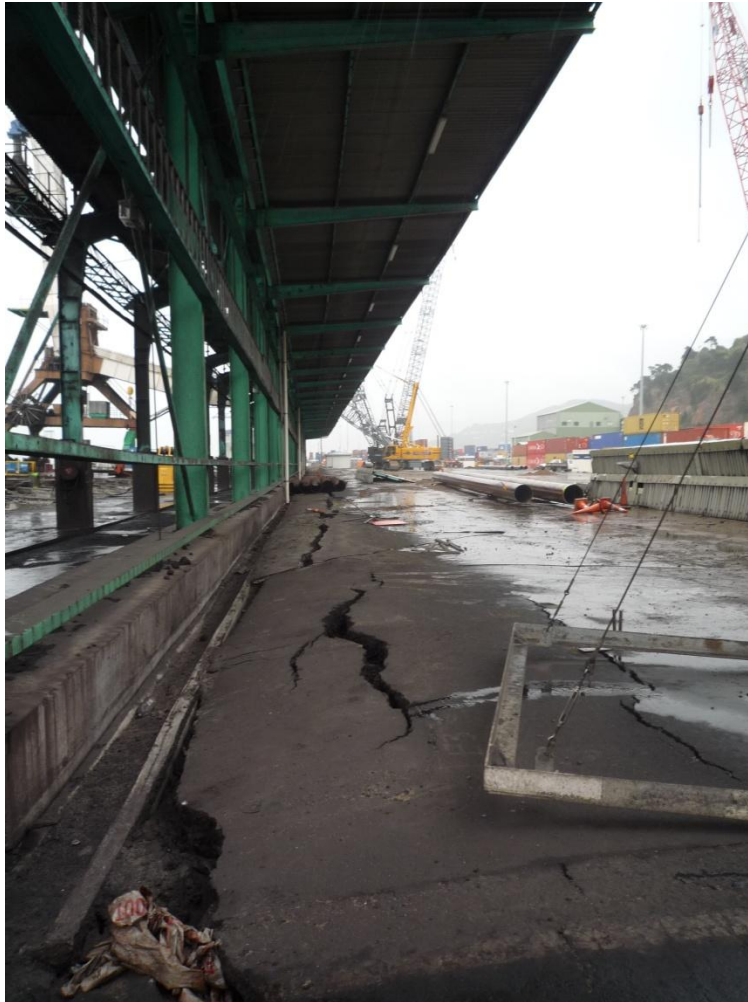
Figure 5.18. Large uniform settlement under the heavy load of the structure. Cracks in the asphalt due to heaving of the ground at right side of the steel structure (site W2 in the map of Figure 5.6)

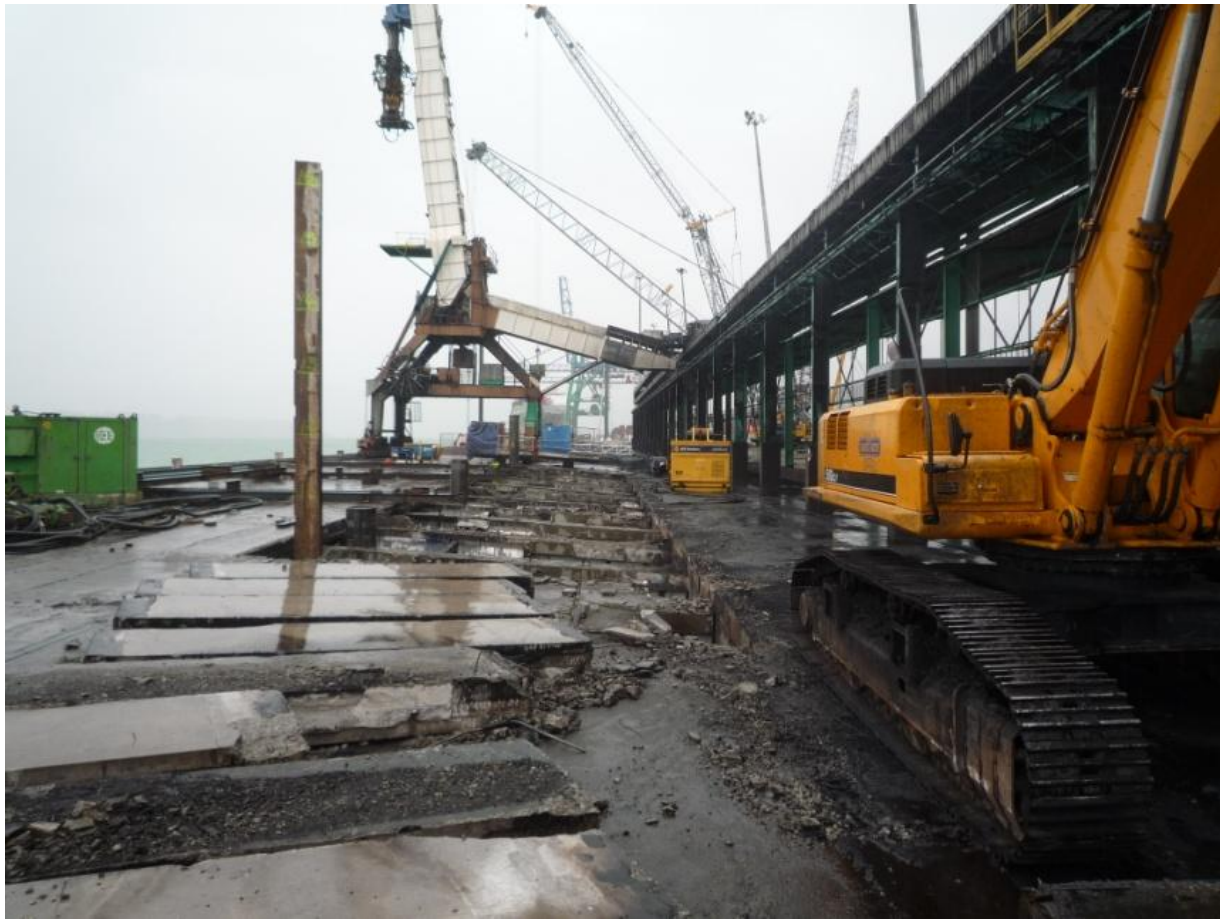
Figure 5.19. Detachment of the slabs of the platform due to differential settlement (site W2 in the map of Figure 5.6). Now the slabs have been removed from their initial place.

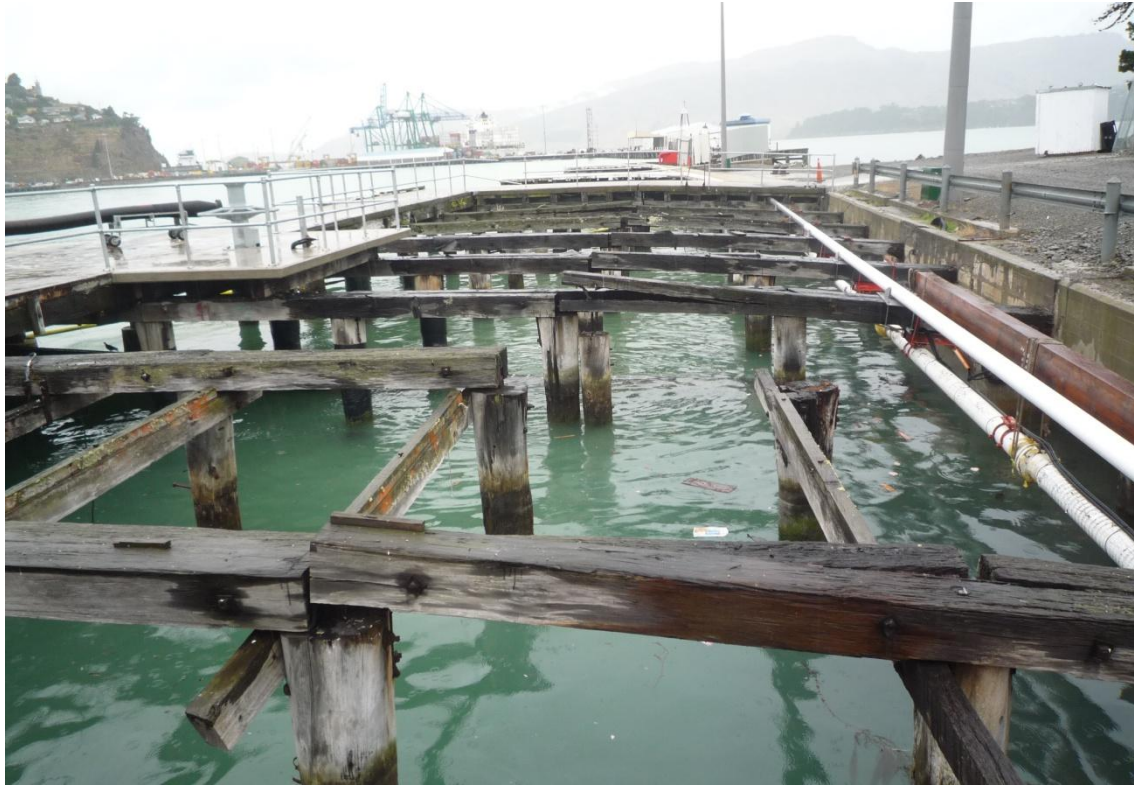
Figure 5.20. Settlement of the backfill caused detachment of the wooden beams from the pile heads (site W3 in the map of Figure 5.6).

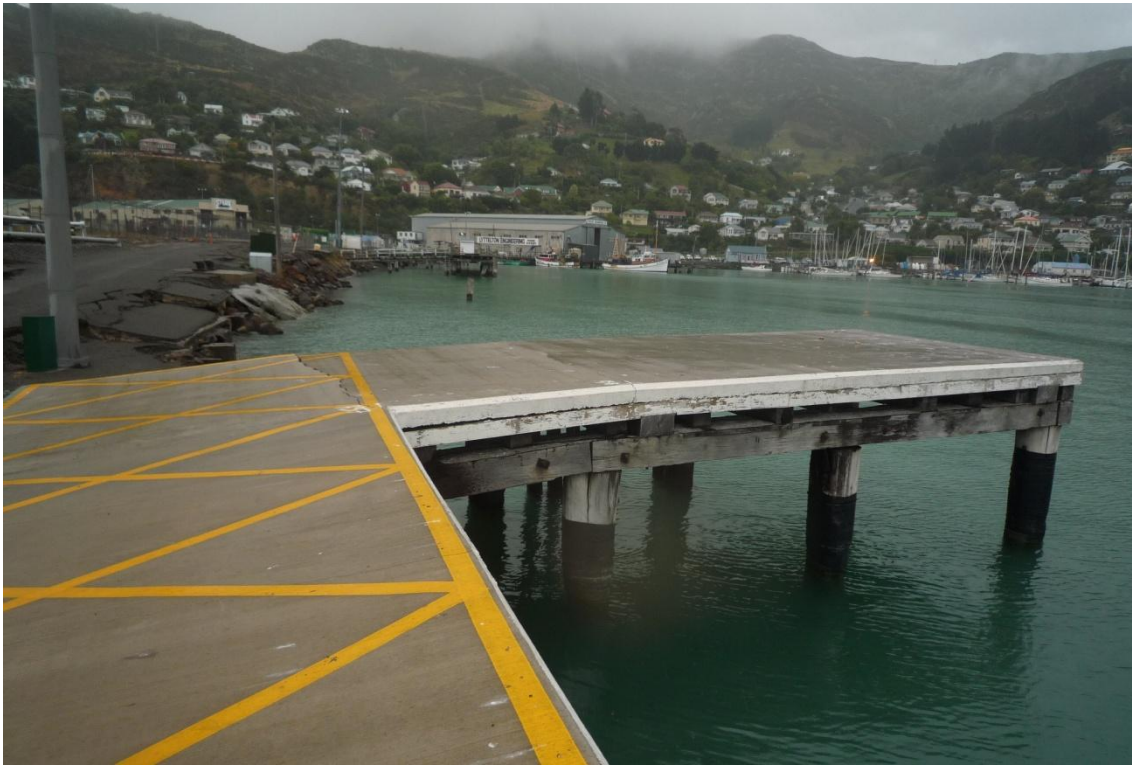
Figure 5.21. One typical pile configuration (site W3 in the map of Figure 5.6). The timber piles have cracked at the top.

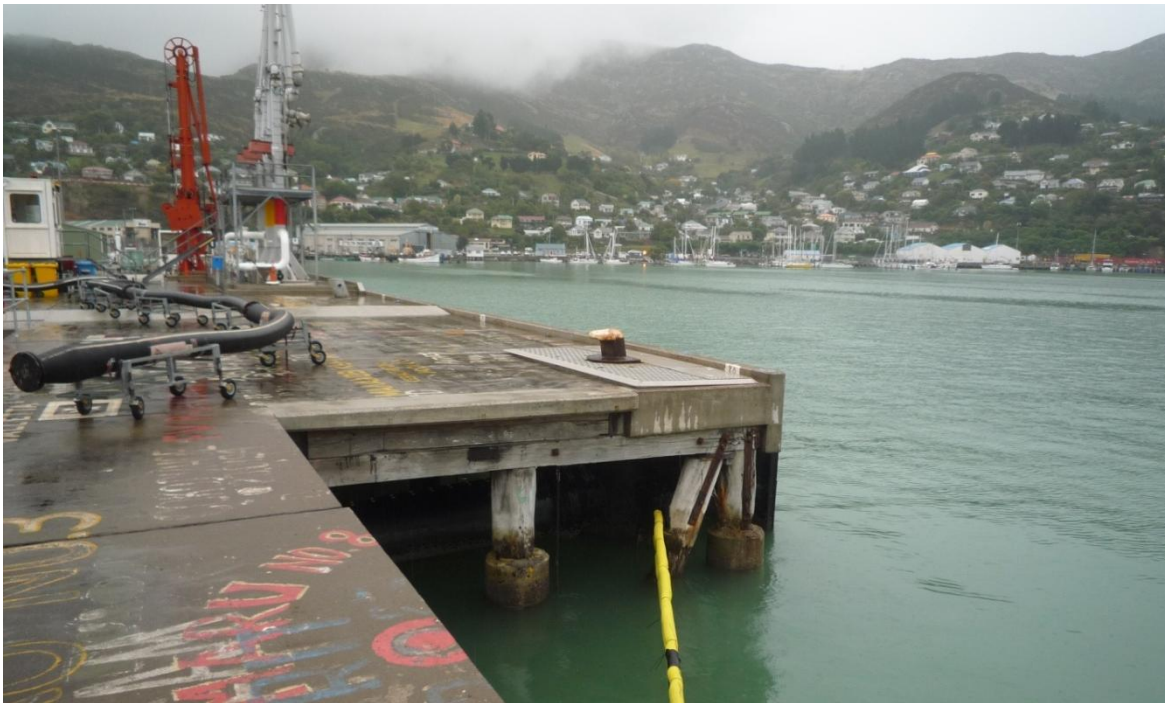
Figure 5.22. Another typical pile configuration (site W3 in the map of Figure 5.6). The concrete piles performed well.

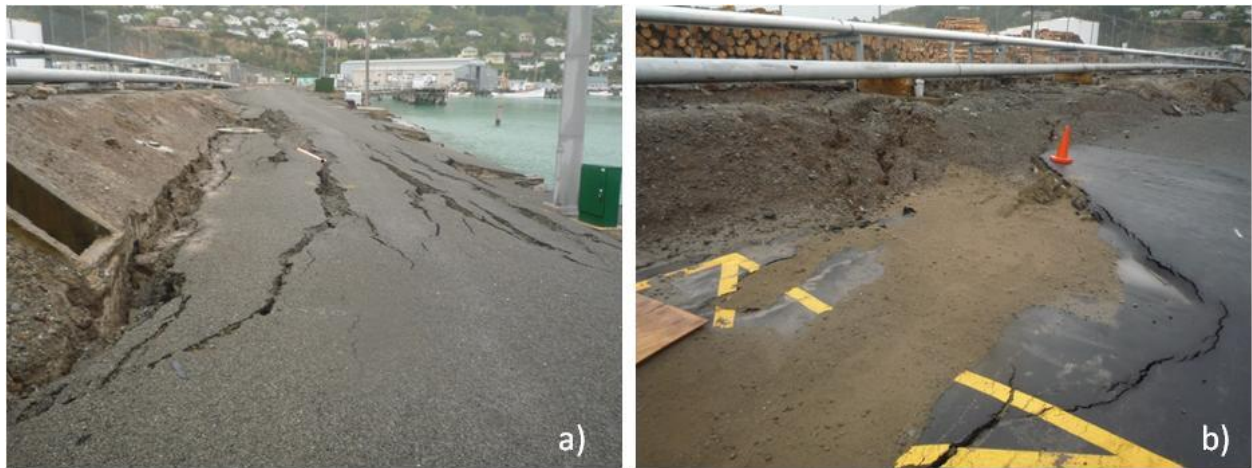
Figure 5.25. a) Cracks in the inclined asphalt due to lateral spreading, b) Ejected sand appeared on the surface indicating that liquefaction has occurred (site W3 in the map of Figure 5.6).

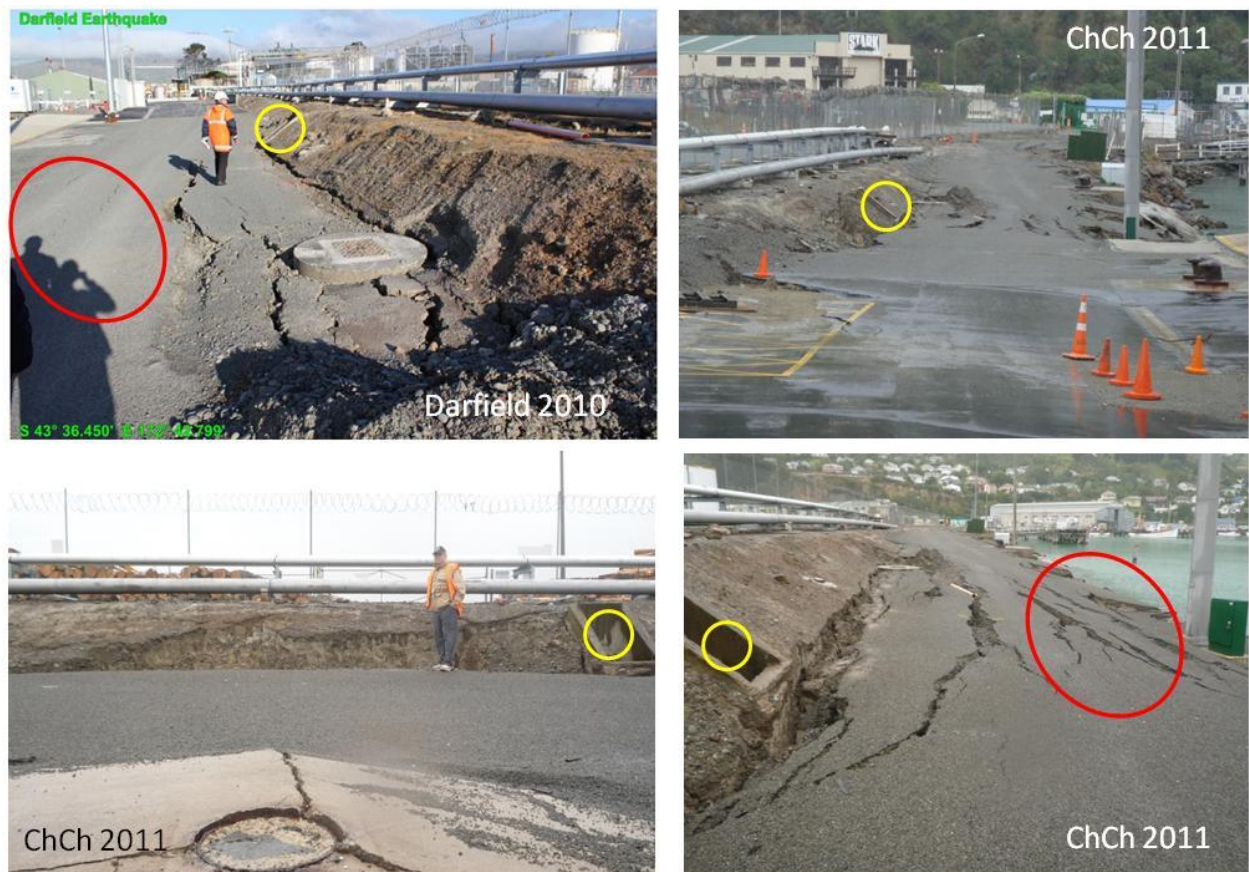
Figure 5.26. Comparison of the damage of site W3 in the map of Figure 5.6 between Darfield and Christchurch earthquakes. The yellow and red circles are the common point of references in all photos. Photograph from Darfield earthquake can be found in Cubrinovsky et al. (2010).

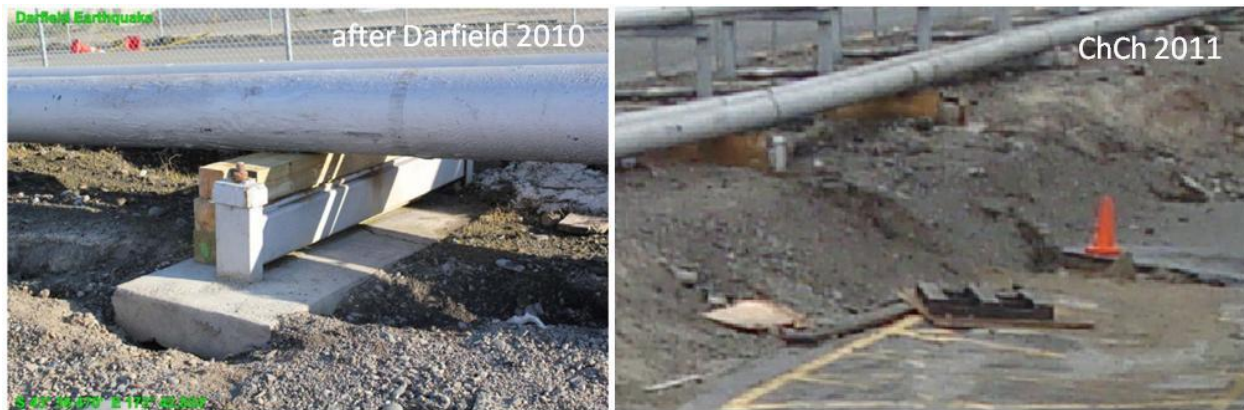
Figure 5.27. Comparison of the fuel pipe line deformation (site W3 in the map of Figure 5.6) between Darfield and Christchurch earthquakes. After Darfield earthquake, temporary wooden support was used to accommodate settlement under fuel line (Cubrinovsky et al., 2010). After Christchurch earthquake, the supports are still there and they have settled together with the fuel line. Photograph from Darfield earthquake can be found in Cubrinovsky et al. (2010).
